An Innovative Structural Solution to Failed Stabilized Earth Embankment in Multilevel Interchange

Cite this article as: Kara A., Tahoun T., “An Innovative Structural Solution to Failed Stabilized Earth Embankment in Multilevel Interchange”, *International Conference on Civil Infrastructure and Construction (CIC 2020)*, Doha, Qatar, 2-5 February 2020, DOI: <https://doi.org/10.29117/cic.2020.0116>

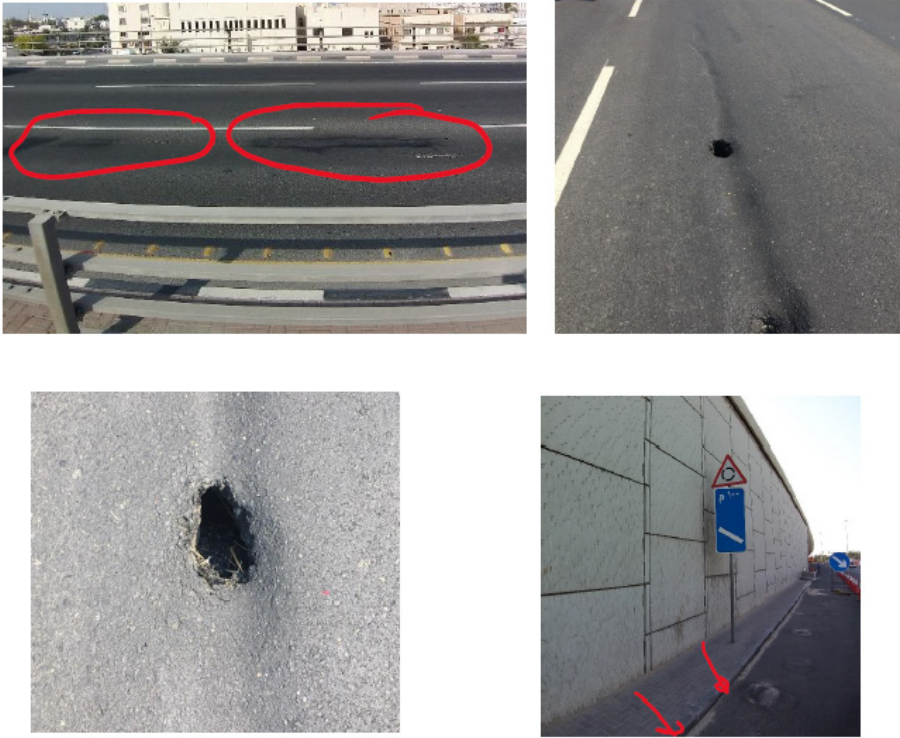
The failure was in the pavement along a deep crack in the backfilling of the ramp embankment as shown in figure 1.

Figure 1: Partial Failure

The MSE wall of embankment approach ramp was deflected by 50mm horizontally measured from top within 50m length. Deep cracks were observed in the asphalt and embankment fill. A vertical settlement of 30mm was observed at the MSE wall. The directly affected area within the ramp is an open crack of around 16m length and 2m

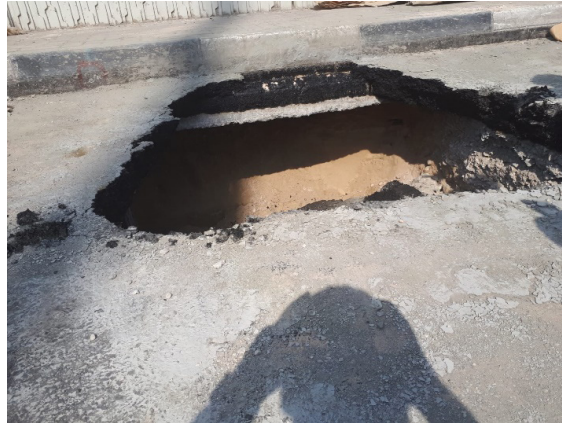
3. The repetitive migration of dune sand under the adjacent service road due to several leaks and movement of water, resulting in partial loosening of the foundation ground under the outer part of the MSE wall is the likely cause of bearing capacity failure of the MSE wall in addition to the washout cavities as shown in figure 2.

Figure 2: Washout Cavities

The likely cause of the bearing capacity failure is the repetitive migration of dune sand under the adjacent road due to several leaks and movement of water, resulting in partial loosening of the foundation ground under the outer part of the MSE wall. The movement took place at the current location since the foundation fill, because of loosening, could not carry anymore the load/height of the MSE wall. On the other hand, the sections towards the lower level of the embankment, which are mostly affected by the migration of the sand with several wash out cavities, did not fail due to their reduced height (less than 2m).

- The repair was carried out by the contractor for the service road at the areas where poor backfilling was captured, it was recommended to divert the utilities away from the MSE walls considering the limitation of the boreholes, trial pits, and geo-physical survey to capture every single area that had poor backfilling in the past.
- Any leakage of the wet utilities at the MSE wall or nearby should be treated immediately.
- As another level of mitigation, vertical permanent shoring could take place adjacent to the MSE wall at the service road level to assure that there will be no impact from the service road backfilling on the MSE walls.
- Regular inspection of the MSE wall to observe any deformation that might occur.
- Regular inspection of the pavement to report any deformation at the bridge level or at the service road if took place.

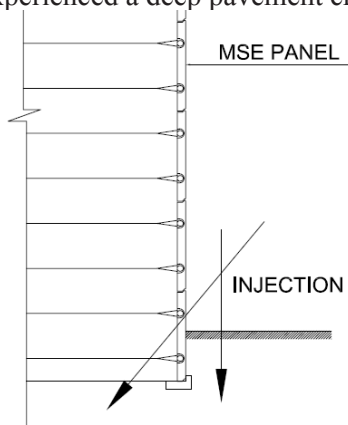
The first option was to provide grout injection at the MSE wall along with rebuilding the top two meters that experienced a deep pavement crack, please refer to Figure 4.

Figure 4: Proposed First Option

This option was not utilized due to the associated uncertainties of the size of the washout cavities that the geophysical surveys indicated. The second option was to rebuild an independent structure consisting of piles and pile cap that carries out the backfilling at the 90 meters length that experienced most of the cavities, Figure 5.

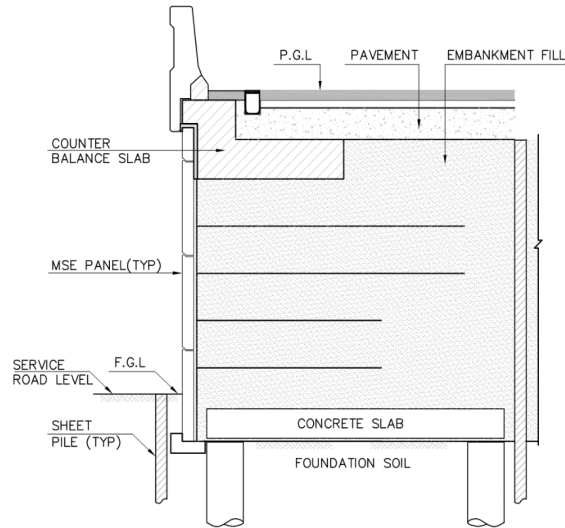
Figure 5: Proposed Second Option

This option was not utilized due to the time limitation which was set as one month for the design and construction. The time constraint for the rectification was the biggest constraint that did not allow to excavate significant depth, build piles and pile cap, then backfill the area under consideration.
