Galvanized Steel as a Sustainable Material-Technology and Failure Analysis

Abdulwahab Ibrahim

Scott MacIntyre

Cite as: Ibrahim A. & MacIntyre S., “Galvanized Steel as a Sustainable Material-Technology and Failure Analysis”, *The 2nd International Conference on Civil Infrastructure and Construction (CIC 2023)*, Doha, Qatar, 5-8 February 2023, DOI: <https://doi.org/10.29117/cic.2023.0102>

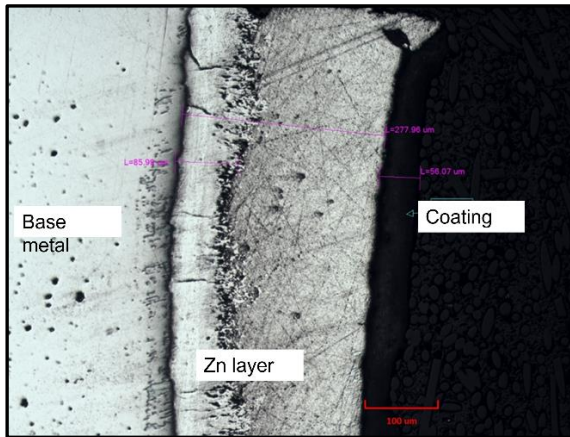
In this failure case, galvanized steel samples removed from a fire-damaged monopole were analyzed for the extent of damage. The HRB hardness, as well as the expected ultimate tensile strength (UTS) and yield strength (YS) were calculated based on the Vickers hardness values. It is found that these values closely correspond to the values obtained from the mill certificate. The result of one of the samples is shown in Table 2. The galvanized layer thickness measurements were performed as shown in Figure 1. The thickness of the sample was in the range between 188 μm and 277 μm with an average of 208 μm which was in the specification range.

Fig. 1: Zinc layer thickness

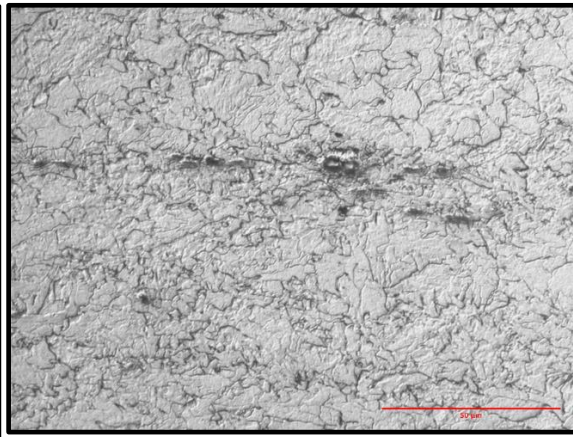
The microstructure analysis of the samples revealed a typical pearlitic structure in a banding form. Some other samples show evidence of spheroidization of pearlite, and others show evidence of carbides dispersed to the grain boundaries. Alterations of the microstructure due to heat would be evident in loss of the elongated pearlite banding generated during rolling operations. At elevated temperatures, the pearlite begins to spheroidize, or decompose into iron carbide particles that diffuse

to the grain boundaries as shown in Figure 2. The strength of the steel is typically lower due to spheroidization, but ductility is typically increased. Spheroidization only becomes a problem when large amounts of carbides are deposited along the grain boundaries, resulting in embrittlement and potential cracking. This is a problem commonly seen in furnace heating tubes that are exposed to elevated temperatures for thousands of hours (Yang & Liu, 2016; Nasiri & Mirzadeh, 2019]. Hence, even the worst heat-affected samples showed adequate hardness values and strengths to remain in service, as the minimum strength required is 300 MPa is.

Fig. 2: Grain boundary carbide precipitates

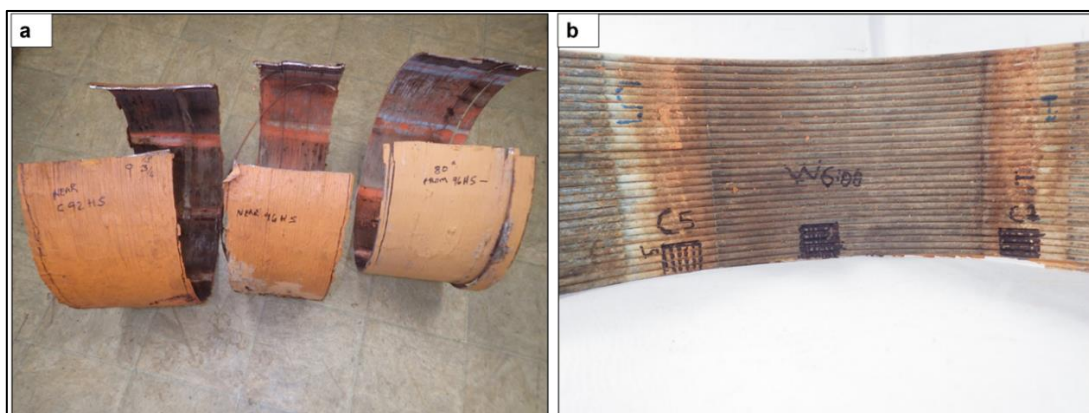
This case involves corrosion evaluation of galvanized wrapping wires used to protect the tension wire cables in a Mackay bridge. Visual inspection shows clearly that the wrapping wires suffered corrosion. Figure 3 shows the sections, after cutting, with noticeable evidence of more corrosion at 6:00 o'clock than 12:00 o'clock positions. Figure 4 shows the galvanized cables and the wrapping wires used for protection as installed. The wrapping wires were zinc coated and painted orange. There are 61 cables inside the wrapping wires and wooden plates were placed inside the wrapping cables for separation. In addition to the wrapping wires, the cables show sign of corrosion, which is mostly associated with 6:00 o'clock position, evidence of localized corrosion was seen as shown in Figure 5 and Figure 6 respectively.

Fig. 3: Wrapping wires. (a) Sections cut; (b) wrapping wires show signs of corrosion

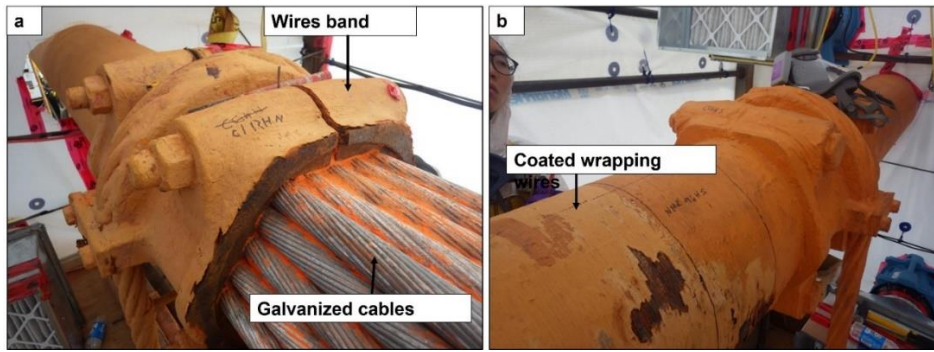
Fig. 4: Close up picture shows (a) exposed galvanized wires, (b) wrapping wires

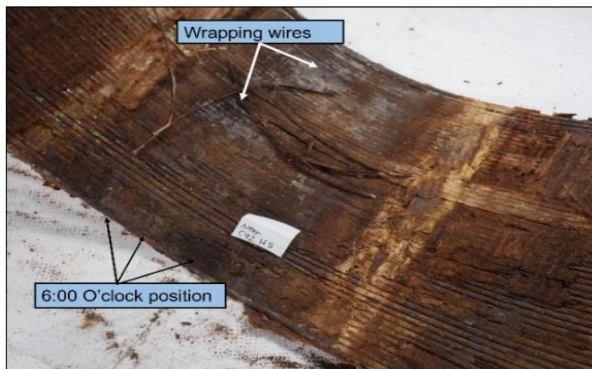
Fig. 5: Wires at 6:00 o'clock position

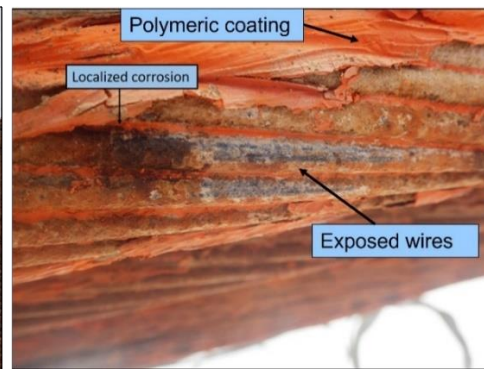
Fig. 6: Exposed wires show corrosion

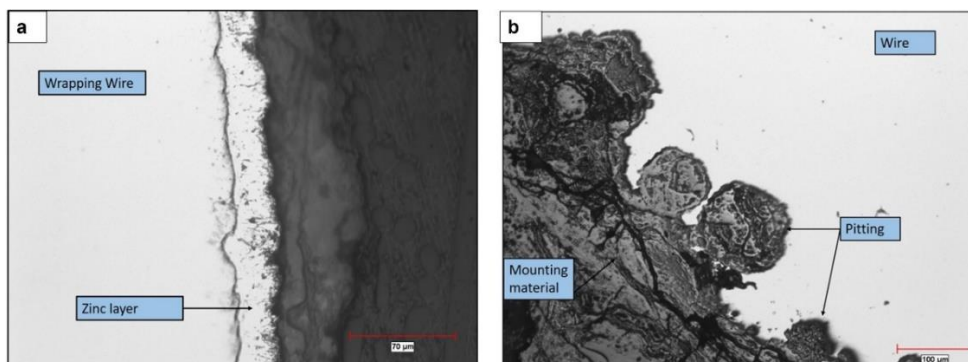
The samples' locations were chosen to represent different positions such as 6:00, 4:00, and 12:00 o'clock. Each sample consists of 5 wires mounted together. Zinc layer thickness measurement was performed at the OD and ID on each wire. Five readings were taken at each side (OD & ID) which makes 50 measurements on each sample. The results show that the zinc layer thickness is higher on the outside (OD) than inside (ID). This is apparently due to the effect of paint on the outer side of the wrapping wires. Figure 7a shows optical micrograph of unaffected galvanized layer. However, some samples show complete deterioration of the galvanized layer and signs of pitting corrosion as shown in Figure 7b.

Fig. 7: Optical micrograph of, (a) zinc layer (b) corrosion pits formed on the wrapping wire

In general, bridge wires and cables are affected by atmosphere that contains acid rain, moisture, and dissolved gases. The exposure of the bridge wires to the de-icing salt and splash are considered as factors affecting corrosion. The main factor that contributes to corrosion of the wires is water entering the wrapping wires/cables and reacting with the cables. Water may enter the wires either as a liquid or as a vapour which may condense when the temperature drops. There was clear evidence that the wrapping wires did not provide enough protection to the cables and permitted water to penetrate. The

damage primarily starts due to the deterioration and depletion of the zinc coating layer which should prevent the wires from direct contact with the environment. The deterioration of the zinc layer is mainly due to contact with water which may contain dissolved carbon dioxide and sulfur dioxide. In conclusion, the wrapping wires will help to protect the cable wires as far as they can prevent water and humidity from getting into contact with the cable wires. Dehumidification is an option to minimize corrosion of the wrapping wires.

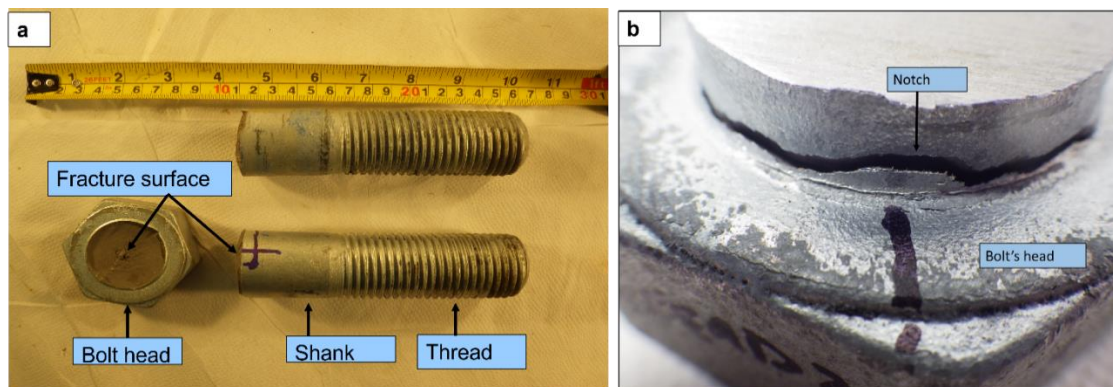
This case represented galvanized bolts that fractured within very short time. The bolt in *as received* condition is shown in Figure 8. The bolt is classified as DG 10.9. Chemical composition analysis performed shows that the bolt is made from AISI 4140 alloy steel as shown in Table 2.

Fig. 8: Bolt as received (a) bolt parts, (b) fracture position and appearance

Microstructural analysis performed on the bolt material in its polished and etched condition did not show any abnormality in terms of inclusions, banded structure, or defects. The flow pattern observed from the macrographs suggest that bolts were manufactured by forging. Fracture surface examination shows a dis-coloured crescent-like zone that initiated at the edge of the bolt head and reached ~2 mm thickness in its center. To identify the nature of the crescent-like zone, the fracture surface examined under the SEM and EDS was used for the chemical analysis.

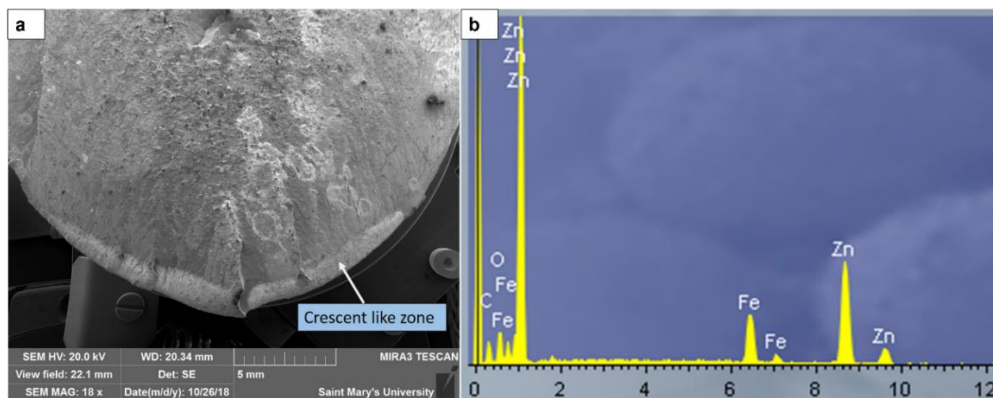
Figure 9 and Table 3 show the fracture surface and the EDS analysis, respectively. The result shows clearly that the crescent-like zone is rich in zinc (~50% by weight) and much thicker than the normal galvanized layer. This finding suggest that the crack happened during the galvanizing stage which consequentially allowed zinc to diffuse inside the crack. The crack eventually propagated and reached its critical length and the bolt failed. HDG cracks have been reported by many researchers (Elboujdaini et al., 2004; Elboujdaini et al., 1995; Carpio et al., 2010); one or more factors may contribute to HDG cracks. According to literature, local strain, hydrogen embrittlement, liquid metal embrittlement, etc. can act individually or together as a cause of cracking and failure (Mraz & Lesay, 2009).

It is reported that the cracking susceptibility during HDG increases with hardness and hence, a critical hardness threshold was proposed. Mraz proposed 34 HRC as a criterion for HDG cracking to start, the hardness measurement on the bolt material shows 39 HRC. This would suggest that the bolt

Fig. 9: SEM of the fracture surface, (a) Crescent-like zone (b) EDS shows presence of zinc

material is very susceptible to HDG cracking. Furthermore, ASTM F568M-02 standards does not recommend this type of steel (10.9) to hot dip galvanized due to its high strength and its high susceptibility for cracking during the galvanization process. In this case, other galvanizing options need to be considered such as thermal metal spry or painting.
