## **Erosion-Corrosion Behavior and Failure Analysis of Offshore Steel Tubular Joint**

*E. Mahdi<sup>\*</sup>, A. Rauf, S. Ghani, A. El-Noamany and A. Pakari*

Mechanical and Industrial Engineering Department, College of Engineering, Qatar University, P. O. Box 2713, Doha, Qatar, Tel. No: +9744034309,

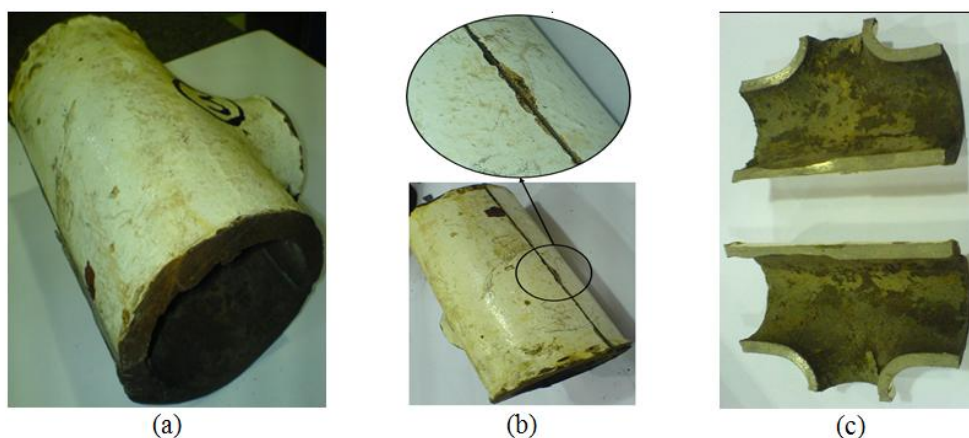
**Figure 1.** (a) The failed T-joint component (b) The leakage location and a zoomed in view (c) Two halves of tubular Joint

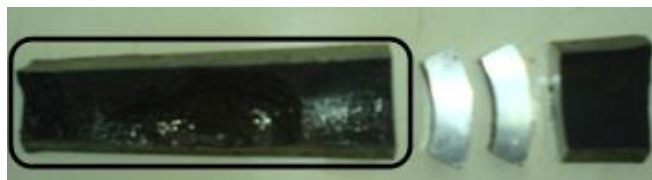
**Figure 2.** The part with the location of interest (first from the left)

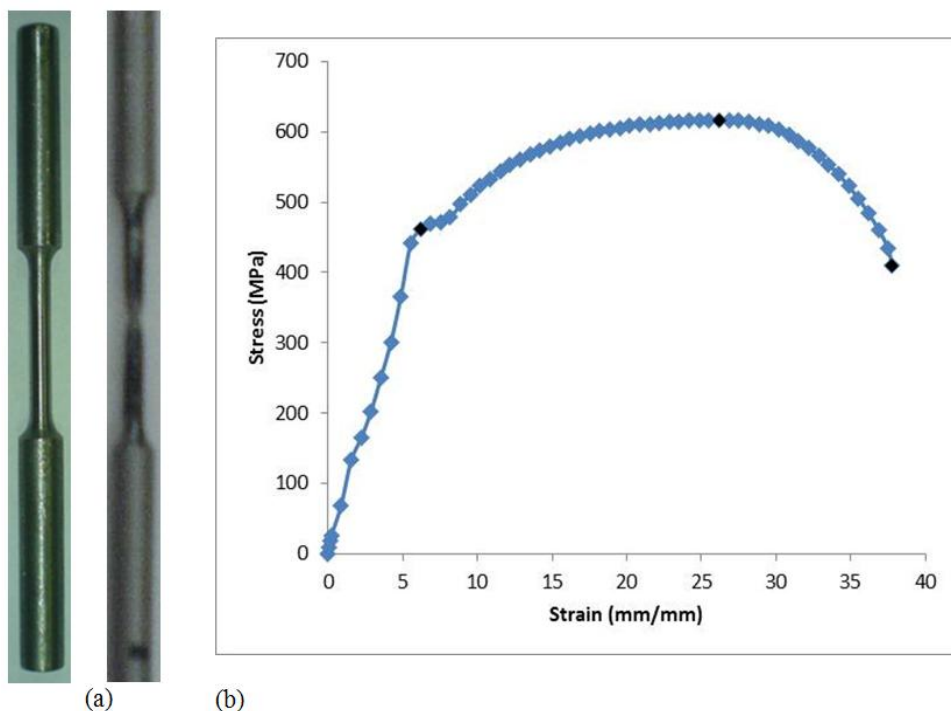
**Figure 3.** (a) Original and deformed specimens (b) Stress-Strain curve of the T-joint material

The results about tensile test are presented in Figure 3b. The ultimate tensile strength, fracture strength and the yield strength were calculated to be 628.15 ( $\pm 5.73$ ) MPa, 426.02 ( $\pm 16.01$ ) MPa and 473.85 ( $\pm 5.95$ ) MPa, respectively. Mechanical properties were calculated and given in Table 1 along with the range for these properties obtained from ref. 15. The tested material is proven to be a ductile material since necking was observed, cup and cone fracture surfaces were noted, and because its stress-strain behavior resembles that of ductile materials. The values of the properties calculated for this material lie within the range of the properties of low carbon steels. This verifies the initial guess; however, it is still early to come to a conclusion. To accurately identify the material, the microstructure examination and chemical analysis has been carried out and will be highlighted in next section.

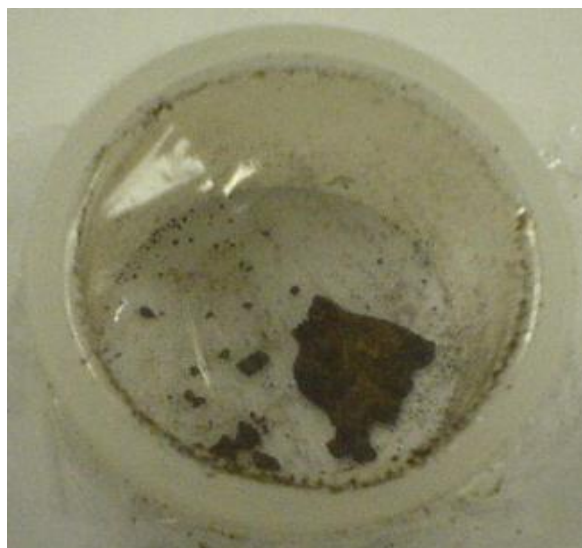
**Figure 4.** Corrosion products taken from inside the T-joint

concentration, which seems to indicate a sulfur-dominant type of corrosion attack. The presence of calcium suggests that the working fluid inside the T-joint might be sea water. Chemical analysis of the T-joint material revealed it to be low carbon steel. Compositions approximately correspond to the AISI 1026 specifications. The results of XRF analysis has been done on the corrosion products inside the T-joint showed a high content of sulfur which indicates a sulfur-dominant type of corrosion attack. Also, sea water was possibly the working fluid causing pitting corrosion.

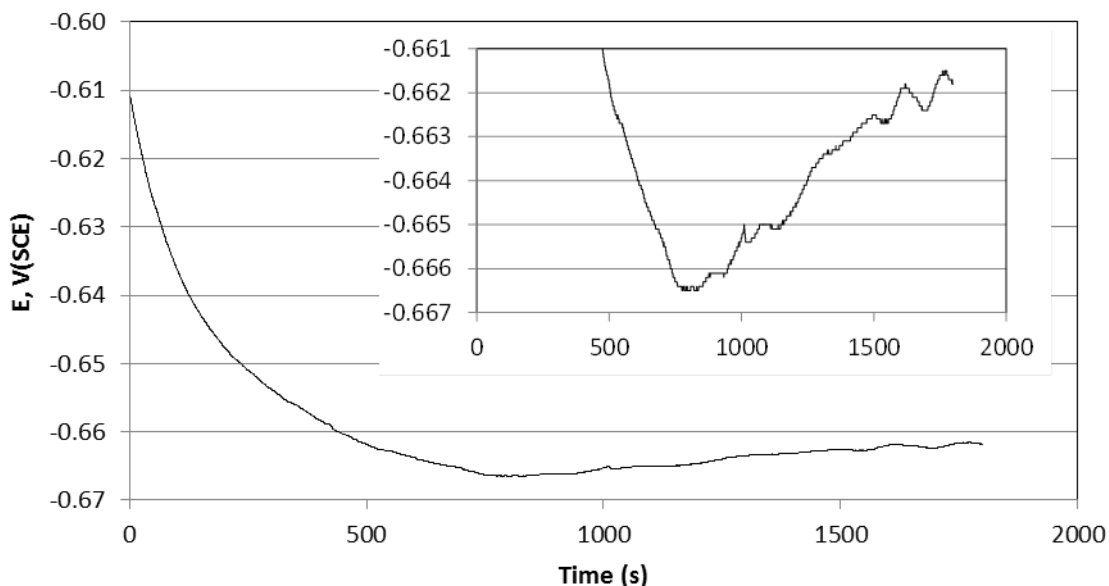
**Figure 5.** The OCP measured for the T-joint material in 0.6 M NaCl. Small pits were observed at the end of the test.

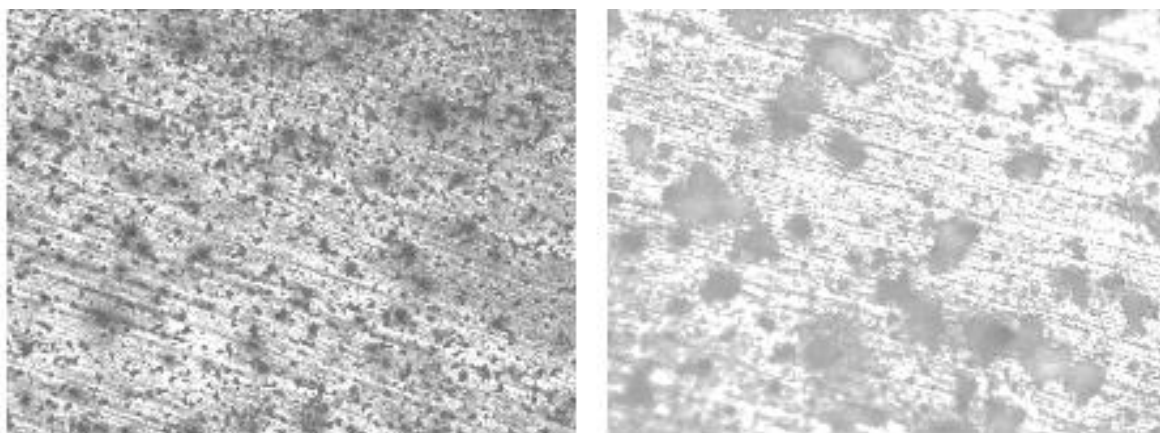
**Figure 6.** After measuring the OCP for the T-joint material in 0.6 M NaCl, the surface of the metal is shown at 500X and 1000X magnifications.

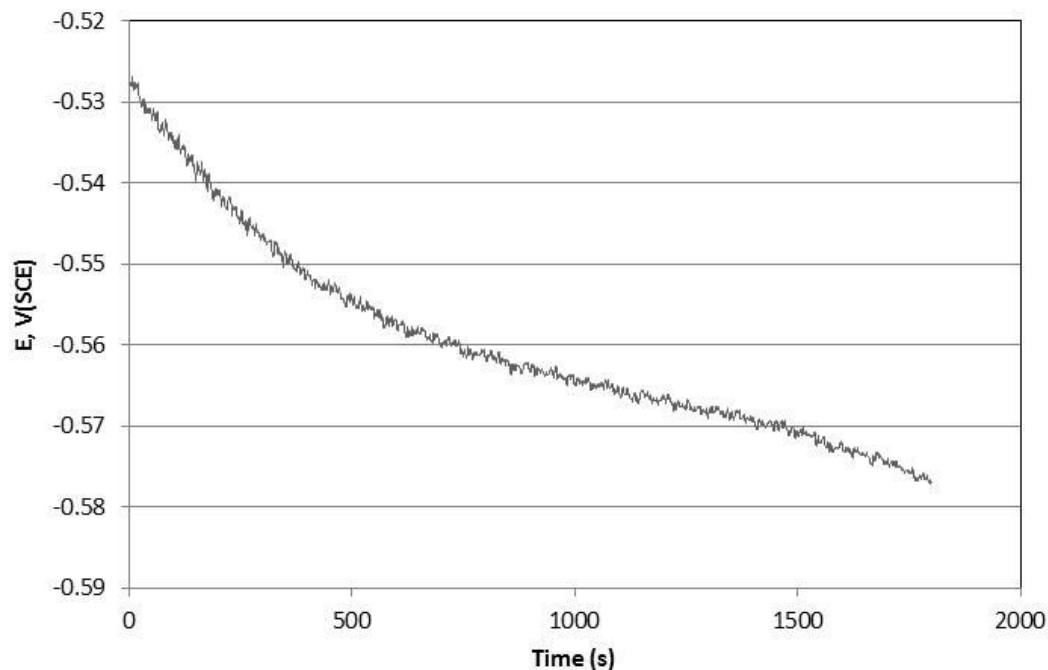
The OCP (Figure 7) turned noisier with higher fluctuations when tested with electrolyte erosion. Pitting corrosion (Figure 8) was observed after 30 min test with electrolyte erosion.

**Figure 7.** In 0.6 M NaCl, the erosion speed of 3.6 m/s was used to measure the OCP for T-joint sample. Big patches of uniform corrosion and many pits were observed.

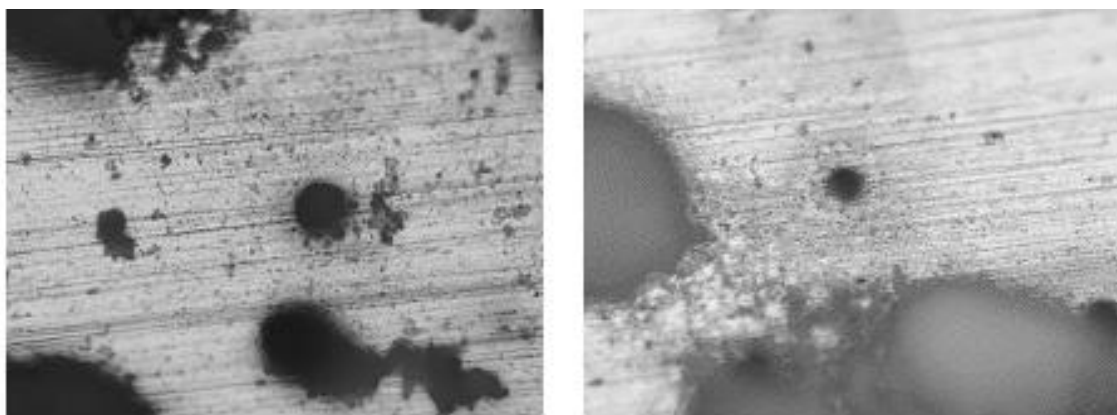
**Figure 8.** The OCP was measured with fluid erosion for T-joint sample in 0.6 M NaCl. Pits were observed at 500X magnification through optical microscope at various locations of surface of metal.

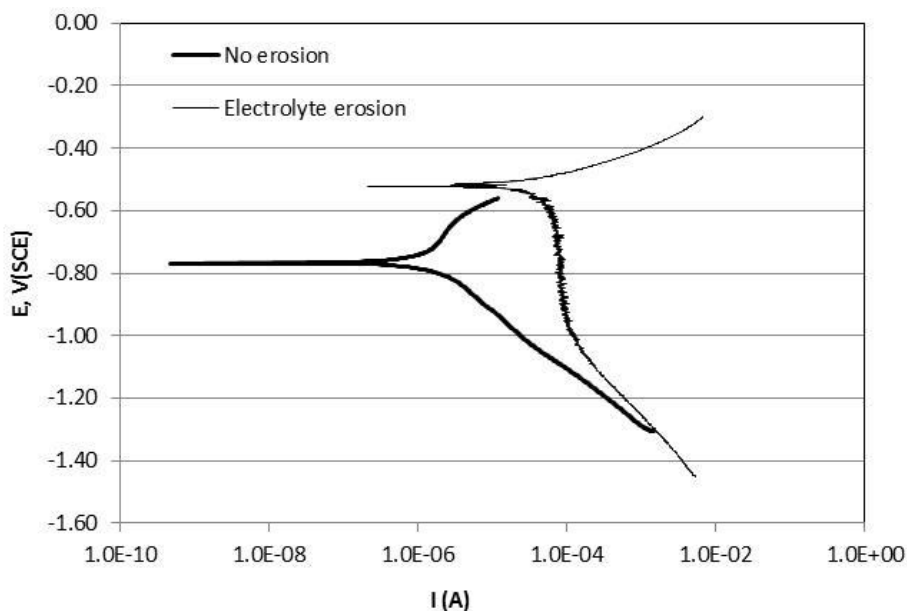
During polarization scan (Figure 9) in 0.6 M NaCl, the material sample taken from T-joint demonstrated a reasonable region of passivation. The corrosion and pitting potentials were observed at -768 mV and -630 mV vs. SCE. After finishing the scan, the surface of the metal was observed under optical microscope at 500X magnification and clear pits (Figure 10) were observed.

**Figure 9.** Pitting was observed after potentiodynamic polarization in 0.6 M NaCl without erosion for T-joint material. Corrosion and pitting potentials were found to be -768 mV and -630 mV vs. SCE.

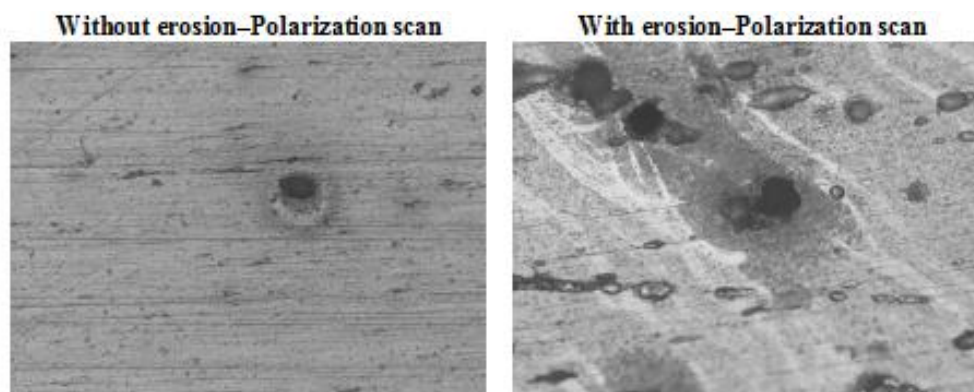
With electrolyte erosion, many large pits growing in the direction of erosion were observed after potentiodynamic polarization. Corrosion and pitting potentials were nearly at the same potential

(Figure 9) at -500 mV vs. SCE. Due to erosion the size and number of pits (Figure 10) increased as compared to the situation of unstirred electrolyte.

**Figure 10.** After scanning the potentiodynamic polarization for T-joint sample in 0.6 M NaCl without and with electrolyte erosion. In both cases, pitting corrosion was observed with the help of optical microscope at 500X magnification

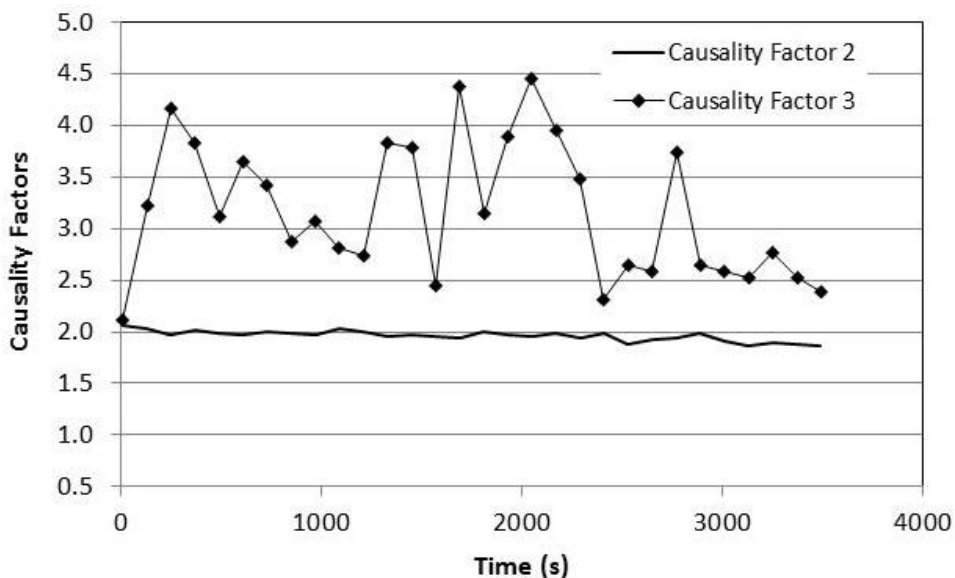
**Figure 11.** Causality Factors of EFM are fluctuating during pitting corrosion for T-joint sample in 0.6 M NaCl.

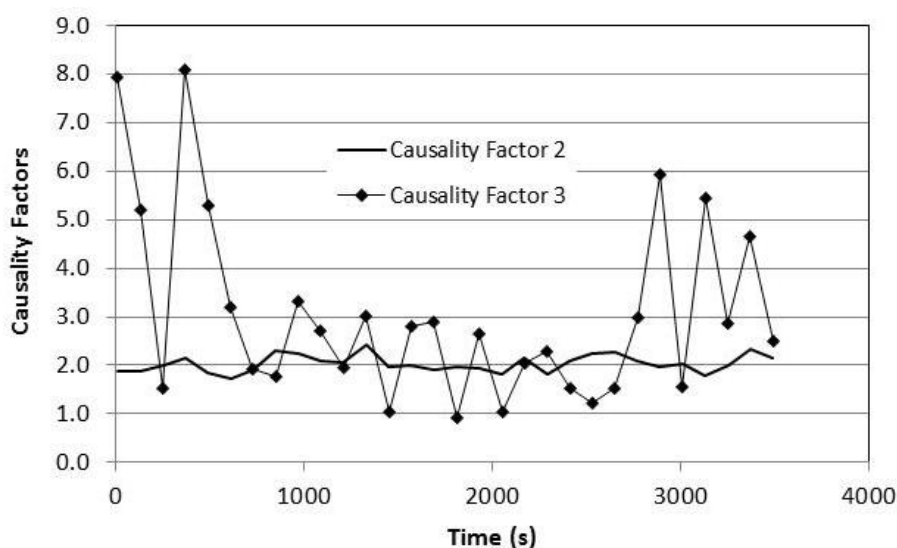
**Figure 12.** Causality Factors of EFM are fluctuating during pitting corrosion for T-joint sample in 0.6 M NaCl with electrolyte erosion. Many pits growing in the direction of erosion were found. After comparing, the size of pits was found larger than the case of without erosion.

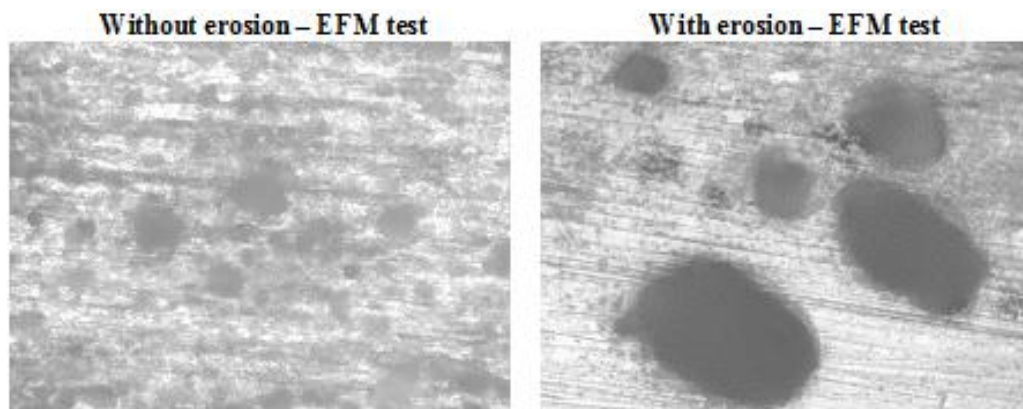
fluctuate during pitting corrosion. At the end of the experiment pitting corrosion was observed (Figure 13). Again pits were observed by using EFM measurements at pitting potential (-500 mV taken from potentiodynamic polarization) and behavior of Causality Factor 3 (Figure 12) confirmed the detection of pitting corrosion. Bigger pits (Figure 13) were observed due to erosion as compared to unstirred electrolyte.

**Figure 13.** The surface of the sample at 500X magnifications after performing the EFM tests at pitting potentials for 1 h each without and with erosion.

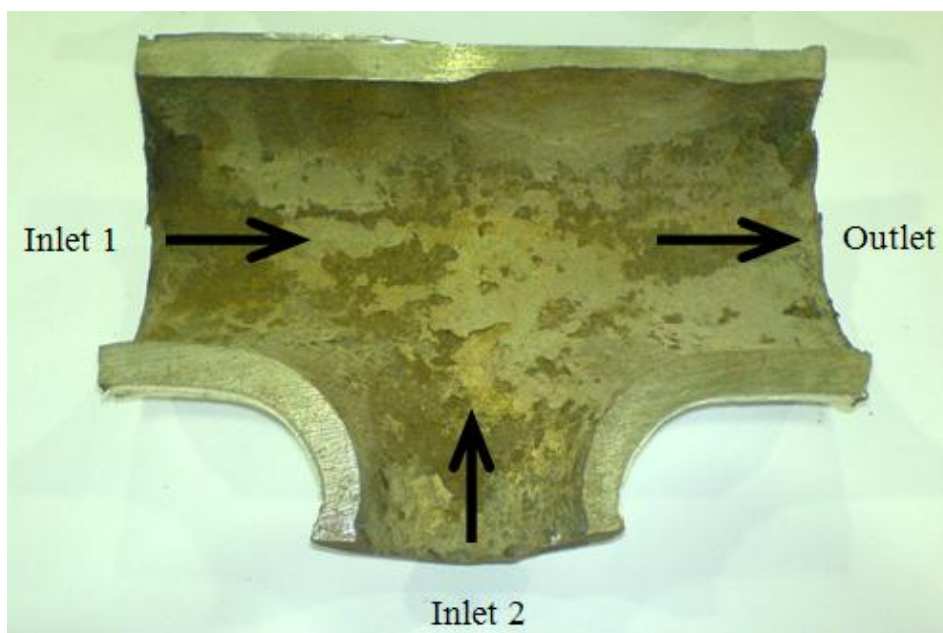
**Figure 14.** A section showing the flow direction

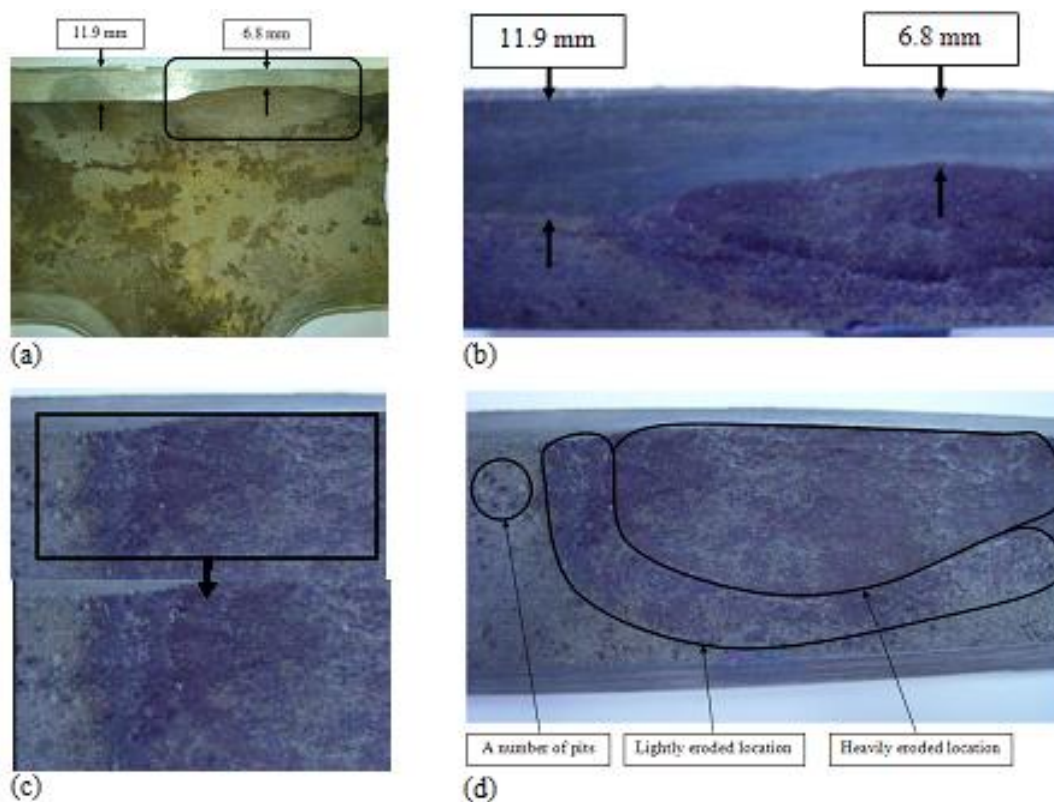
The leakage location was examined from the inner surface. The component is observed to be painted from the outside with a white colored material as shown in Figures 1a and 1b. Corrosion products are observed on the inner surfaces as shown in Figure 1c. This indicates that the material of the T-joint is susceptible to corrosion; however, the corrosion may have happened during storage. There is a possibility that some corrosion may have happened during service and lead to the failure. The leakage location and a zoomed in view are shown in Figure 1b. A localized removal of material is labeled at the inner walls of the T-joint (see Figure 15a). The direction of the flow can be determined by examining the location of material removal (Figures 14, 15a and 15b). The location of material removal is not directly opposite to inlet 2 but a little to the right as shown in Figure 15a. Figure 15d shows the effect of erosion on the thickness of the T-joint. There is a high possibility that the component was placed with inlet 2 upwards so that gravity accelerates the flow above the normal expected designed velocity; however, this is only true if the gauge pressure inside the pipe sections is close to zero.

**Figure 15.** (a) The localized material removal location (b) Magnification of erroded section (c) Erroded section showing a scattered pits location (d) Failure locations.

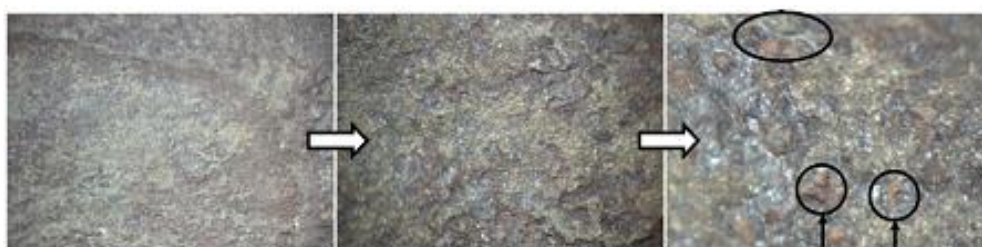
The cleaned part is examined under the optical microscope. Three locations were identified: a scattered pits location, a lightly eroded location and a heavily eroded location as shown in Figures 15 and 16. Corrosion products were detected on the part. These corrosion products either were not removed while cleaning the part or were a result of the interaction between the newly cleaned surface and surrounding medium (air and moisture).

**Figure 16.** Zoomed-in views of the heavily eroded location (magnification increases from left to right)

However, it is noted that erosion was not the only cause of leakage, but fatigue due to the fluctuation of pressure inside the piping system may have initiated a crack similar to the one seen

which caused the leakage when it reached the outer surface. The pits that were noted on the surface may have formed during shutdowns when the working fluid stagnates in the rough eroded surface. These pits may have acted as starting points for cracks which grew due to fatigue and caused the leakage. It is also possible that one of the pits grew till it reached the outer surface of the T-joint and caused the leakage. Erosion, corrosion and fatigue are most likely the three main factors that resulted in the T-joint failure.

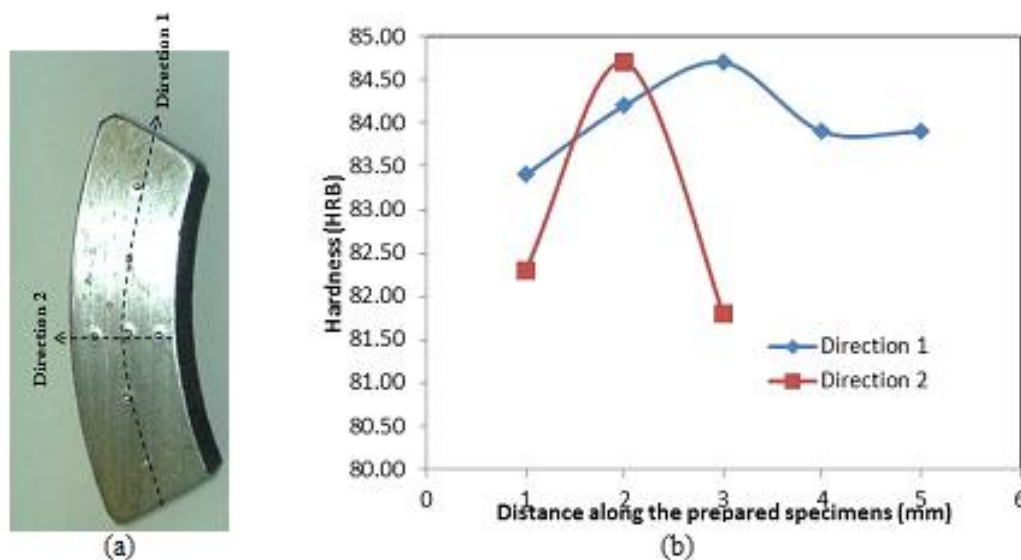
The hardness test was applied to the specimen in two directions as shown in Figure 17a. The hardness along direction 1 and 2 is presented in Figure 17b. It can be seen that there is almost no variation in hardness along direction 1, while the hardness is higher at the middle of direction 2. Using the average hardness the tensile strength of the T-joint material can be roughly approximated. Using the Standard Hardness Conversion tables the tensile strength is approximated. The average Hardness is 83.5 HRB which is equivalent to 160.5 HB. The relationship between the ultimate tensile strength and the hardness is

From the tensile test, the strength is approximately 628.15 MPa. The %deviation is approximately 11.85%. From Figure 17b, it can be seen that there is almost no variation of hardness along direction 1, while the hardness is lower near the edges along direction 2 which can indicate that the material is more vulnerable to scratch or indent at the locations where the hardness is lower. Hardness tests across the section cut through the T-joint showed a soft inner zone, followed by a harder zone and then a soft zone which can mean that the outer layers of the T-joint lost carbon due to the heat treatment during manufacture. Also, by performing the hardness test an approximation of the tensile strength of the T-joint material have been found.

**Figure 17.** (a) The specimen prepared for hardness test (second from the left) (b) Hardness along directions 1&2 as shown in (a)

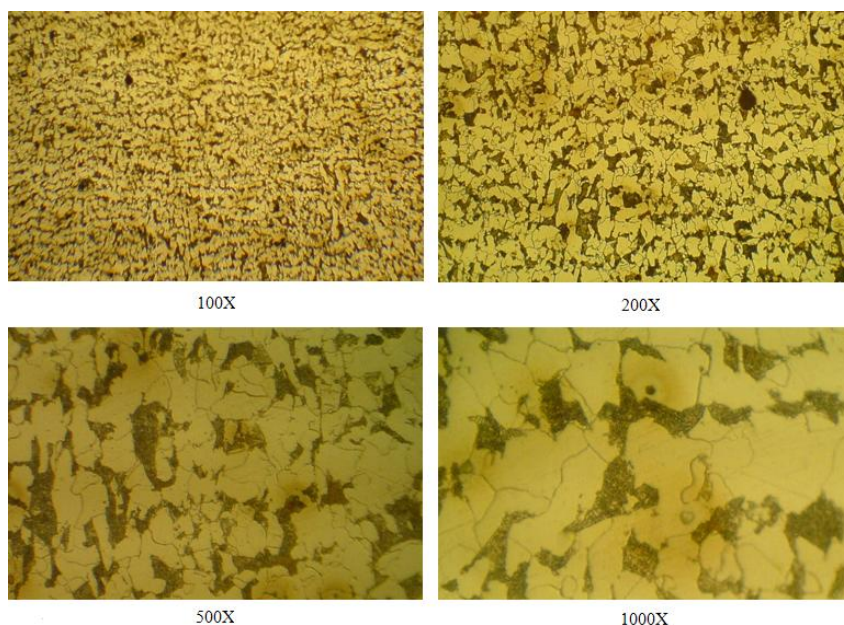
The microstructure at different magnifications (100X, 200X, 500X and 1000X) is shown in Figure 18. The fact that the microstructure was revealed using Nital validates the assumption that the material used to make the T-joint is Carbon Steel. To determine more information concerning this material, the microstructure at a magnification of 1000X is further studied (Figure 19). Two phases can be seen in the microstructure; the light Ferrite and the dark Pearlite phases. The availability of those two phases indicates that the material is Carbon Steel with Carbon content in the range from 0.022 to 0.76 wt% C. The Ferrite phase is a soft and ductile phase, but the Pearlite phase is a hard and brittle phase. The Ferrite phase is available in more quantities than the Pearlite phase. The ratio is approximately 7:3. This indicates that the material is actually Low Carbon Steel (0.05 to 0.25 wt% C). Due to the existence of those two phases, the material properties are expected to be intermediate between them but a little closer to the properties of the Ferrite phase since it is available in more quantities. Also, the metal has likely been slowly cooled during the heat treatment of manufacturing process. ASTM E112 standard test methods considers one of the most widely cited ASTM standards,

This indicates that the material has small grains. In addition the heat treatment or manufacturing process of the material included a slow cooling process. The material is believed to be soft and ductile rather than hard and brittle; with generally good mechanical properties.

Figure 18. The microstructure of the T-joint at different magnifications (as indicated)

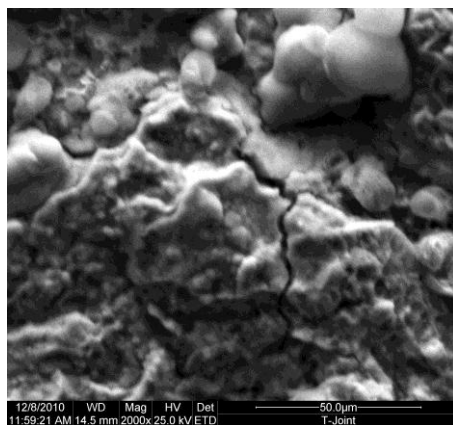
Using the scanning electron microscope, two of the three parts are scan at five magnifications (100X, 250X, 500X, 1000X and 2000X). The first location is a heavily eroded while the second location is a scattered pits location. At 1000X, the second location is scanned for the elements present and their relative quantities. The SEM images of the two scanned locations at 2000X are shown in Figures 22–26. The Energy-dispersive X-ray spectroscopy (EDS) spectrum was obtained at 1000X magnification. Note both locations are characterized by a rough surface. Some areas are characterized by a white foam or bright appearance. On the first surface, deposits and cracks are noted. On the second surface, cracks and an inclusion are noted. The cracks noted in the heavily eroded location (first location) are longer and are available in larger quantities than in the scattered pits location (second location). The EDS spectrum shows a number of elements that the material of the T-joint is composed of and foreign elements. The foreign materials are Aluminum (Al), Calcium (Ca) and Oxygen (O). The rough surfaces are an indication of erosion. The white foam or bright areas in the images shown above represent corrosion products. The noted cracks indicated that stresses on the T-joint (due to the pressure of the fluid inside) have contributed to the failure. As shown, the cracks are longer and are available in larger quantities in the eroded location which can be explained by noting the thinning that has occurred due to erosion. Note that the rough surface helped to some extent in trapping the cracks and stopping crack growth; however, with repeated loading, the crack eventually reached the surface and caused the leakage which was reported. The foreign elements may represent the inclusions, deposits (that may have come from the working fluid inside the T-joint) or corrosion products. Aluminum is believed to have been identified when scanning the inclusions. On the other hand, Calcium is believed to have been identified when scanning the deposits. Oxygen is believed to have been identified when scanning corrosion products. The working fluid inside the T-joint is probably sea water as Calcium was found in the form of what is believed to be deposits on the inner surface of the T-joint.

Figure 22. The SEM image of the first location at 2000X

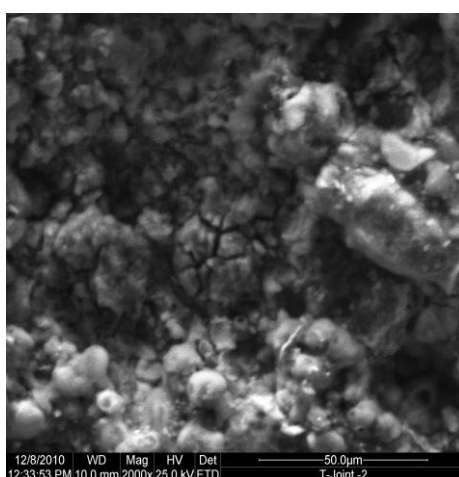
Figure 23. The SEM image of the second location at 2000X

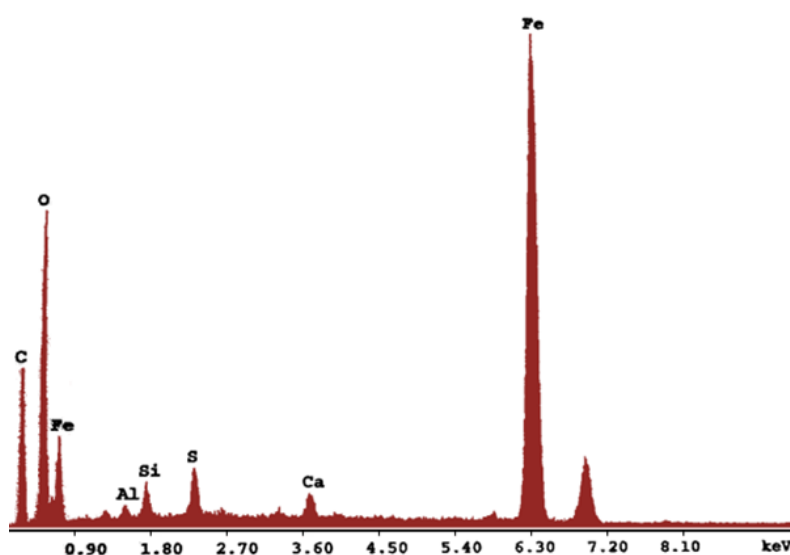
Figure 24. The EDS spectrum of the second location

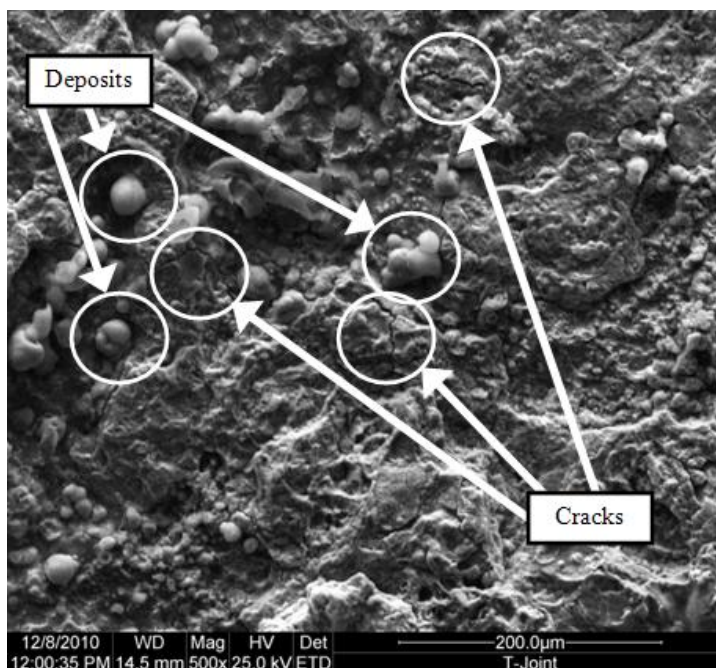
**Figure 25.** The SEM image at the first location at 500X showing deposits and cracks

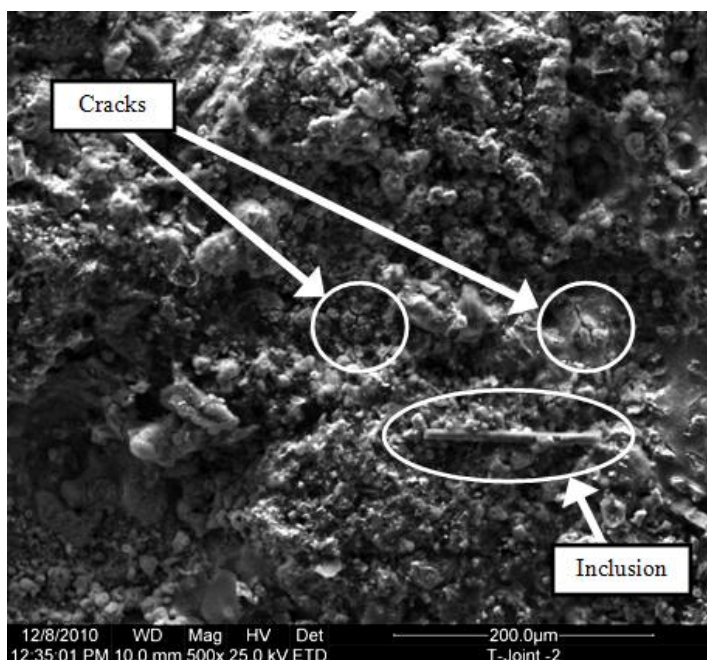
**Figure 26.** The SEM image of the second location at 500X showing cracks and an inclusion

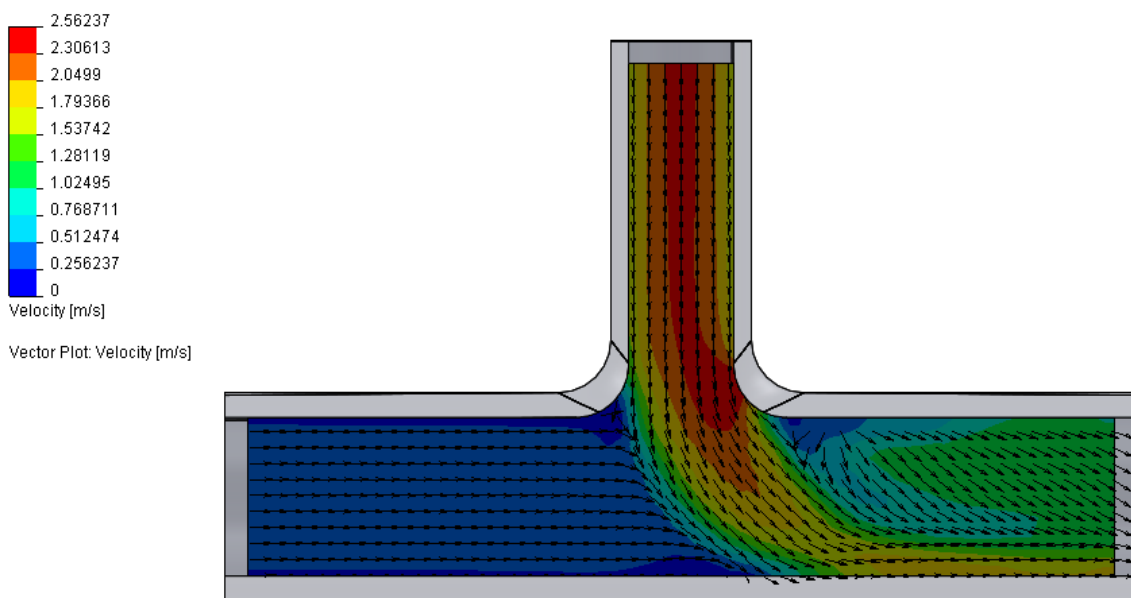
**Figure 28a.** A cut plot of the velocity contours and vectors of the T-joint model

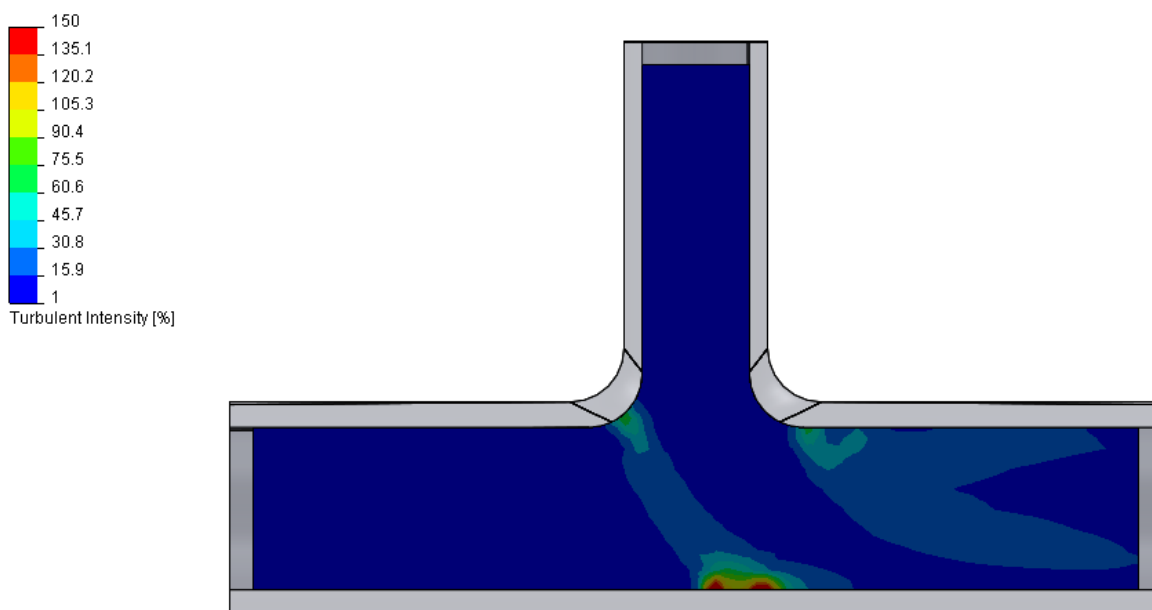
**Figure 28b.** A cut plot of the turbulence intensity contours of the T-joint model

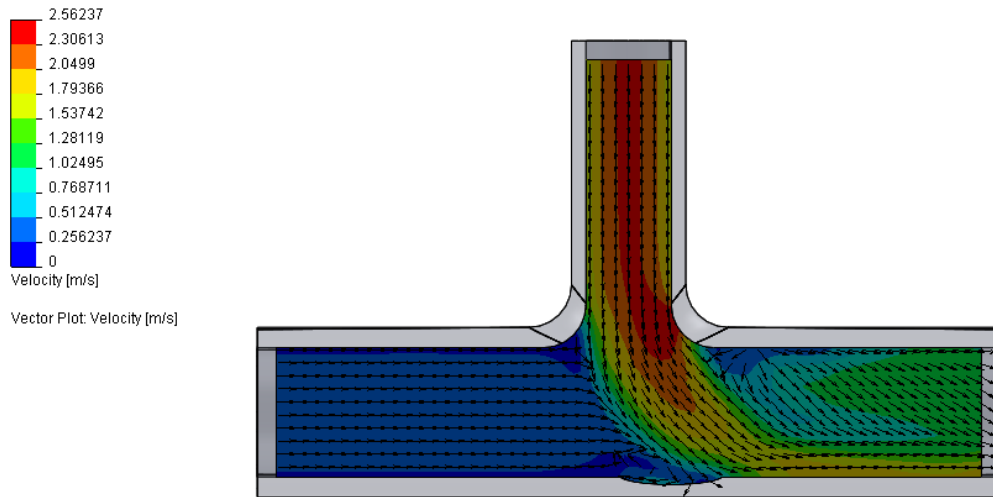
Figure 28c. A cut plot of the velocity contours and vectors of the eroded T-joint model

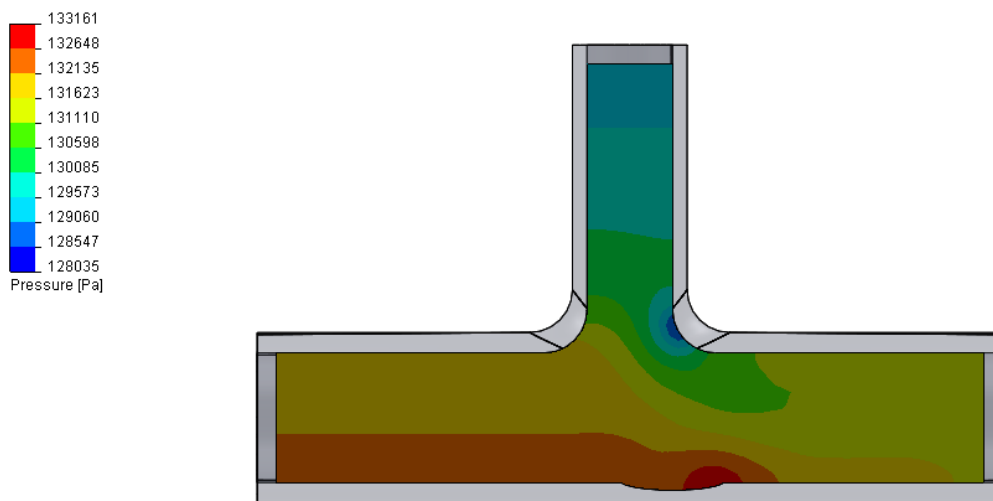
Figure 28d. A cut plot of the pressure contours of the eroded T-joint model

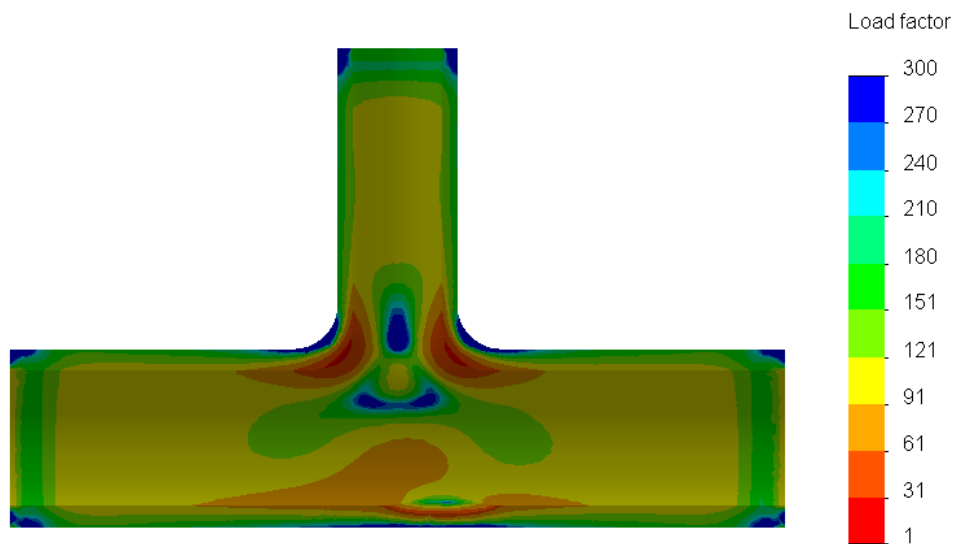
The failure mechanism includes the combined effect of erosion, corrosion and fatigue. The failure mechanism is believed to be as follows:

- Fast flowing fluid continuously eroded the surface.
- Corrosion has occurred throughout the lifetime of the component.

- The combined effect of erosion and corrosion accelerated material removal in the location under the most sever conditions.
- Pits formed on the rough eroded surface where water stagnates during shutdowns.
- Pressure variations initiated small cracks on the rough eroded inner surface of the T-joint, or the cracks initiated from one of the pits.
- As pressure fluctuated inside the T-joint, the cracks in the weakest location started to grow till it reached the outer surface.

Figure 28e. A section plot of the fatigue load factor of the eroded T-joint model

The material of the T-joint is Low Carbon Steel (AISI 1026). Inclusions are noted in the material. The harsh working conditions are believed to have caused the failure. The failure is believed to have started with erosion which reduced the thickness of the wall at the location of leakage. General corrosion and pitting are believed to have helped in initiating a crack which ultimately led to leakage when it reached the outer surface of the T-joint. The crack grew due to the fluctuation of the pressure inside the T-joint. Using a Y-joint is believed to be one of the possible solutions for this failure.
