## Failure Analysis of 316L Air Cooler Stainless Steel Tube in a Natural Gas Production Field

The purpose of this work was undertaken to study an industrial case regarding the failure behavior of 316L SS air chiller tube supplied by a Qatari Gas Company. Macroscopic failure characteristics of the specimens were examined using SEM and XRF techniques.

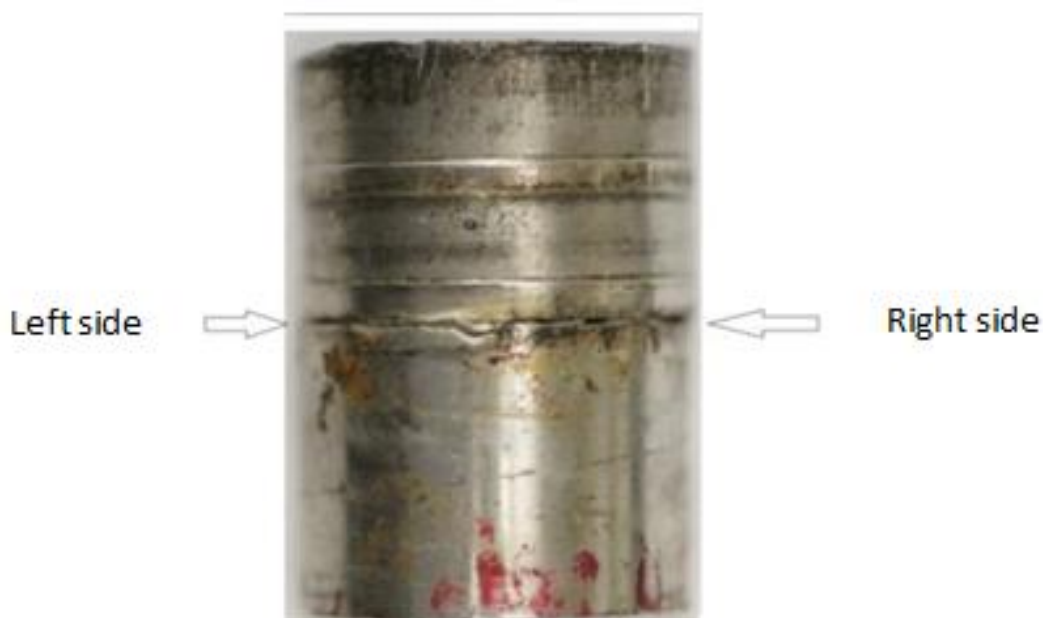
In this work a detail failure analysis of 316L SS air cooler from a Qatari Gas company with a peripheral crack at the edge of the roll expansion close to the clamping area is performed. Figure 1 shows photograph of the as received failed 316L stainless steel tube connected to the cooler pipe.

**Figure 1.** Overview of the as-received failed tube connected to the cooler pipe. Arrows refer to the inspected regions.

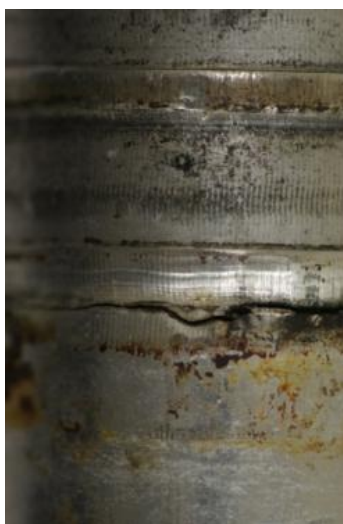
**Figure 3.** Photograph image for the crack region of 316L SS tube.

Visual examination of the cracked tube section was performed by naked eye and a digital camera before and after cutting. Digital imaging of the fracture surface clearly revealed the crack was localized at the center of tube and adjacent to the clamping area, as shown in Figure 3 .

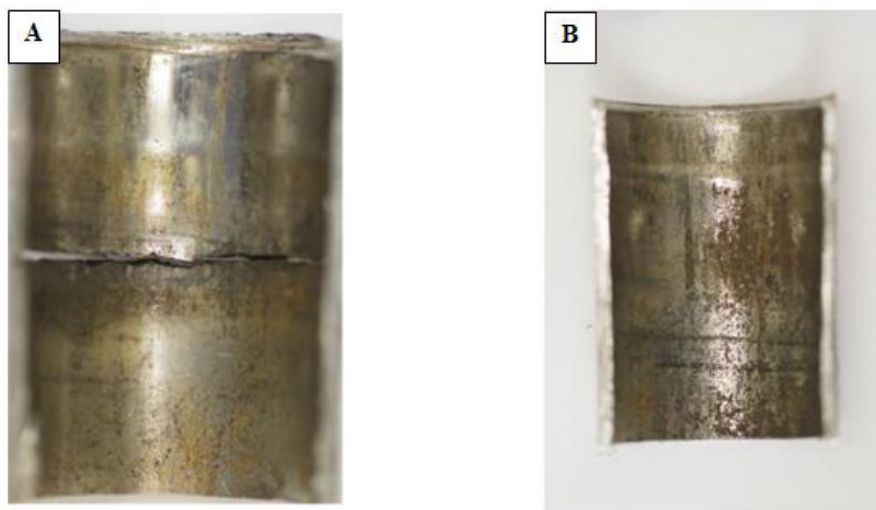
**Figure 4. [A and B].** Show the inners cross section of 316L SS tube after cutting.

The sectioned sample showed accumulation of corrosion products at the inner surface which was even denser at the outer side, as illustrated in Figure 4 [A and B]. Correspondingly, the fracture surface at the central region showed a deep dark color (pointed out in Figure 5), which was more intense and closed to the inner surface, as depicted in Figure 2 [A, B and C]. However, the black tint diminished in magnitude towards the ends of the crack area, see the regions 1, 2 and 3 in Figure 2. A release of the pronounced internal stresses was noticed during the cutting of the tube e.g. sudden brittle failure occurred and the part fell into several pieces although the cutting was done ca. 1cm apart from the failure.

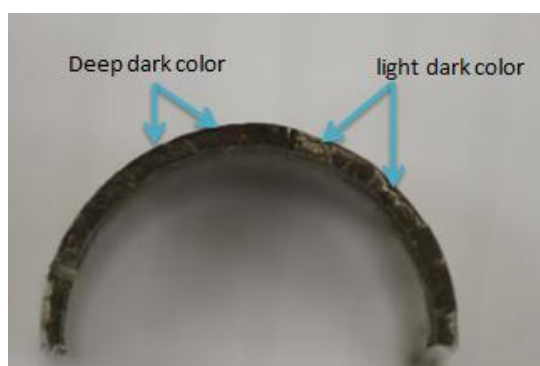
**Figure 5.** Overview of the fracture surface of 316L SS tube showing heavy oxidized regions (deep dark color) and less oxidized places (light color).

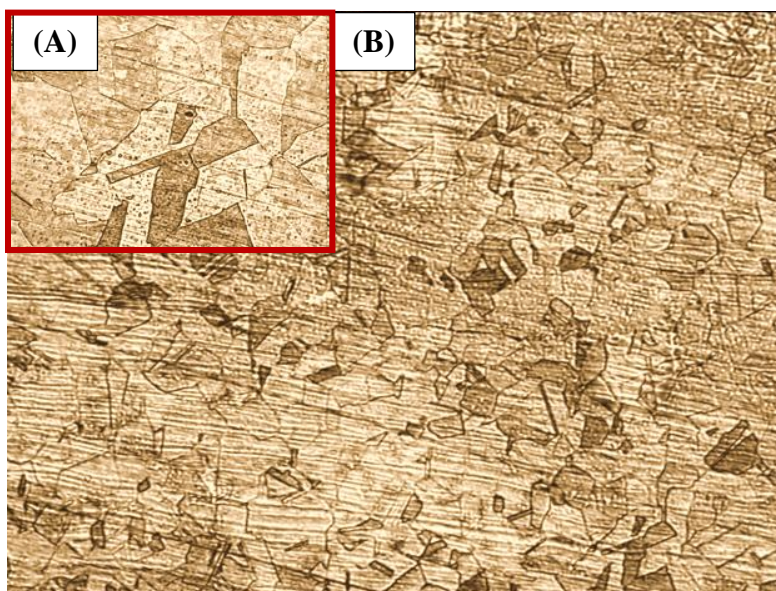
**Figure 6.** Optical microstructure of 316L SS air cooler tube using Fry's reagent at (A) 50X and (B) 10X magnifications.

Figure 6 shows the microstructure of 316L stainless steel. The average size of the austenitic grains (austenitic isles in a continuous matrix of ferrite) is about  $30\ \mu\text{m}$  which is reasonable in case of 316L stainless steel. It may be observed that different types of corrosion induced by  $\text{Cl}^-$  resulted in failure of the tub. The first type is chloride induced fatigue cracking corrosion due to internal cyclic stress, resulted in ductile fracture. The second type is chloride induced stress cracking corrosion under constant external stress (due to clamping around air cooler tube circumference). Chloride ions accumulate locally at the regions at stress concentration and induce the initiation of a crack. The combined effects of these corrosion types led to the final failure of 316L SS.

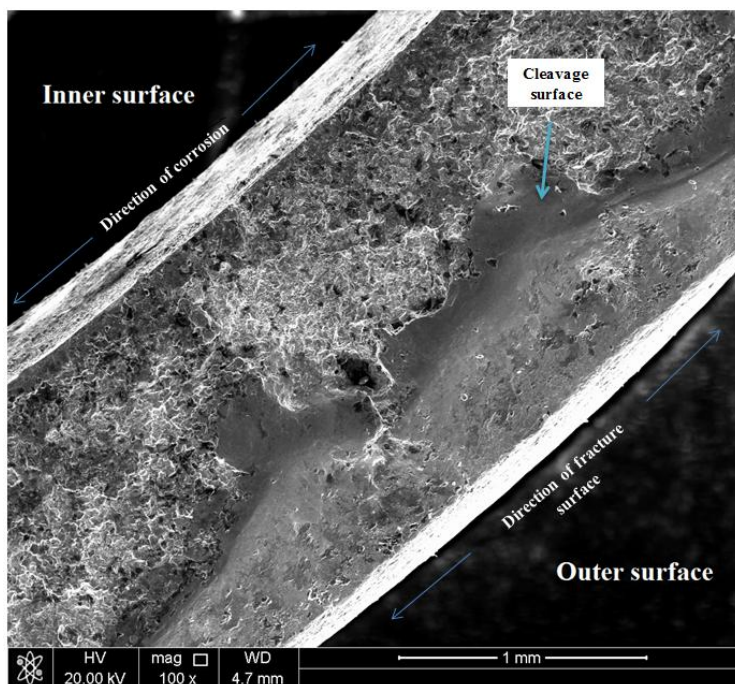
Figure 7 illustrates that the actual corrosion event initiated at the inner surface and was followed by subsequent cleavage occurring at the outer surface which led to the ultimate failure of stainless steel tube.

**Figure 7.** SEM micrograph at low magnification showing the cracking corrosion of inner surface and cleavage fracture at outer surface.

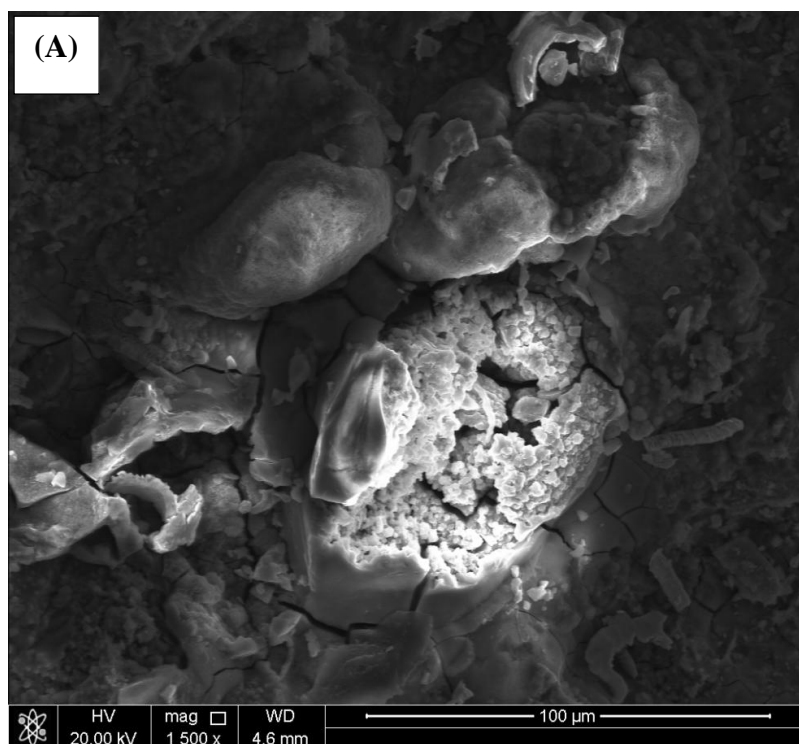
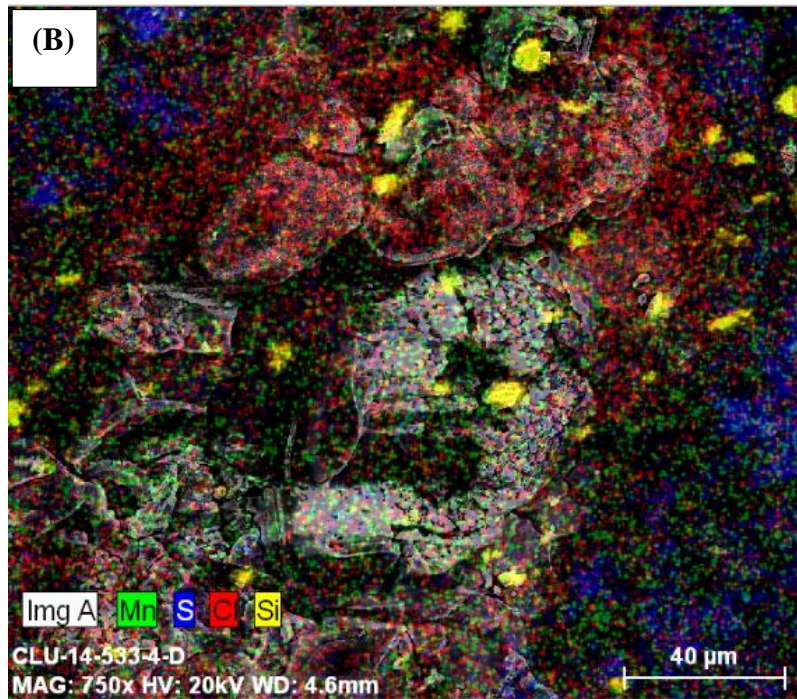
The first corrosion type occurred as result of interaction of  $\text{Cl}^-$  ions with manganese sulfide (MnS) inclusions, which acts as active sites for initiation of corrosion pits, see Figure 8 (A and B). Dissolution of inclusions were noticed and proposed to be the first step for pit formation [15, 16]. This proposed mechanism originated from the presence of Mn, where it segregates sulfur as MnS instead of

**Figure 8.** (A) The initiation of pits formation due to MnS inclusion on the inner surface of 316L stainless steel and (B) the corresponding EDX mapping image.

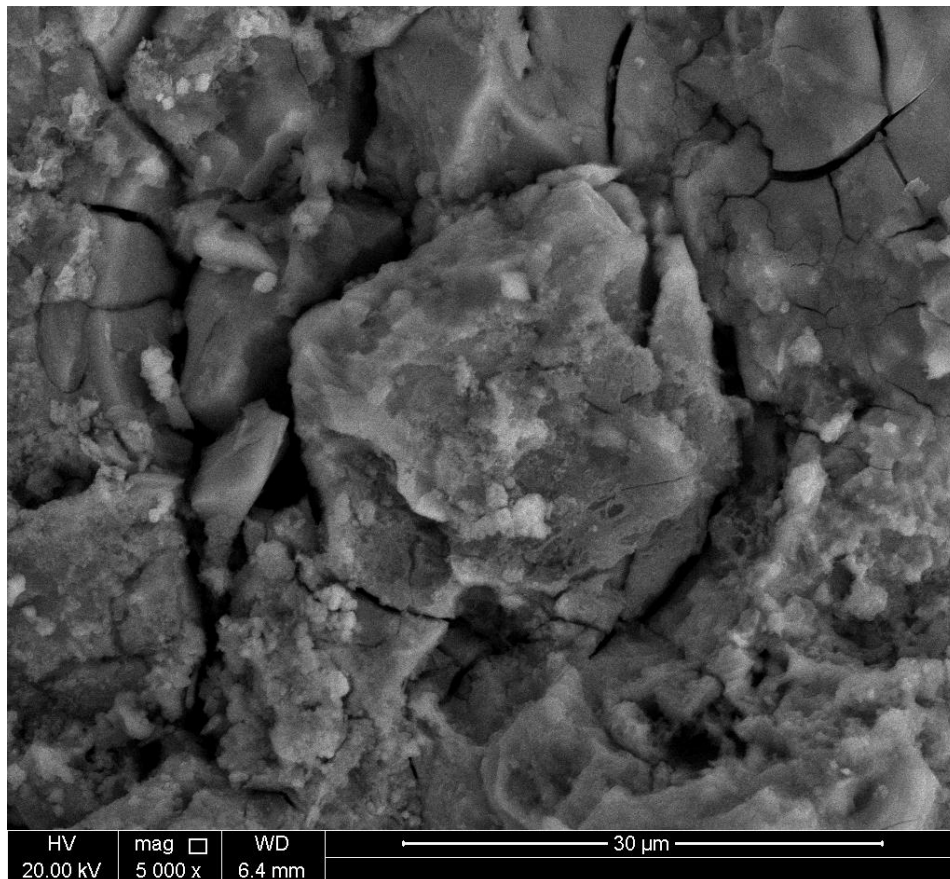
**Figure 9.** Typical SEM micrograph of the corrosion- fatigue fracture on the outer surface of 316L stainless steel tube.

Intergranular corrosion fatigue cracks, as illustrated in Figure 9, are presumably as a result of cyclic stresses. Figure 10 shows the formation of microcracks at the inclusion sites where the pits were formed and their subsequent propagation from the base of pits. This observation is in agreement with the most common mechanism of crack initiation and propagation due to corrosion fatigue as suggested by Butler and Isom [20].

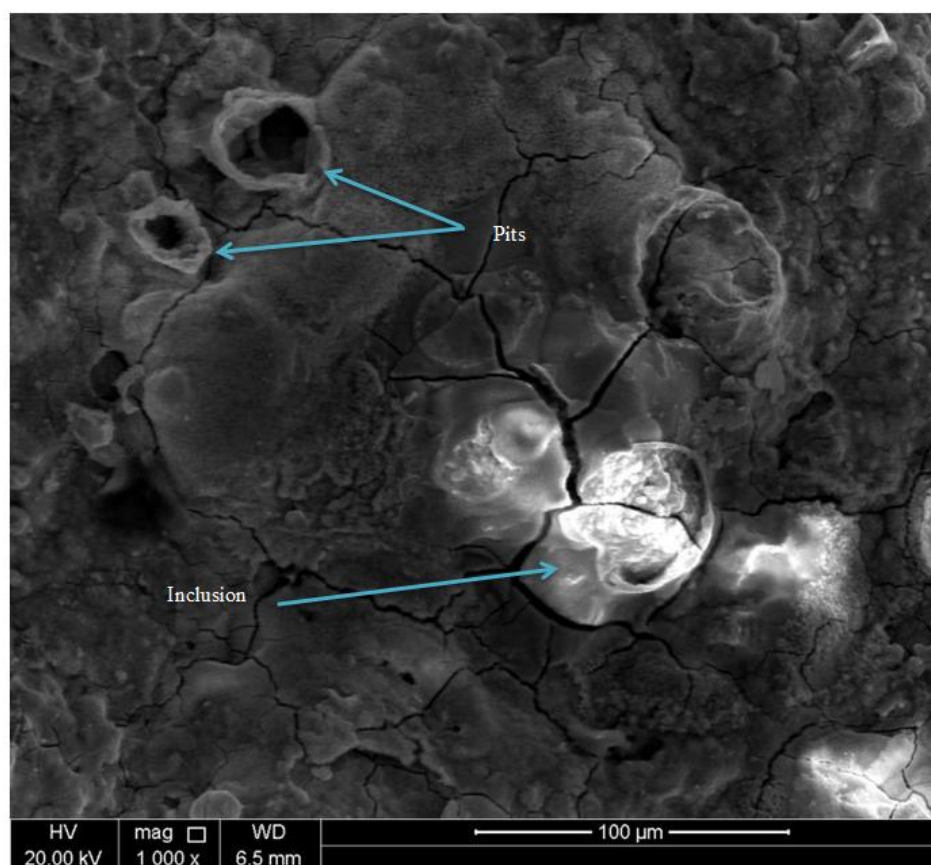
Different regimes have been suggested to clarify the corrosion fatigue behavior [21, 22]. Bayoumi [23], indicated that the endurance of chloride induced fatigue corrosion arises through incorporation of both environmental factor and applied cyclic stresses. Many researchers have reported pitting as an important element in corrosion and thereby in corrosion fatigue cracking of materials containing second phase particles [24] and consequently, resulted in the formation of micro-cracks (at/around the location of an inclusion), as an evident in Fig. 10.

**Figure 10.** SEM micrograph showing the formation of stress cracking corrosion around of pits on outer surface of 316L SS air cooler tube.

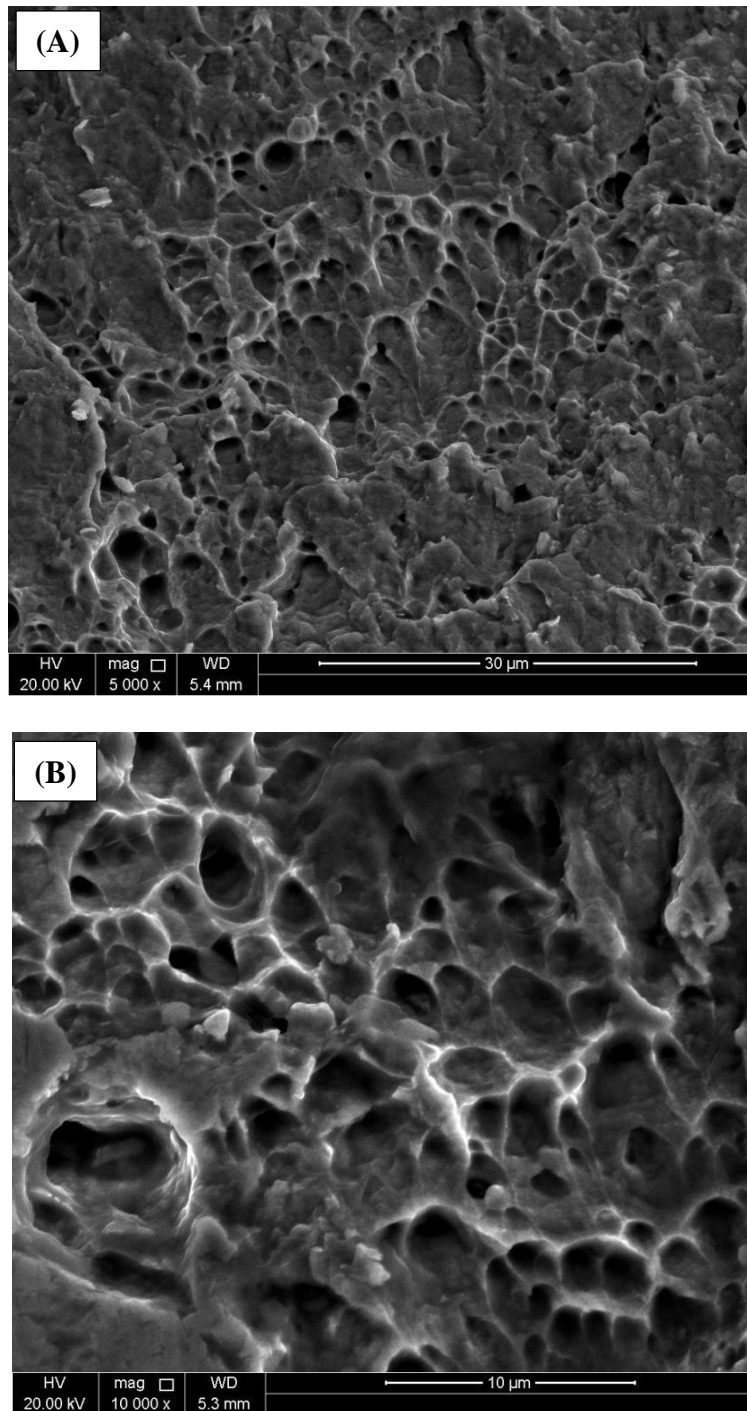
**Figure 11 [A and B].** Fractography of the ductile fracture on the outer surface of 316L stainless steel at different magnifications.

Figure 11 (A & B) illustrates how the formation of microcracks facilitated the eventual ductile fracture which in a good agreement with the results obtained Sudhakar [25].

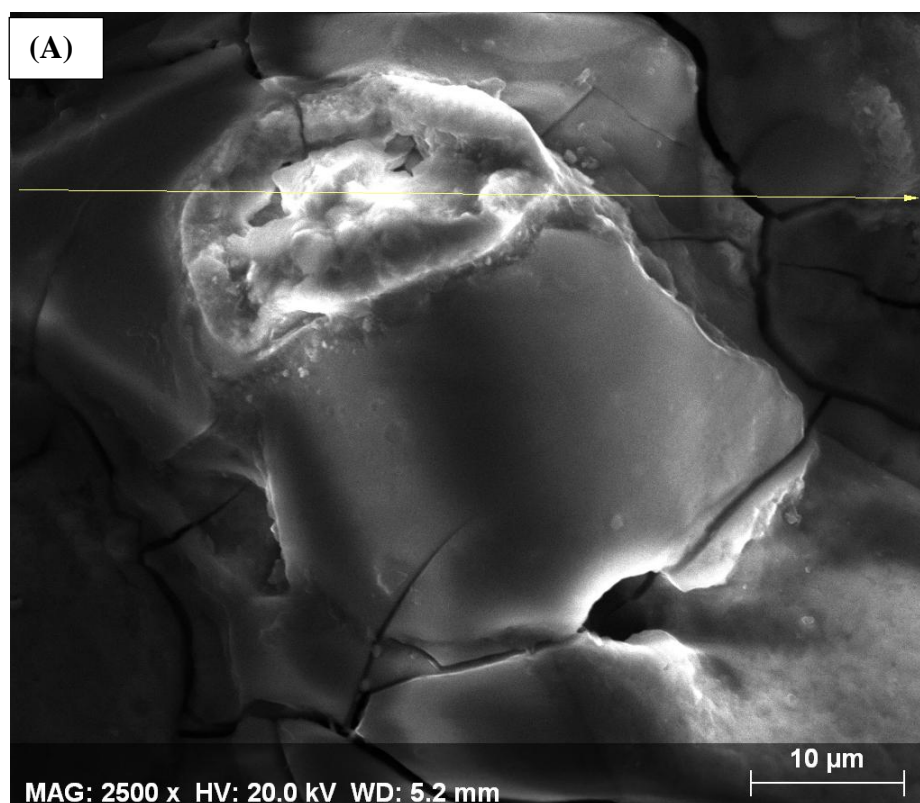
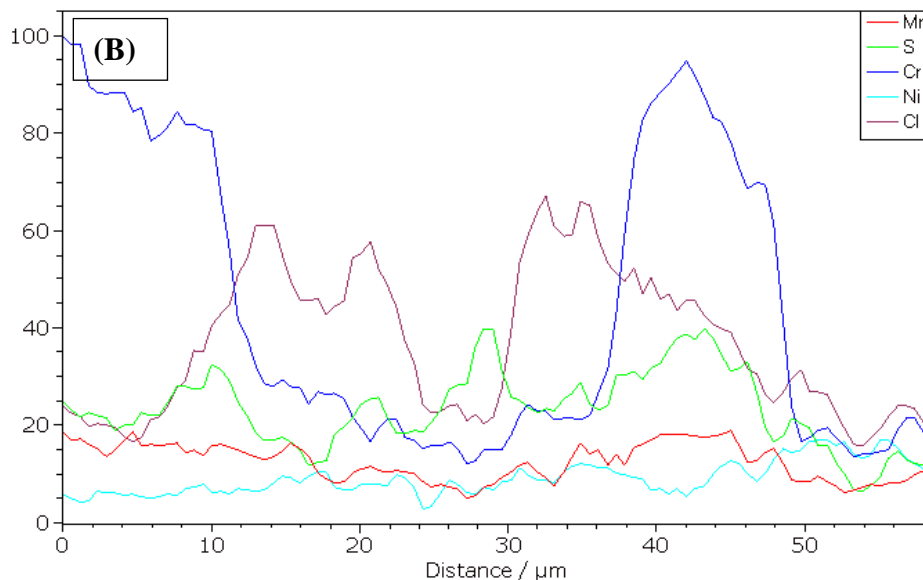
The SEM line scans were carried out across the inclusion/steel – interface, in order to detect the composition at the inclusion. It was observed an increment of Cr signal intensity and a decrease of Cl and S signal intensity at the steel/inclusion-interface. Fig 12 indicates depletion of Cr and

accumulation of S and Cl as the scanning approached from the inclusions to the inclusion/steel interface.

The present results are in accordance with the observations which detect Cr-depletion around inclusions [26]. The signal intensity of Cr around inclusion remains strong compared to Mn signal. This strong peak of Cr however indicates to the formation of either chromium carbide or chromium sulfide. The formation of these phases is thermodynamically possible only at relatively high temperature, e.g., chromium carbide and chromium sulfide are formed at 550 - 950 and 1400 °C, respectively. These high temperatures were not applicable during the operation and welding processes. Therefore, the formation of both chromium carbide or sulfides is out of the scenario.

**Figure 12.** SEM image of an inclusion of 316L stainless steel (A) and a corresponding SEM line scan (yellow line). (B) Gives the energy-dispersive X-ray analysis of the inclusion.

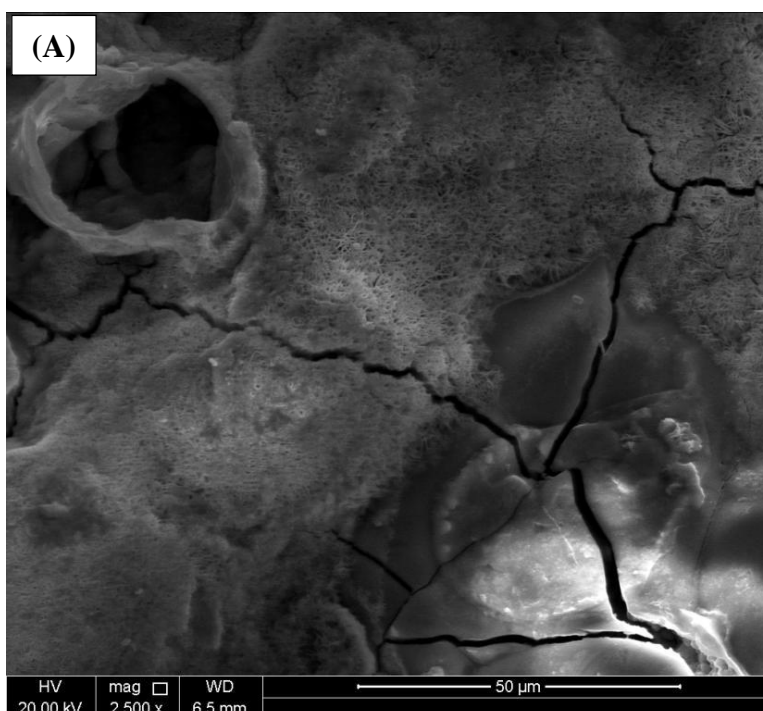
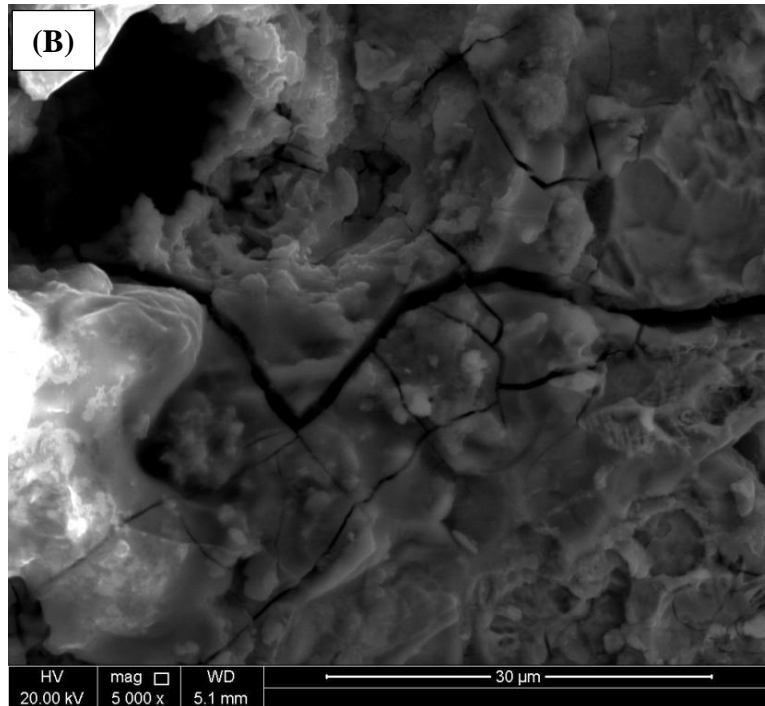
Combination of Figure 12 and Figure 13 demonstrate that the crack initiates from the active pit sites at which the Cl<sup>-</sup> concentration is high which is an indicative of CLSCC as was outlined by Yin et al. [27]. Rate of dissolution of MnS inclusion as the origin of pit and corresponding crack growth rate at pits was observed to be faster than the overall corrosion rate, which is in a good agreement of Fantechi's results [28]. Moreover, Elsariti and Ftirman [29] indicated the possibility and propensity of pitting and Stress Corrosion Cracking behavior of austenitic stainless steel at the room temperature as well as elevated temperature. All these evidences indicate that CLSCC is the most probable mechanism responsible for the failure event of the air cooler tube where some local small pits were formed on the internal surface of tube and became the stress concentrations sources. The constant internal stress of clamping contributes to the propagation of CLSCC, as shown in Figure 14.

**Figure 13[A and B].** SEM images illustrate the formation of pits which acted as active site for initiation of chloride stress cracking corrosion on the outer surface of 316L stainless steel.

The formed pits act as stress concentrators which at the end lead to SCC. Consequently, the used 316L stainless steel must be replaced with higher quality one that is free of Cu to lower the pitting susceptibility of the alloy. It was reported that low alloying percentage of Cu increases the corrosion resistance of 316 SS in presence of chloride and H<sub>2</sub>S but its effect is completely reversed when H<sub>2</sub>S is absent where the corrosion rate increased dramatically [30 & 31].

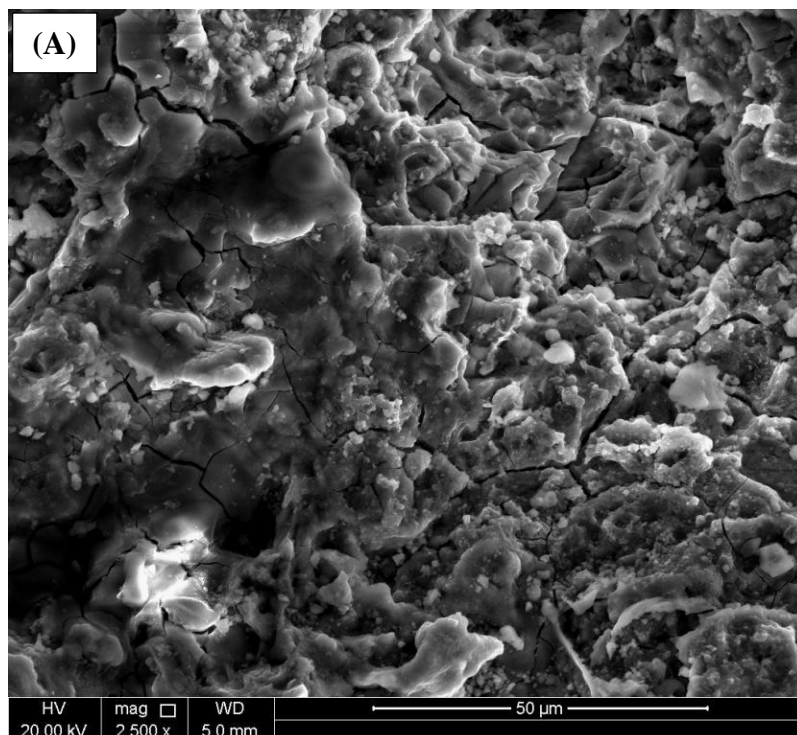
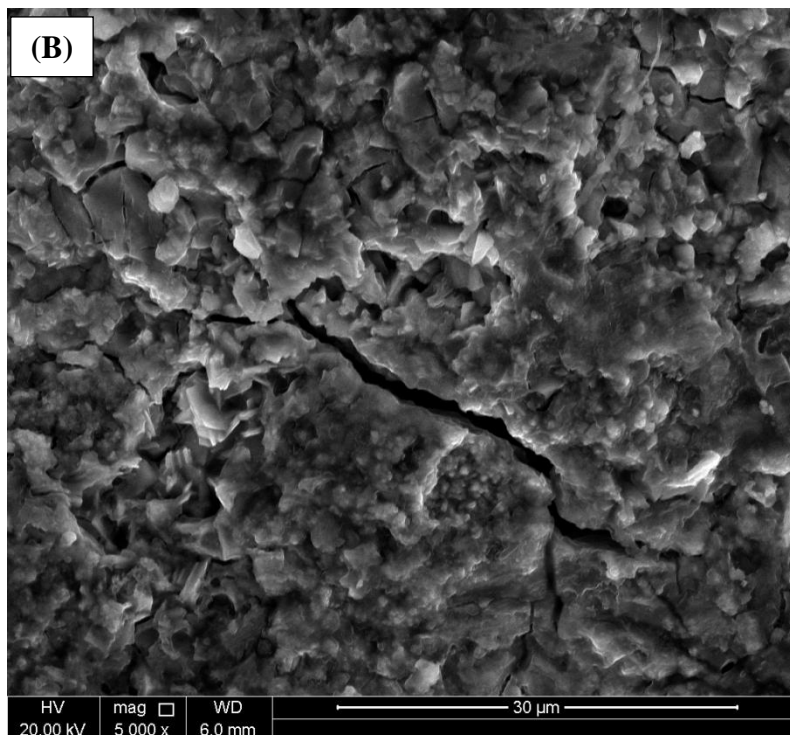
**Figure 14 [A and B].** SEM images showing the formation of intensive IGC due to chloride stress cracking corrosion on inner fracture surface of 316L SS air cooler tube.
