# **CONCRETE DETERIORATION AND REPAIR IN AN INDUSTRIAL ENVIRONMENT**

**Mustafa H. El-Kady**

**M.A. Abdul-Salam**

## **ABSTRACT**

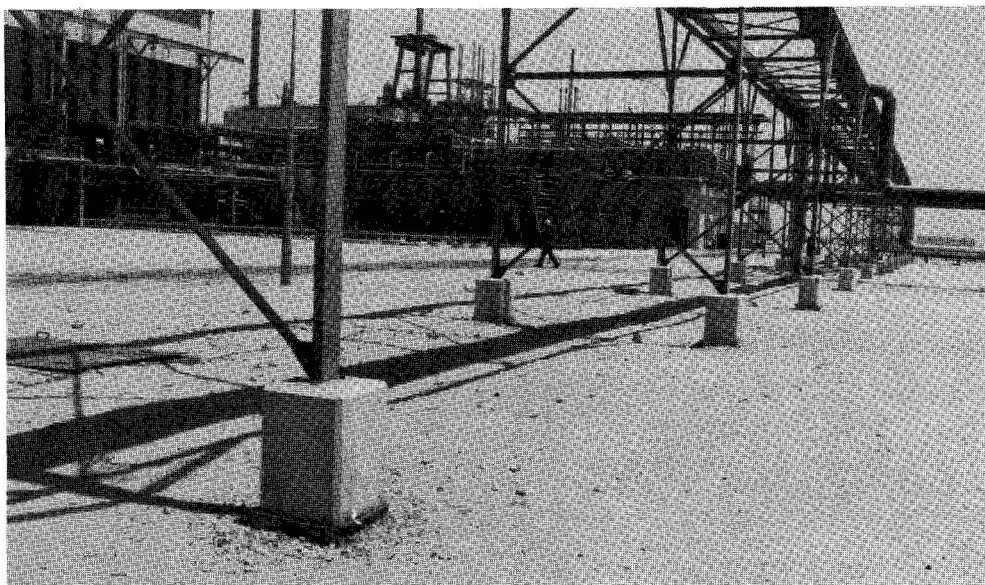
**Fig. 1:** General view of a pipe rack and its concrete supports

These two procedures were used in the year 1987 to repair about 300 pipe rack supports . Figure-1 and Figure-2 show the conditions of these supports after 5 years of repair, the supports still look like new ones. Further check was carried out in 1994 using non- destructive methods and proved that the concrete condition is sound. The results of this testing are presented later in this paper.

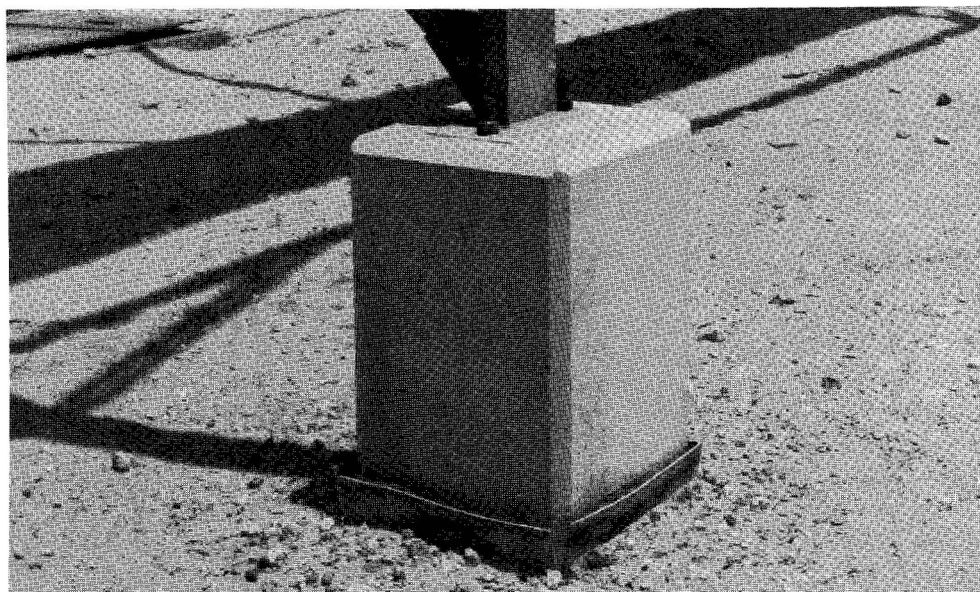
**Fig. 2:** Single concrete support for a pipe rack

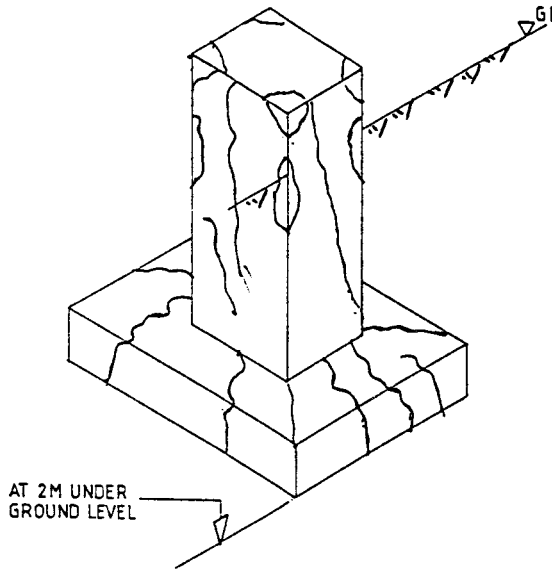
- a) Some supports (Fig. 3) had completely deteriorated and the footing and the column had deep cracks. Most re-bars were severely corroded and some of them completely diminished in size.
- b) Other supports (Fig. 4) had developed cracks in the upper portion above ground and for a distance of 300-400 mm underneath the ground surface.
- c) All concrete surfaces were bare without any surface coating or protection .
- d) The concrete cover was no more than 25 mm.

As the concrete supports are constructed with ordinary concrete of sulfate resistant cement without any coating and with small concrete cover, chloride penetrated through pores and shrinkage hair cracks appeared in the concrete. Consequently, the re-bars got corroded which led to the expansion, hence more

**Fig. 3: Complete deterioration of concrete support**

**A- The completely deteriorated supports were completely demolished and reconstructed with the following concrete mix design, (figure 7):**

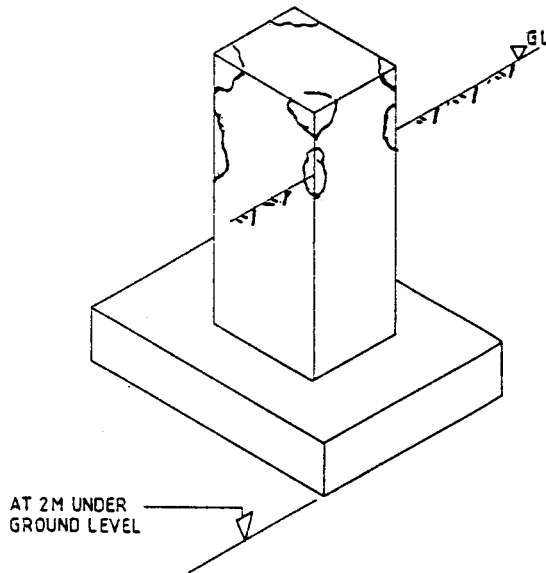
**Fig. 4: Partial deterioration of concrete support**

**B- The partially deteriorated supports got patch repair according to the following procedure:**

- 1- The cracked loose concrete was broken to expose the sound one. The breaking out continued to expose the full circumference of the steel bars and to a further depth of 50 mm beyond it .
- 2- The corroded bars of diameter less than 0.7 of the original diameter were replaced.
- 3- All exposed reinforcing bars and other steel structure parts in contact with the concrete were grit blasted up to sa 2.5 according to the Swedish Standard Institution specification for surface preparation for painting steel surfaces ( SIS 055900 - 1967) or ISO 8501-1-1988, [1].
- 4- The grit blasted steel parts were coated with "Epoxy Zinc Rich Primer".
- 5- The under ground and the above ground concrete parts were coated with the same system described above for reconstructing the completely deteriorated supports.
- 6- The back filling was done by salt free desert fill of about 1 m thickness.

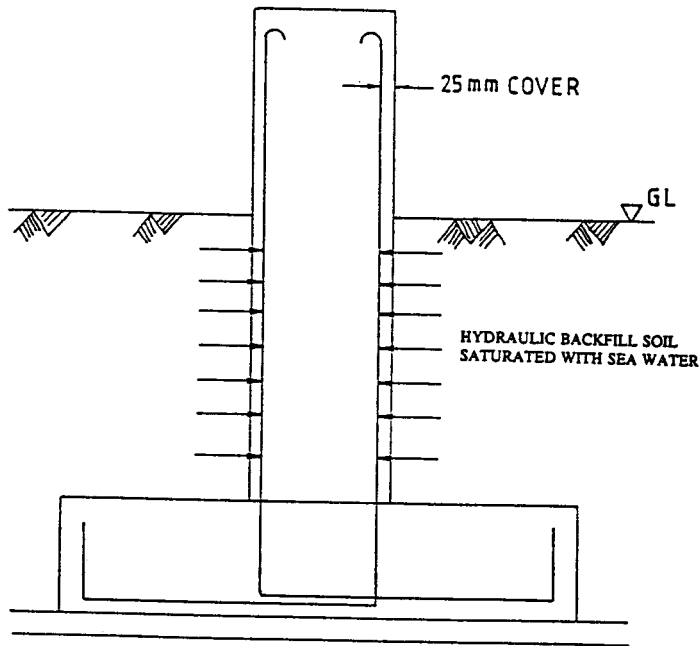
cracks and more penetration of the chloride and so on until complete deterioration and failure of the supports ( Fig. 5).

**Fig. 5: Penetration of salt into R.C.C.**

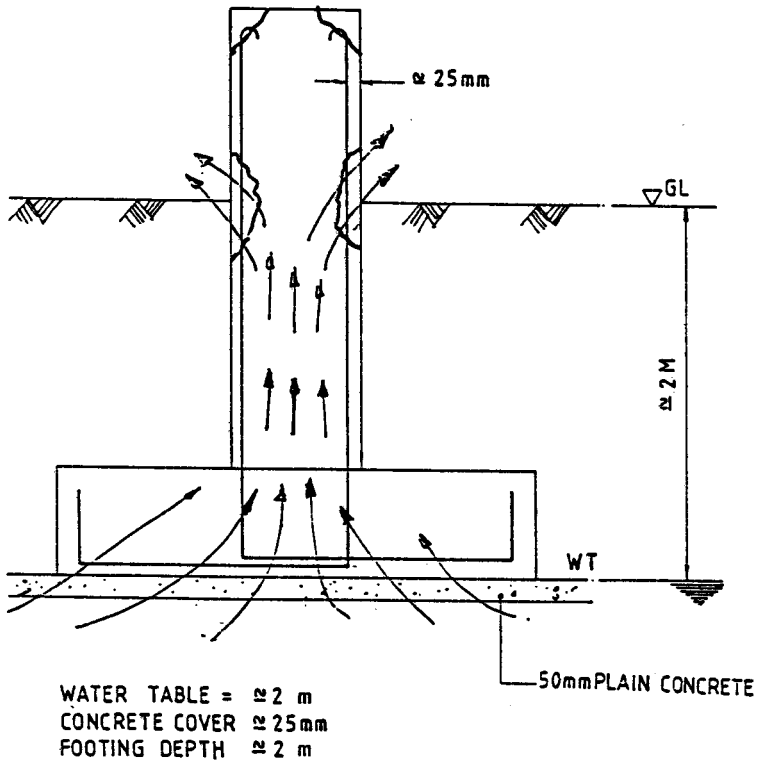
The water table at the site is about 2 m below ground level and therefore most bases of the footings of the concrete supports are in contact with the underground sea water . As the concrete has smaller pores than the adjacent ground soil the sea water rises through the concrete to a higher level than through the soil due to the capillary action. In many of supports the sea water reached the ground level and evaporated leaving the salt (chloride) inside the top portion of the support. The process is a continuous one, which means the salt is pumped to the top portion of the concrete support. This accumulated salt reacted with both the concrete and the re-bars and led to the deterioration of the top portion of the concrete supports (Fig. 6).

Fig. 6: Under ground salt pumping

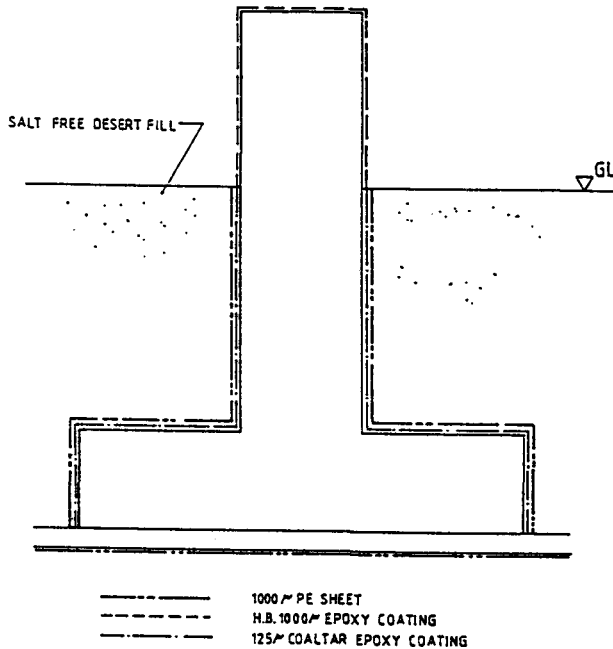
Fig. 7: Reconstructed foundation with improved specification

- 1- Cement : Ordinary Portland Cement.
- 2- Minimum cement content of  $400 \text{ kg} / \text{m}^3$  of concrete.
- 3- 10-15 % of cement to be replaced by Micro Silica.

- 4- Maximum water/cement ratio 0.4 .
- 5- Maximum total content of chloride from all sources not to exceed 0.3% by weight of cement.
- 6- Maximum total content of sulfates from all sources not to exceed 4% by weight of cement.

- 7- Minimum cube strength after 28 days not to be less than  $30 \text{ N/mm}^2$  .
- 8- Maximum temperature for concrete pouring  $25^\circ\text{C}$  .

- 9- All under ground concrete surfaces coated by coal tar epoxy of minimum dry film thickness of 125 micron.
- 10- All above ground surfaces coated by epoxy sealant as a primer and high built epoxy paint of minimum dry film thickness of 1000 micron .

- 11- The excavated areas around the concrete supports back-filled with salt free desert fill of about 1 m thickness.

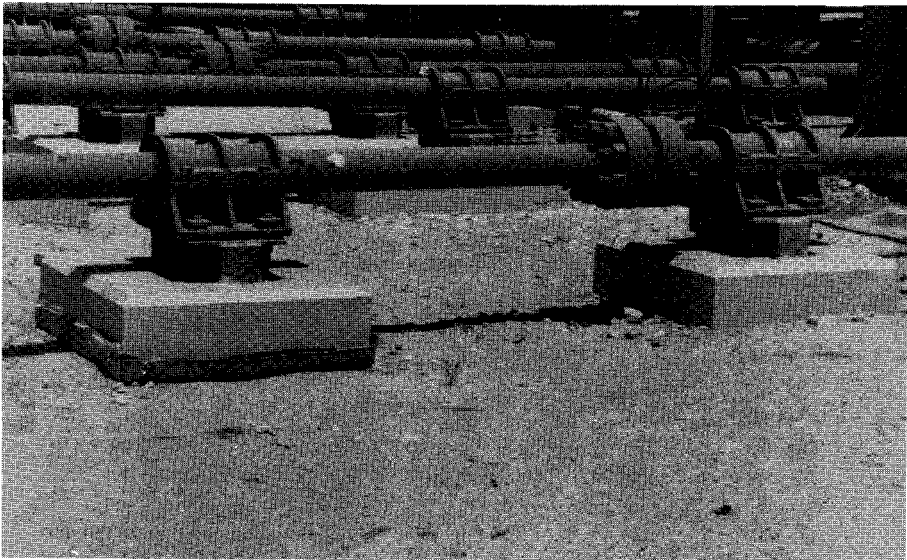
In the year 1991 the same procedures were used to repair concrete supports for "High Pressure Pipe Lines" in which the gas is compressed to 2000 bar by the reciprocating compressor (Fig. 8 ), and the concrete base of the deethanizer C1501 (Fig. 9). All figures indicate that even after two years of repair the concrete is in good condition .

**Fig. 8:** Close-up view of high pressure pipe supports

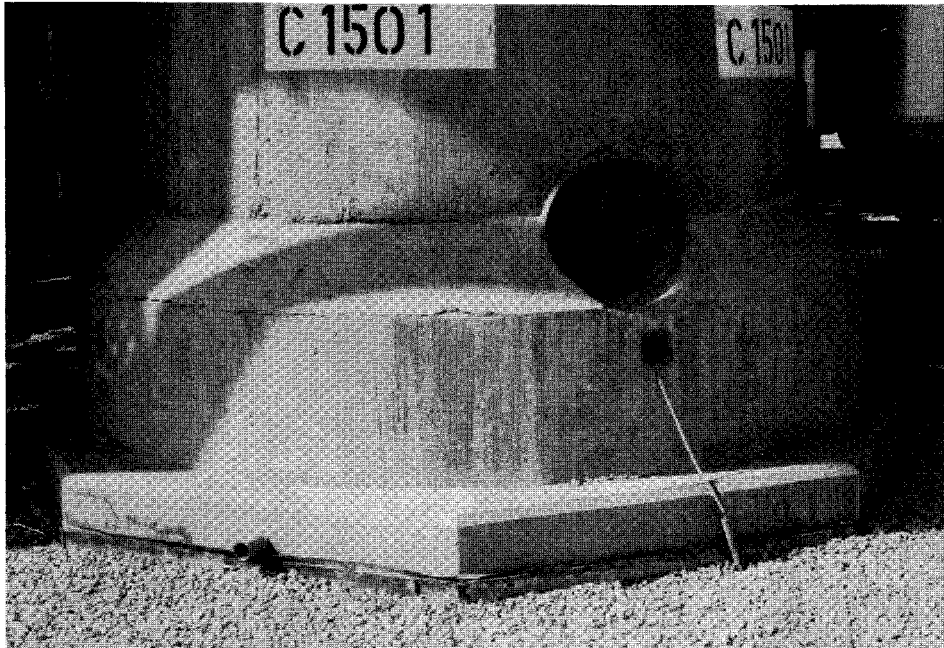
**Fig. 9: Concrete base of column C-1501 after repair**

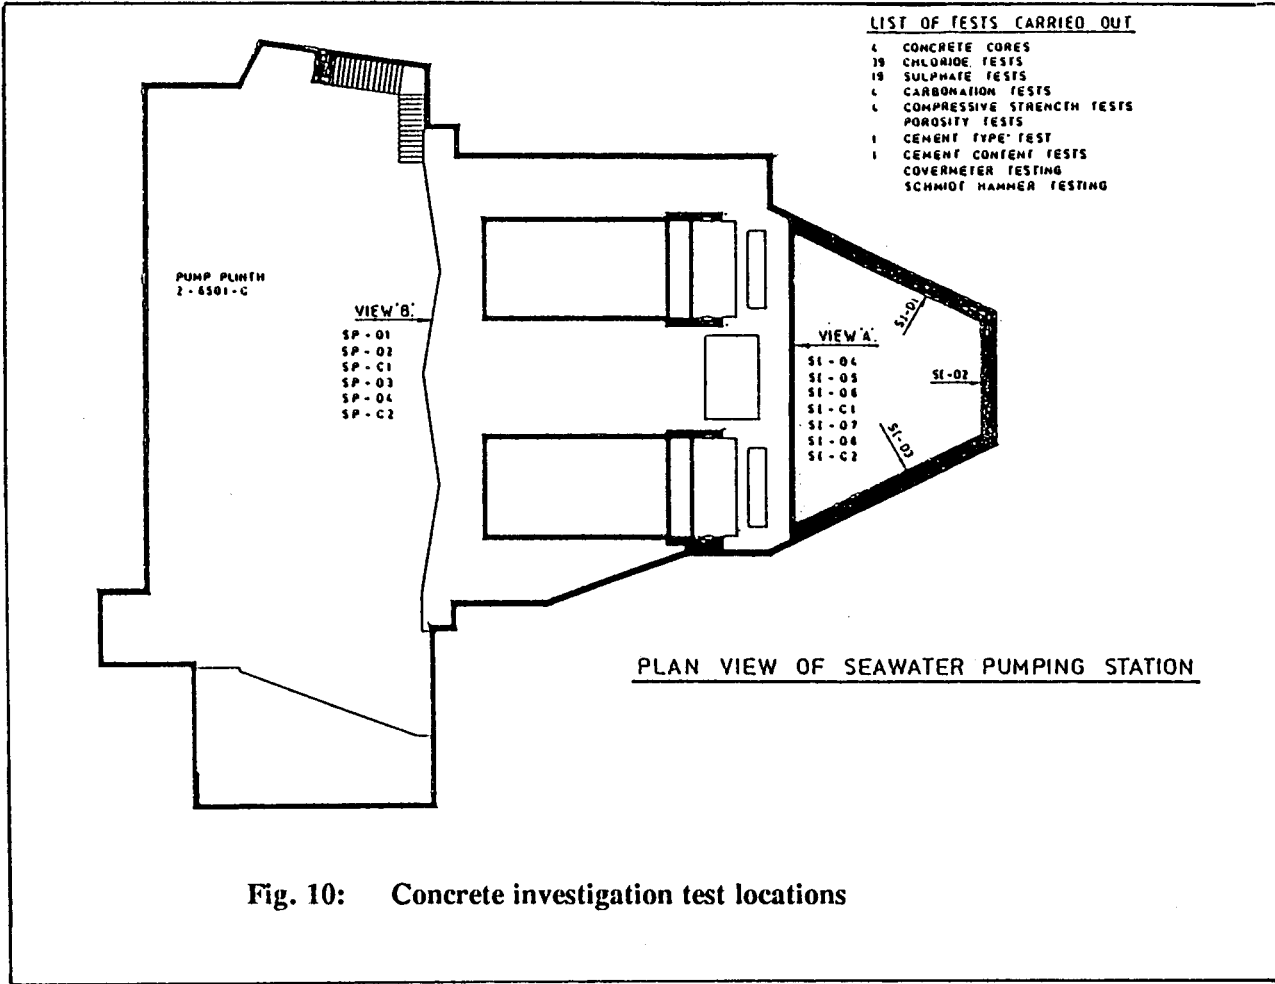
Fig. 10: Concrete investigation test locations

Figures (10) and (11) show the plan, the section and locations of sampling. The results of the chloride test for samples from the pumping station are presented in Tables 1, 2 and 3.

It can be seen from the results that the level of chloride contamination varied considerably between the structures and was generally higher in the Sea Water Outfall Chamber (1.24% chloride by weight of dried concrete or 6.31% chloride by weight of cement). In several locations the value remained consistently high throughout the full 200 mm depth of concrete tested (from 0.36 to 4.27 % chloride by weight of cement; whereas the maximum permissible % of chloride by weight of cement is 0.3% ).

At the Sea Water Pumping Station the level of chloride contamination at the location tested was consistently high at the surface but generally reduced through the initial 120 mm depth of concrete to levels below the limit set by BS 8110, [3].

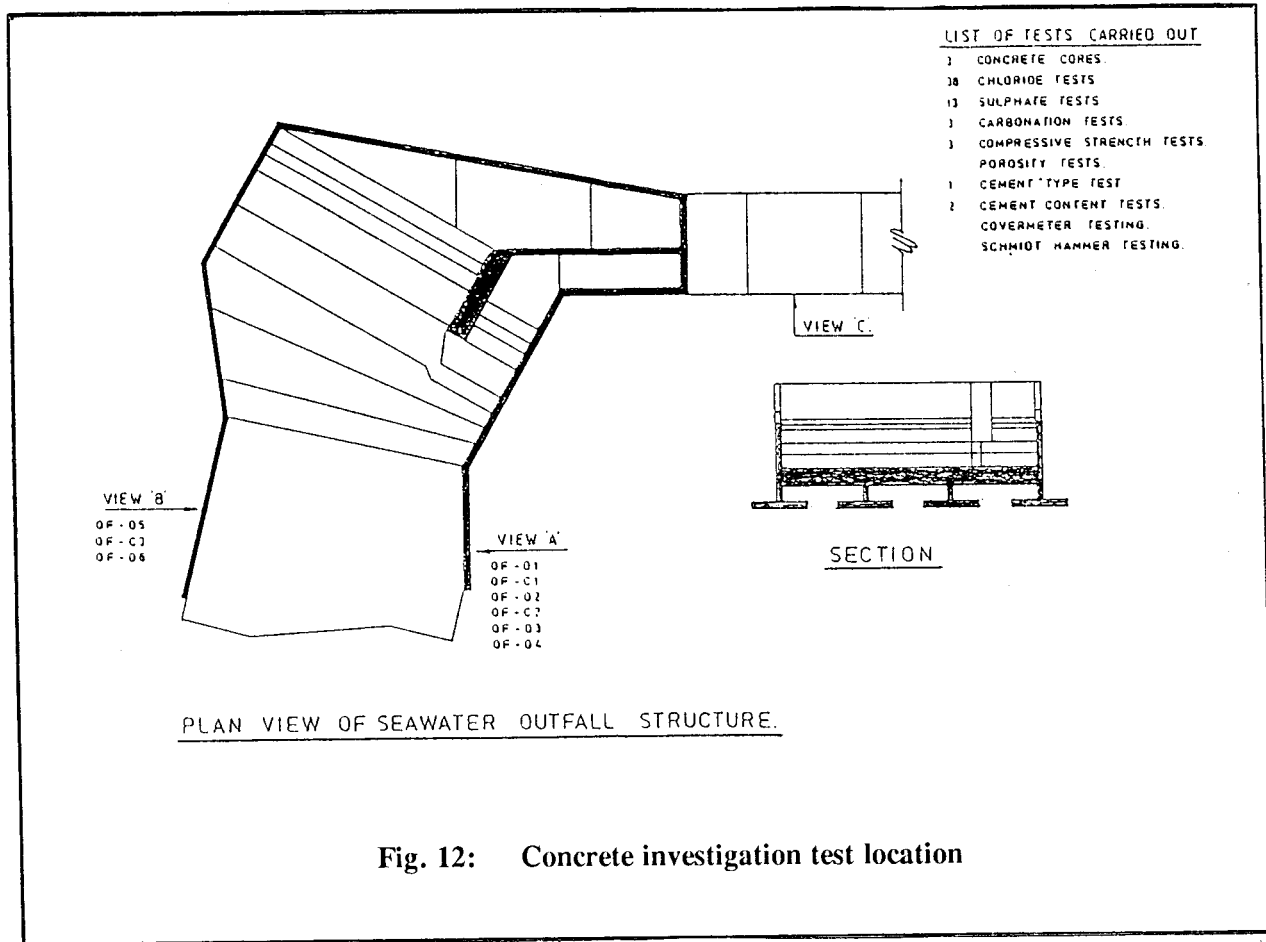
Fig. 12: Concrete investigation test location

Figure (12) shows the plan, the section and locations of sampling the outfall chamber. The results of the chloride test for samples are presented in Tables 4 and 5.

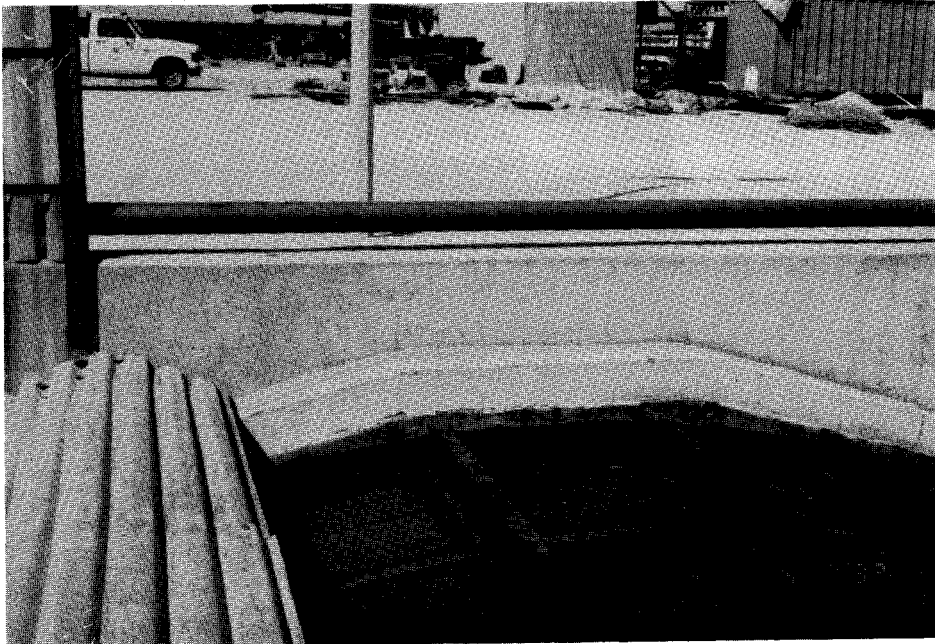
The repair procedure was the same as previously mentioned. Figures (13) and (14) show some parts of the sea water units after two years of repair.

**Fig. 13: Water intake wall**

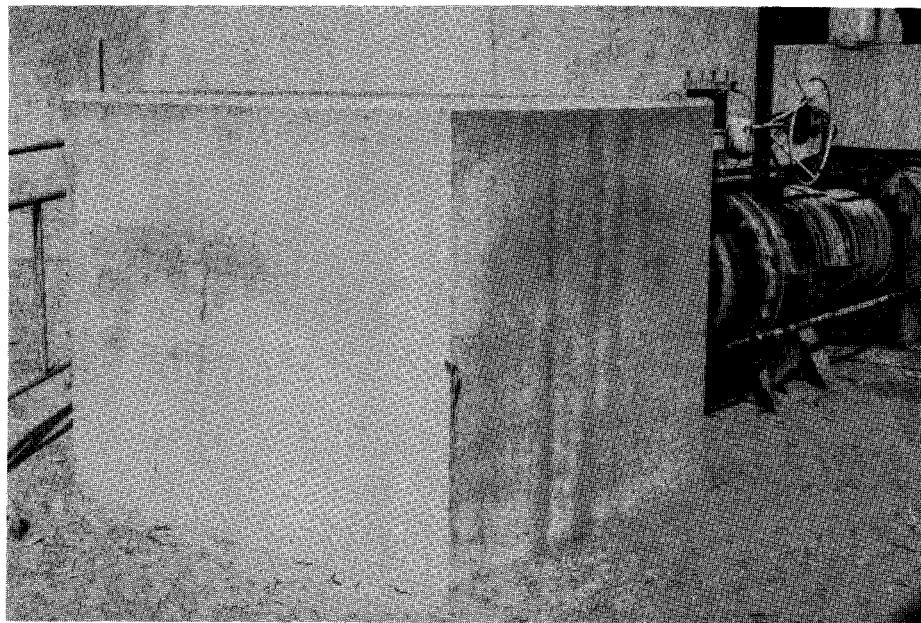
**Fig. 14: Sea water unit**

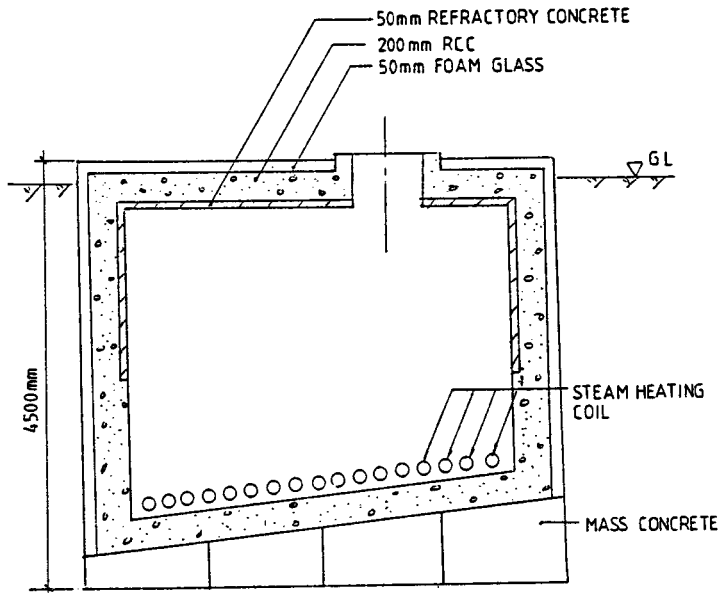
Fig. 15: Details of sulphur pit T-2101

three to four years of construction the ceiling and the internal upper portion of the side walks were delaminated and the reinforcing steel bars became exposed in some parts .

- a- Severe corrosive internal environment due to continuous presence of "sulfur vapor" and the occasional presence of mixtures of "sulfuric acids" which form as a result of corrosion of the steam heating coils and consequently admitting the steam to go through the sulfur liquid up to the upper portion of the pit .
- b- Internal high temperature which accelerates all the chemical reactions between the concrete and the attacking acids, and causes cracks due to cyclic heating to 150<sup>0</sup> C at starting up and cooling to ambient temperature at shut down periods .

In the year 1987 a new sulfur pit was constructed using "Portland Blast Furnace" cement. The ceiling and the upper 1.5 m of the side walls were lined with 50 mm thick high alumina concrete reinforced by stainless steel wire mesh of 5 mm diameter at 50 mm c/c, Fig. (15). This pit was in service up to the end of 1992 without any deterioration or delamination of the refractory lining or the main construction concrete .

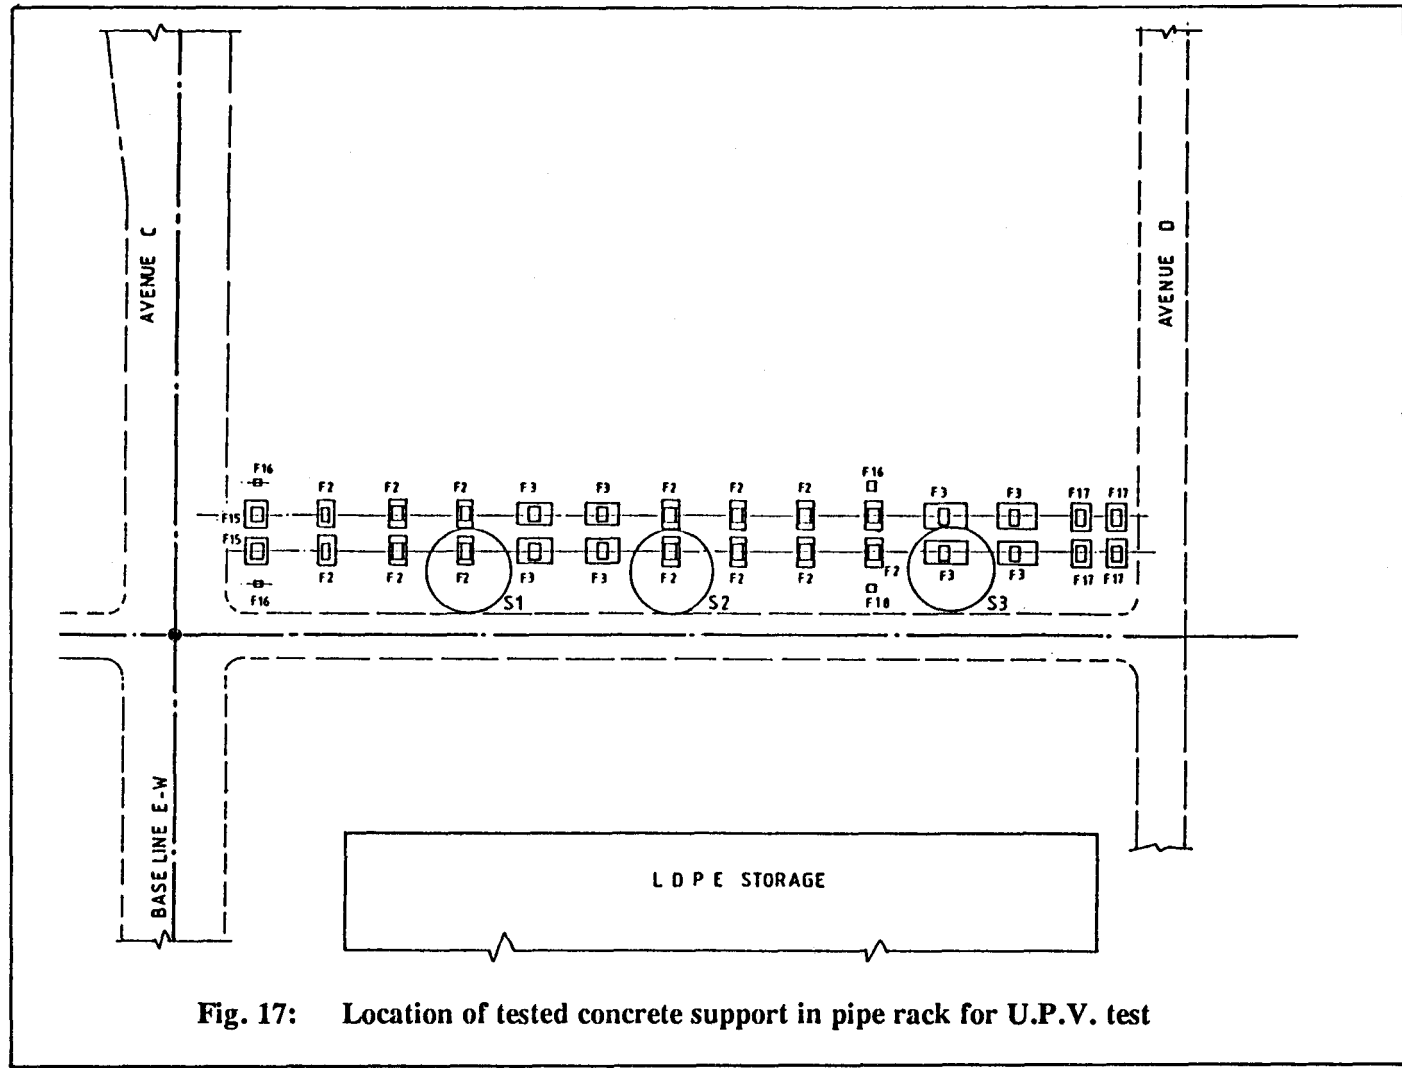
Fig. 17: Location of tested concrete support in pipe rack for U.P.V. test

Six readings were taken on the reconstructed concrete supports for pipe racks at the locations S1 to S6 shown in Figs. (17) and (18). One reading was taken on reconstructed concrete support of high pressure pipe as shown in Fig. (19), location S7.

It can be seen from table 6 that the partial repair seems to be more successful at the support of Exchanger E-1308A than at the Water Intake wall . Old concrete strength varies considerably as seen by comparing readings S9, S10 and S13. The reconstructed supports concrete is uniform with medium strength, reading S6 seems to be odd and might be disregarded. It must be noticed, however, that strength is not the only needed property of concrete.

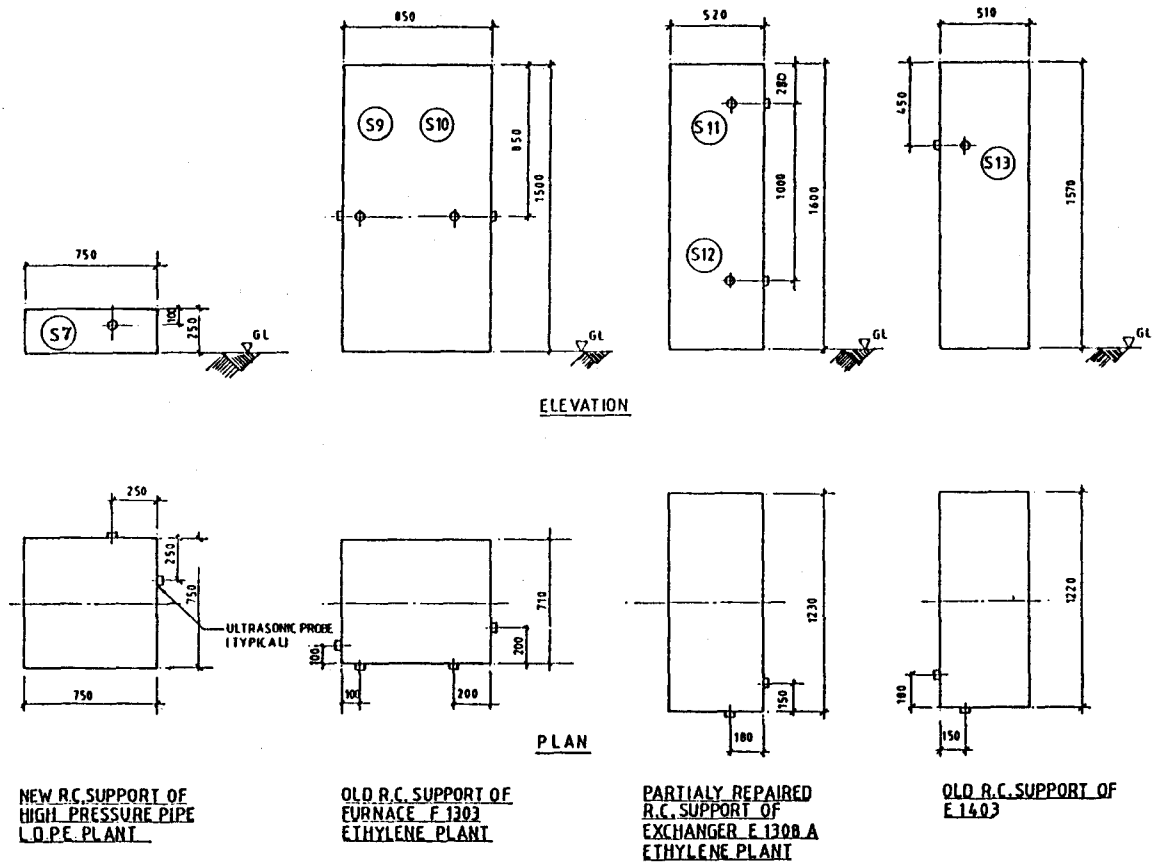
Fig. 19: Location of test point for different R.C. support for U.P.V. test

One reading S8 was taken on the partially repaired Water Intake wall and two readings S11 and S12 on one partially repaired support to Exchanger E-1308-A, Fig. (19).

Readings S9 and S10 are on an old (un-repaired) concrete support to Furnace F-1303 and reading S13 on an old support to Exchanger E-1403, (Fig. 19).
