Impact of Prolonged Exposure to Sour Service on the Mechanical Properties and Corrosion Mechanism of NACE Carbon Steel Material Used in Wet Sour Gas Multiphase Pipeline

The corroded sample analyzed in this research is part of a wet gas inlet pipeline coming from offshore and going to the slug catcher. The corroded piping was a 2" bypass of an emergency shutdown valve (ESDV13) installed on a 38" mainline, as seen in Figure 1.

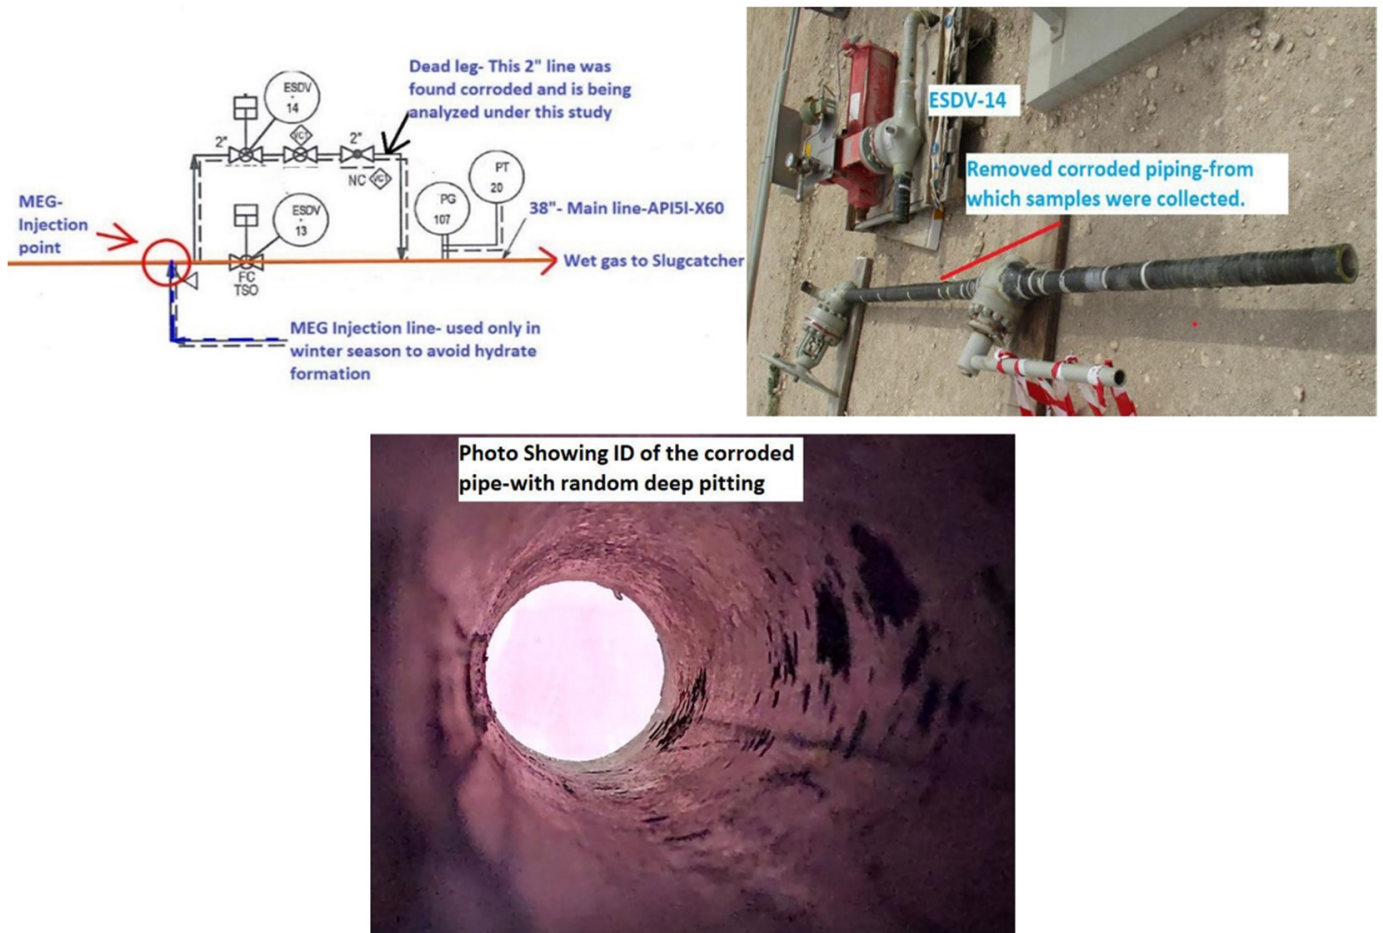
Figure 1. Showing the actual location of the corroded sample analyzed in this research and the inner diameter (ID) of the failed spool.

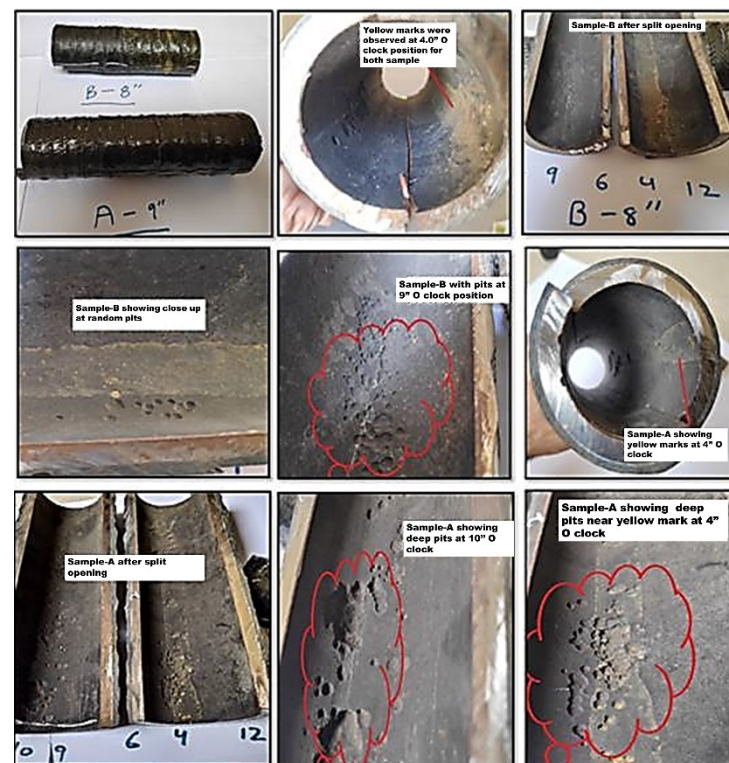
Figure 2 shows two pipe spools (A—9" and B—8") which were cut from the removed piping for investigation purposes. The bottom (six o'clock) position was marked in both spools. The corroded piping was externally composite-wrapped to avoid failure during operations. Composite wrapping is visible in the sample photographs. Close visual inspection was carried out on as-removed samples. Following are a few critical observations made on the collected samples: Both samples showed a band of yellow marking at the four o'clock position. Random pits were observed on both samples. The severity of pitting was at its maximum at the 9–10 o'clock position, near the yellow marking.

Figure 2. Visual observation graphs highlighting all critical points.

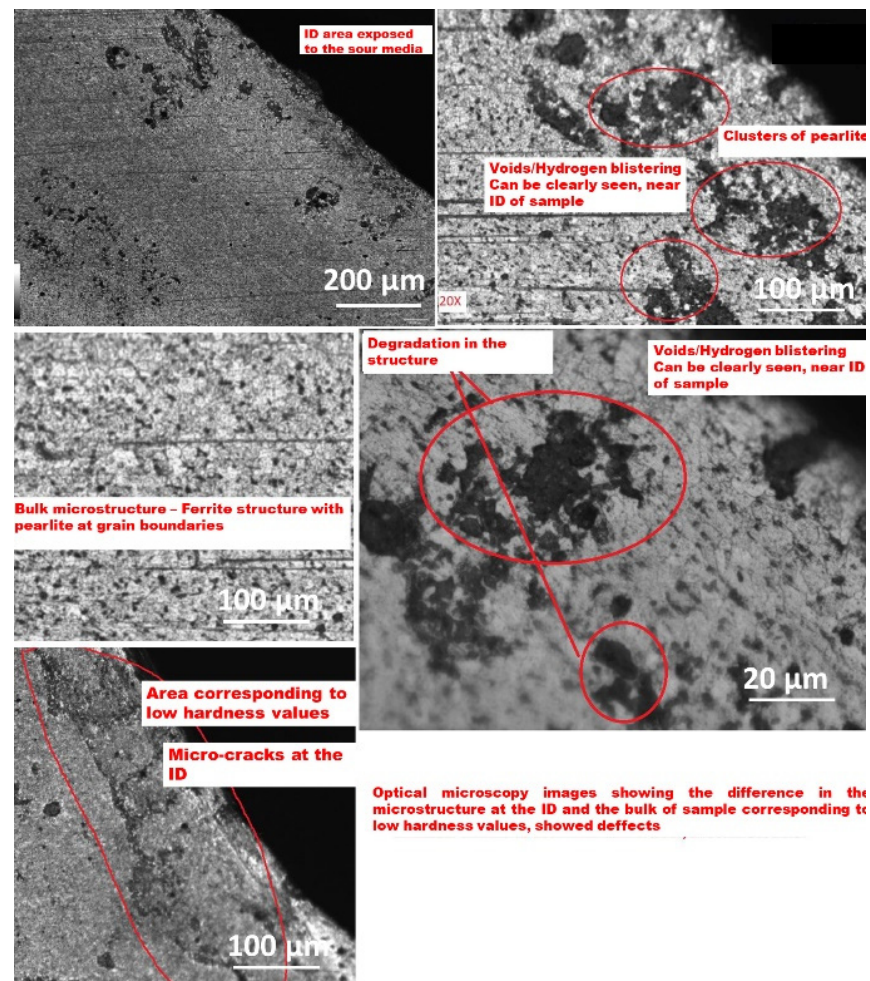
Different points in the defected surfaces were examined by optical microscopy to understand the difference in microstructure at the ID and bulk of the sample. Optical microscopy images, Figure 3, clearly indicate differences in microstructure in the area exposed to service (sample ID) and at the bulk of the samples. The cluster of hydrogen blisters can be seen near the ID of corroded samples. The area near the ID/corroded surface also corresponds to low hardness. The presence of micro-cracks near the ID of the sample is also clearly visible. These findings indicate significant degradation in the material due to long-term exposure to sour service.

Figure 3. Optical microscopy images at various mag, for both ID and bulk.

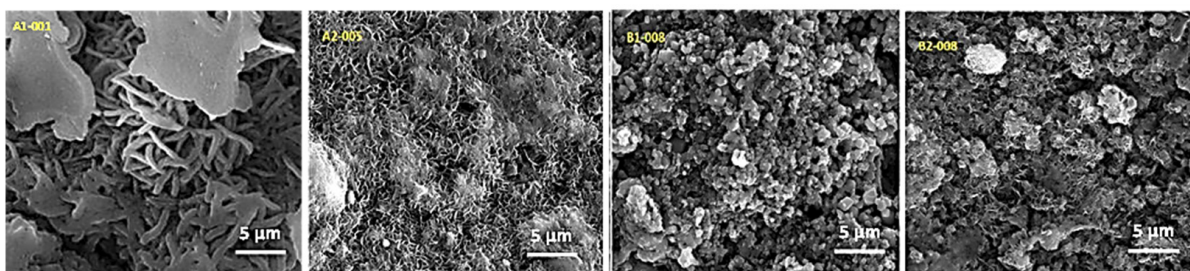
Figure 4 depicts the SEM images of samples with pitting in the yellow-mark area represented in points A1, A2, B1, and B2. All points prove the porous nature of corrosion scales; furthermore, in the close-up view of the scales in B1 and B2, the aggregated particles confirm the presence of sulfur.

Figure 4. SEM micrographs samples with pitting inside yellow-mark area (A1, A2, B1, B2).

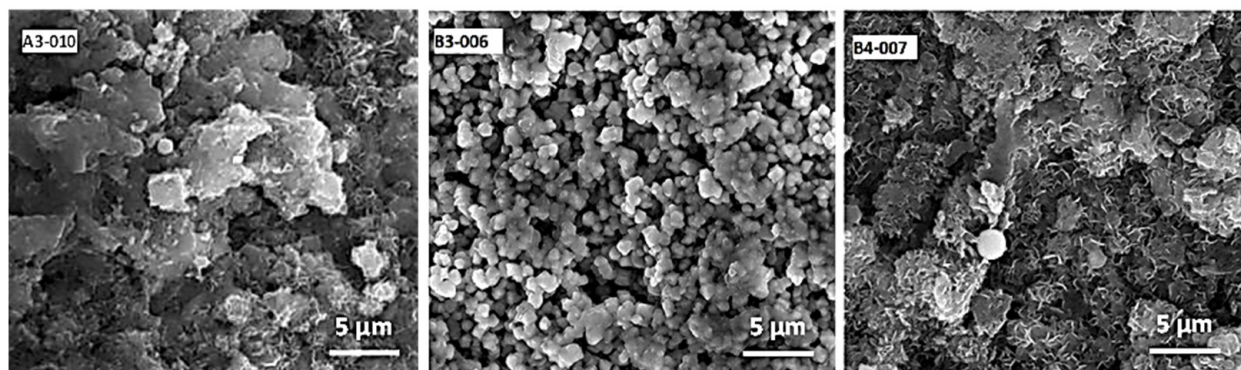
Figure 5 shows the SEM images of the samples with pitting corrosion outside the yellow-mark area: A3, B3, and B4. The SEM images are evidence of the sulfur grains of these samples.

Figure 5. SEM analysis for samples with pitting outside the yellow-mark area (A3, B3, B4).

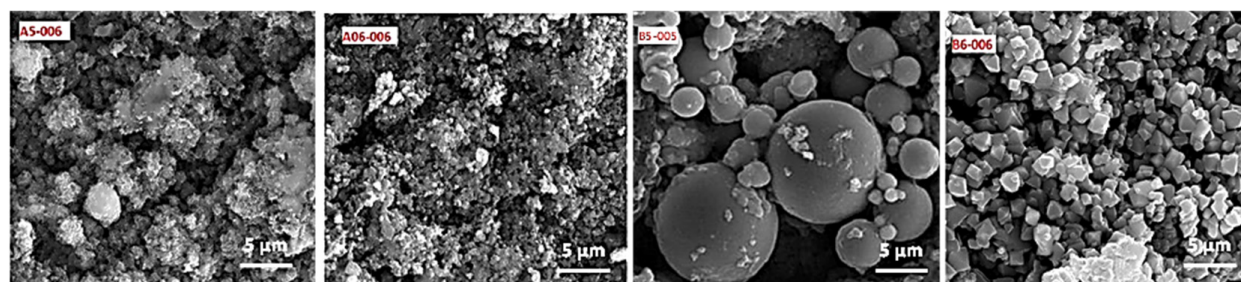
Figure 6 represents the SEM images of the samples with no evident pitting corrosion (A5, A6, B5, B6). It can be noticed that the SEM image of point B5 shows a spherical mineral aggregate. Meanwhile, the caption of the B6 image shows possible sulfur grains.

Figure 6. SEM analysis for samples without pitting (A5, A6, B5, B6).

Carbon, iron, elemental sulfur, sodium, and potassium were found in all EDS analyses. The corrosion deposit layer was found porous (non-adherent) with multiple cracks, which indicates active corrosion. Samples with visible pits were also seen with corrosion products, similar to the one found in the pitted samples. The SEM images clearly indicate active corrosion happening in the piping.

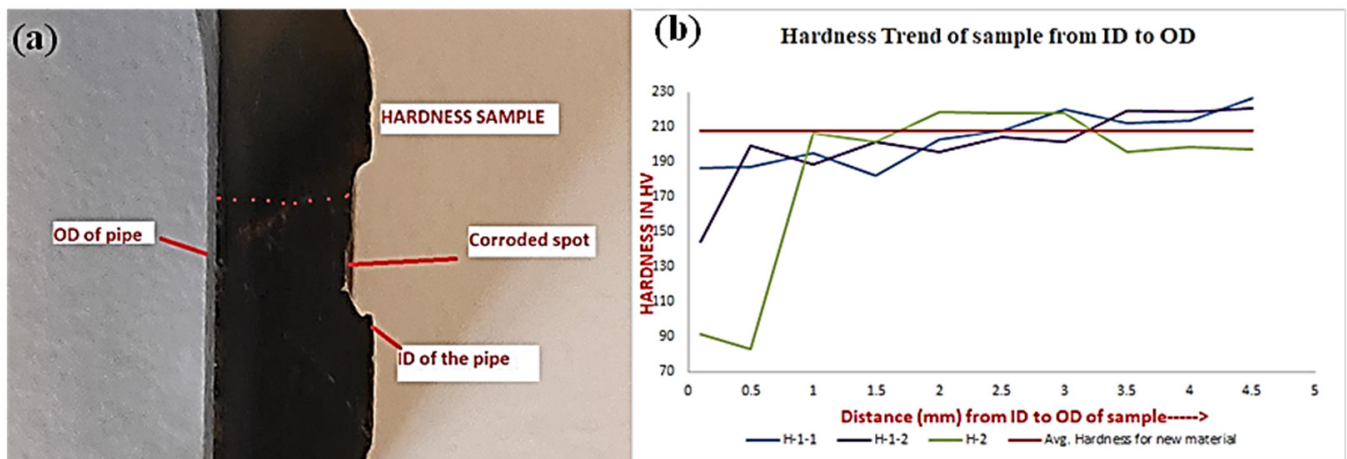
The low thickness is evident at the ID (near the corroded surface) of the samples. Hardness in the bulk material (at center and OD) is observed to be similar to the average hardness of the new API 5L-X60 material. Loss of hardness is aligned with yield strength, and UTS results obtained from these samples. This indicates the effect of a prolonged in-service environment and active corrosion. The overall mechanical results can be summarized as a loss of strength and toughness, accompanied by a reduction in hardness (especially at the exposed surface). Nykyforchyn et al. reported similar results, and it was explained by the proposed theory of the development of microdefectness after 10–20 years of service [11].

Figure 7. (a) Image for one of the tested samples and (b) Hardness results of the samples.

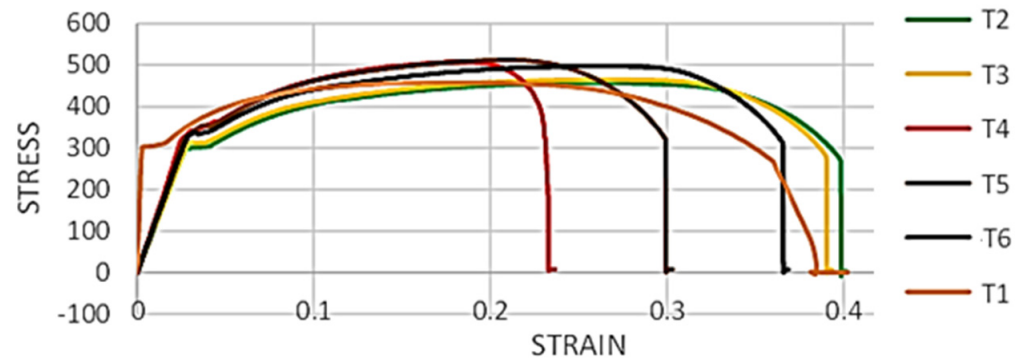
Figure 8 shows the elongated length of all failed samples. It is evident that the elongated length of corroded samples (T4, T5, and T6) is lesser than the elongated length of un-corroded samples (T1, T2, and T3). The difference in the elastic modulus of stress-strain curves is due to the resistance of the sample to elastic deformation; hence, the samples with higher elastic modulus are harder than samples with a lower elongated length. Based on the observed results, the area under the stress strain curve clearly shows a reduction in the toughness of the corroded samples. The loss in yield and tensile strength is evident in all samples (corroded or non-corroded). In wet H_2S environments, the H^+ ions combine with the electron released by the corrosion of piping, and from atomic hydrogen. More active corrosion yields more atomic hydrogen on the piping surface exposed to the sour service. Atomic hydrogen can recombine to form molecular hydrogen, which is usually harmless for steel. However, this atomic hydrogen recombination reaction rate is significantly reduced due to the presence of H_2S . Thus, the accumulated atomic hydrogen on the steel

Figure 8. Stress-strain graphs of all tensile samples.

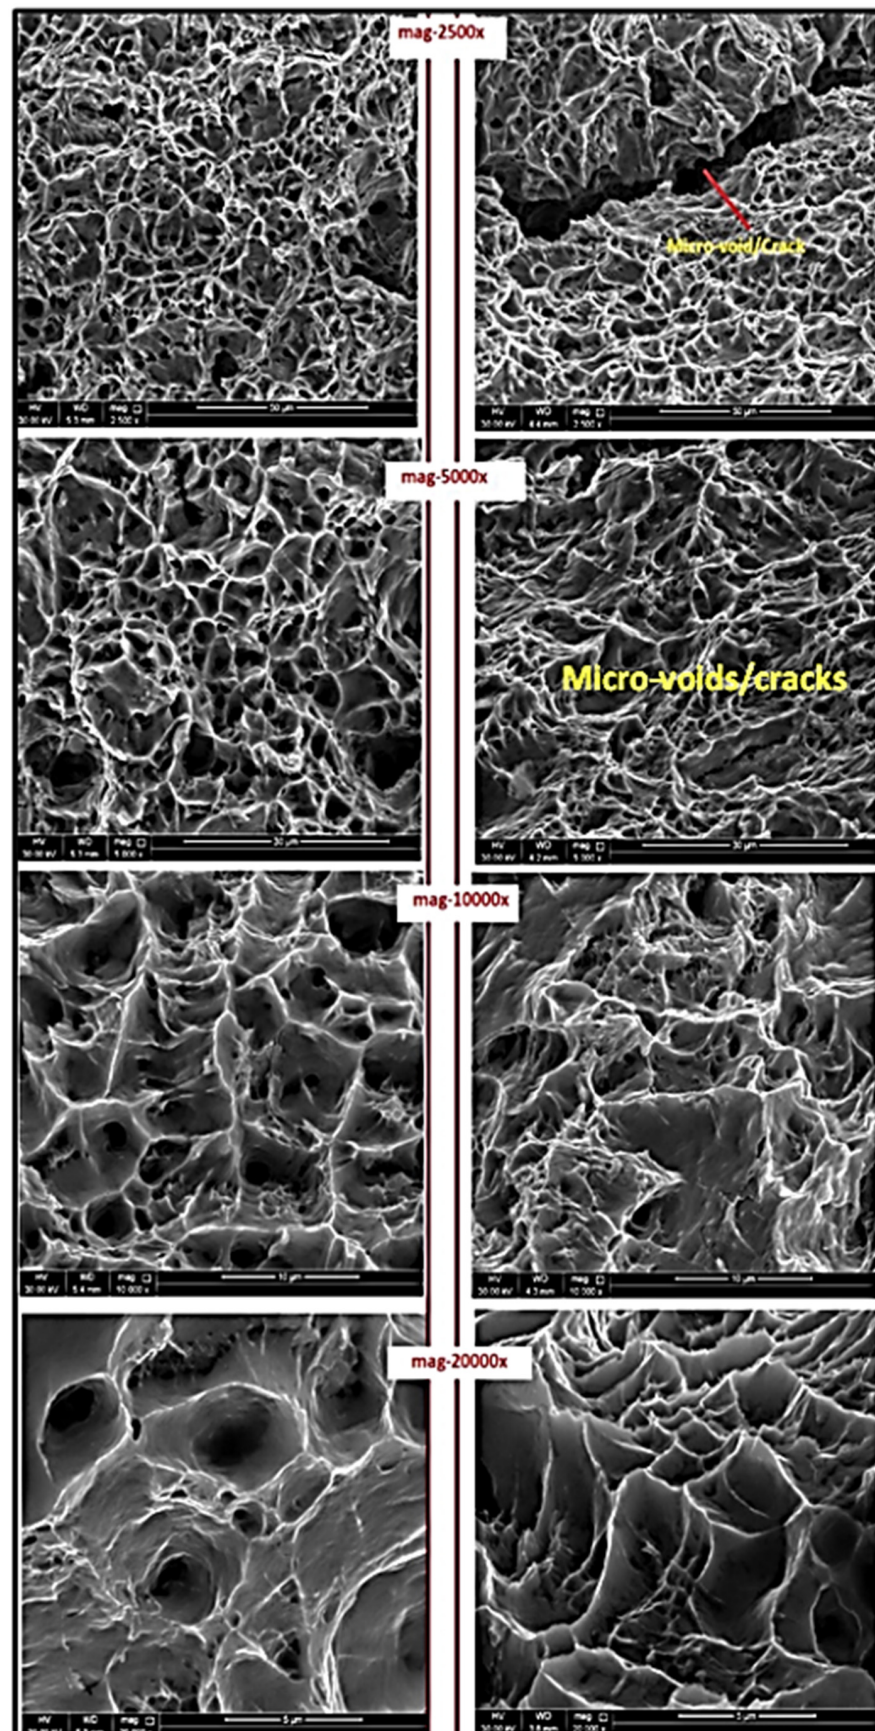
Two fractured surfaces from the tensile test for corroded and non-corroded samples were analyzed with SEM to understand the difference in the failure mode of corroded and non-corroded samples, which are represented by T2 and T4, respectively. Figure 9 shows the SEM images at different magnifications of both samples. Significant differences can be noticed in the failed tips. Micro-voids or cracks can be seen in sample T2. The depth of the cup/cone is significantly more in the T4 sample. Thus, indicating that active corrosion impacts the ductility and microstructure of the piping material. The same was noticed in terms of the elongation% results.

Figure 9. SEM images for failed T2 (Left) and T4 (Right) tensile samples.

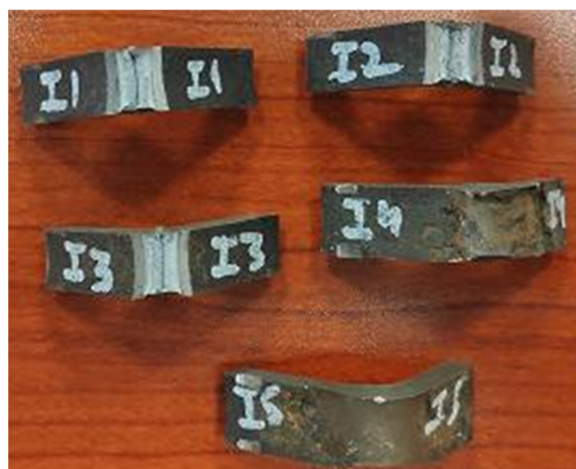
Figure 10 illustrates the broken impact samples. It is evident that the samples without a notch did not break and absorbed more energy. Additionally, the notched samples were not broken into two pieces. However, as per the ASTM standard-E23: If a fractured impact specimen does not separate into two pieces, report it as unbroken. Unbroken specimens with absorbed energies of less than 80% of the machine capacity may be averaged out with the values from broken specimens [14].

Figure 10. Charpy specimens after the test.

A significant decrease in brittle fracture resistance (absorbed energy) at room temperature was noticed in all tested samples. This may be explained by the presence of hydrogen (produced due to corrosion) mostly bound in deep traps and inclusion sites available in the original material. During the impact tests, the diffusion and accumulation of hydrogen were inhibited due to the high-impact speed. The reduction in the Charpy absorbed energy of specimens after corrosion is mainly attributed to the decreasing Fe-Fe bonds and the presence of hydrogen-induced microcracks [20]. Similar results were also reported by researchers while testing an in-service material X52 Steel [11].
