AI and IoT-based concrete column base cover localization and degradation detection algorithm using deep learning techniques

Khalid Naji^a, Samer Gowid^{b,*}, Saud Ghani^b

^a Department of Civil and Architectural Engineering, Qatar University, Qatar

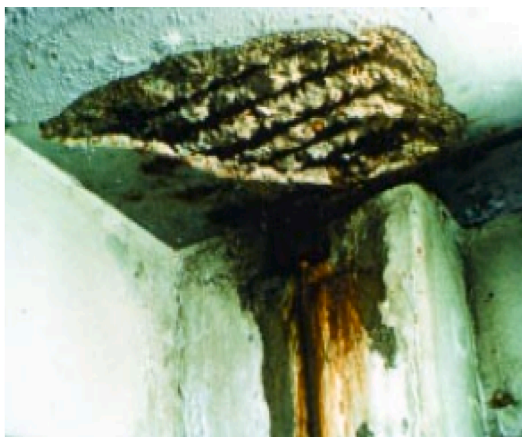
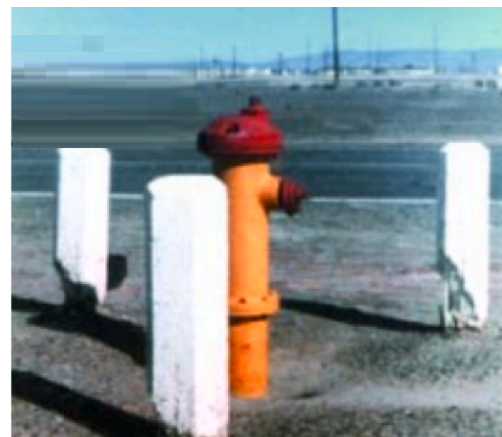
Fig. 1. Causes of concrete spalling.

(a) Corrosion of reinforcing steel

(b) Concrete posts suffered from a sulfate attack

Many facility management organizations are currently investigating technologies to efficiently and timely inspect the health condition of civil structures at reduced labor costs. Visual inspection of concrete structures is costly as it requires intensive and continuous monitoring [1]. Due to the deterioration of concrete and the criticality of the inspection task, smart automated health condition monitoring systems are highly required defects [2 3 4 5]. The following factors summarize the potential causes and the factors that influence concrete deterioration: corrosion of embedded metals is the most common cause of concrete deterioration, freeze–thaw deterioration, chemical attacks due to acids, salts, alkalis, and sulfate found in soil or dissolved in groundwater, abrasion/erosion, exposure to fire/heat, expansion of the aggregates, restraint to volume changes due to the fluctuations in moisture content and temperature, overloads, and impacts [6 7]. Concrete spalling and rebar exposure are among the major concrete column defects and widely exist in buildings and concrete structures (see Fig. 1 [6]). Those defects

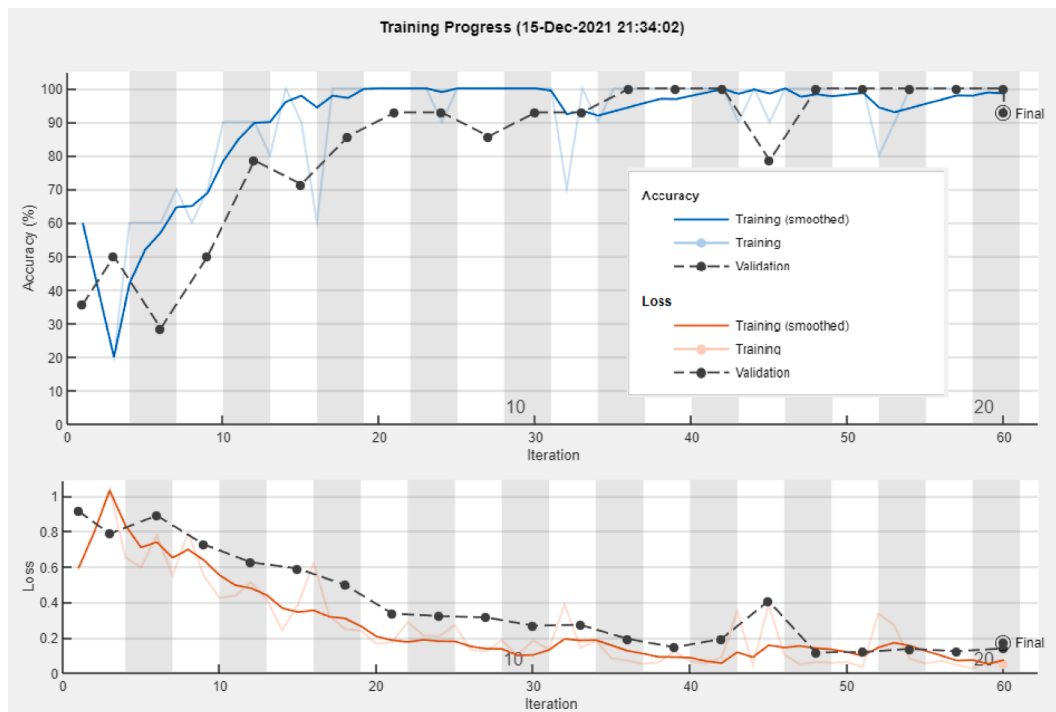
Fig. 8. Training progress of the AI-based defect detection algorithm using Resnet50 network and gray images (classification accuracy of 92.5%, MATLAB Figure).

1) with a total summed score value of 1 for all classes. For example, the algorithm may classify the cover as good with a score of 0.6 and as defected with a score of 0.4, given that the softmax vector includes two elements as we have two classification classes only (good or defected cover). The larger the difference between the classification score of each class, the better classification certainty. Table 1 summarizes the classification scores yielded by the Resnet-50 architecture using RGB images, grayscale images, and different learn rate factors of 10 and 20. All network configurations using different input image types yielded a performance of 100 % except the Resnet-50 network when trained using grayscale images. It yielded a classification performance of 92.5 % only (see line 11 in Table 1).

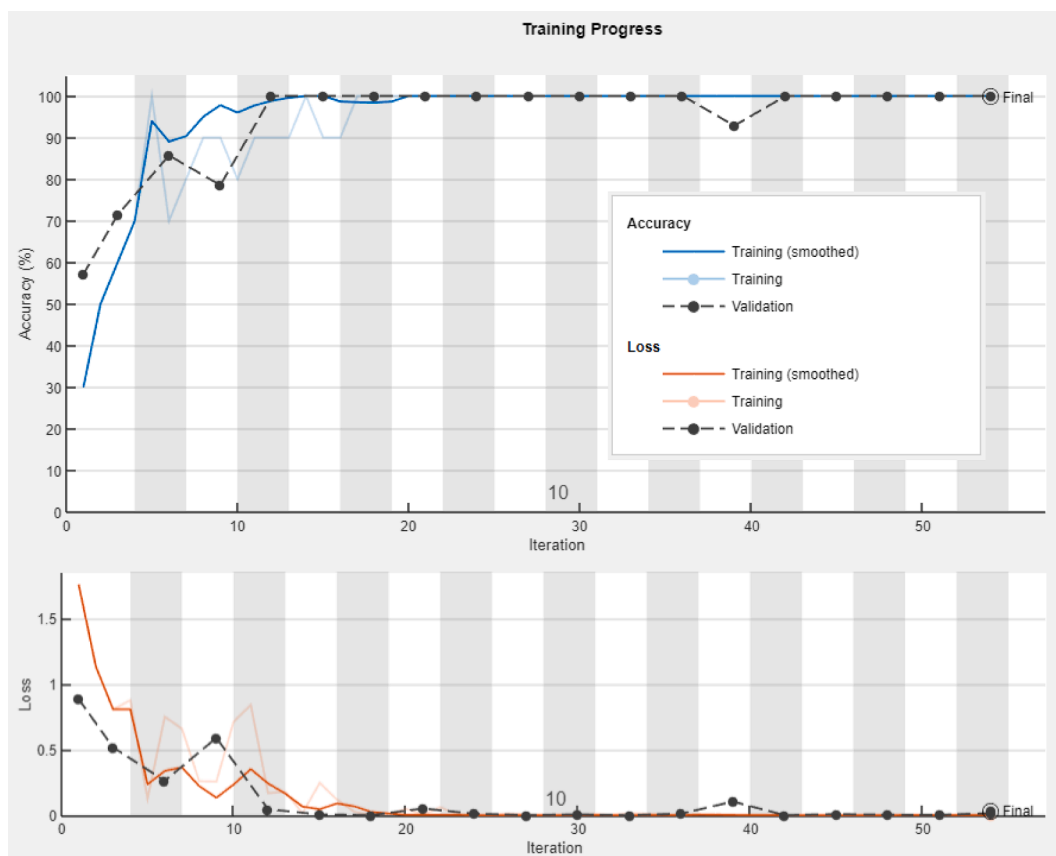
Fig. 9. Training progress of the AI-based defect detection algorithm using VGG19 network and gray images (classification accuracy of 100%, MATLAB Figure).

Fig. 9 shows the training progress of the best-performing pre-trained CNN network. RGB and grayscale images were used as inputs to the CNN network. Despite that, the classification rate remained unchanged at 100 %, the conversion of RGB images to gray images improved the classification certainty as it reduced the maximum error score from 12.77 % to 0.87 % and the RMSE from 4.81 % to 0.29 %.

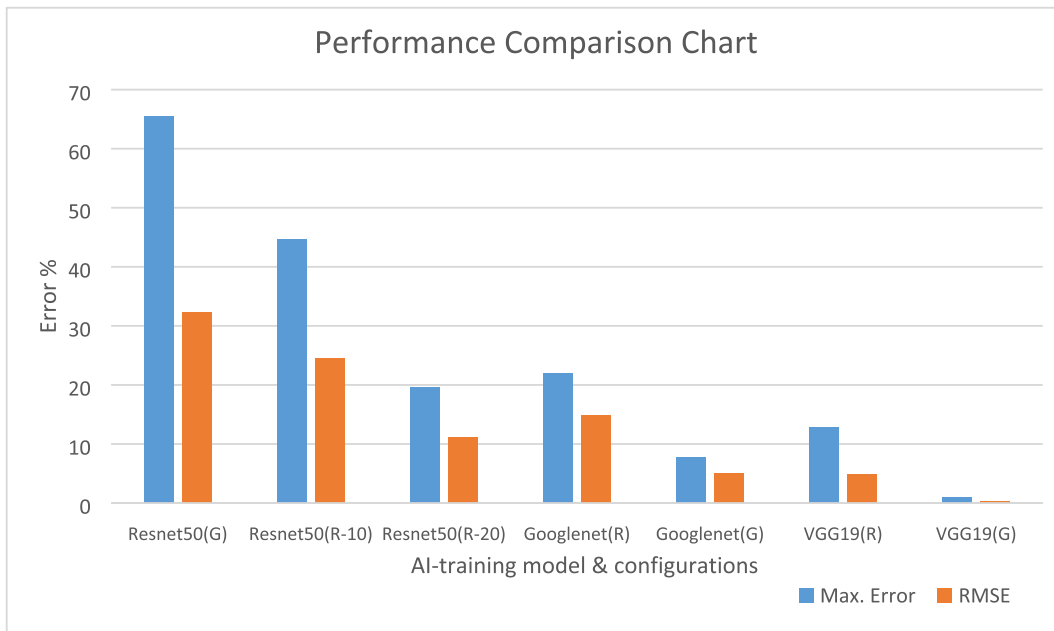
Fig. 10. Performance comparison chart for the addressed deep learning pre-trained algorithms.
