QATAR UNIVERSITY

A NON-DESTRUCTIVE METHODOLOGY FOR LEAK DETECTION IN
WATER NETWORKS USING INFRARED PHOTOGRAPHY (IR) AND
GROUND PENETRATING RADAR (GPR)

Master of Science

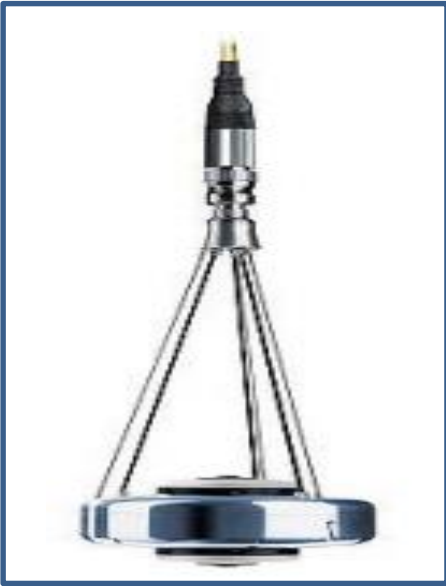
Figure 7. 3D optical manhole scanner [20]

A 3D optical scanner Figure 6 operated with the help of two digital cameras (high resolution) connected to a wide-angle, distortion-free lenses where the captured data are transmitted to a control unit (vehicle) to be stored and analyzed by experts [20].

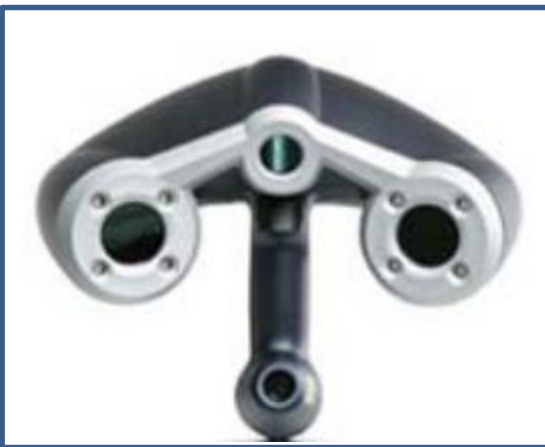
Figure 8. Handy scan 3D [20]

Handyscan 3D approach Figure 7 is a visual leak detection technique that consists of two cameras of laser and stereo vision combined for accelerating the process of profiling the object's surface with high-resolution images that can be analyzed using special softwares [20].

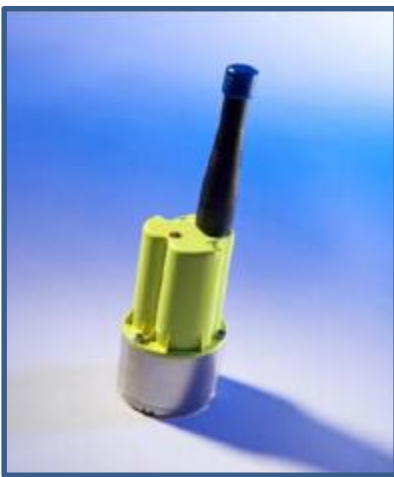
Figure 13. Permalog [20]

Permalog Figure 12 is an acoustic system installed in-pipe for detection and classification of leak noise in water distribution networks. It can be installed semi-permanently or permanently through valves or pipe fittings and can be collected back using magnets. It usually operates at night where the background noises are minimum, and pressure is high. Once the leak is detected the unit produces an alarm sound and emits a radio signal to indicate a leak event [33]. Information carried by the loggers can be retrieved by removing the loggers and acquire the data manually (lift and shift) or by transmitting the data through radio through a patrol system to a moving patrol vehicle (drive by), or through transmitting the data directly to a lab computer using radio network (PermaNet). Due to its ease usage, Permalog has been implemented by several water authorities (Las Vegas Valley Water District, West Virginia American water, and Birmingham Water Works Board).

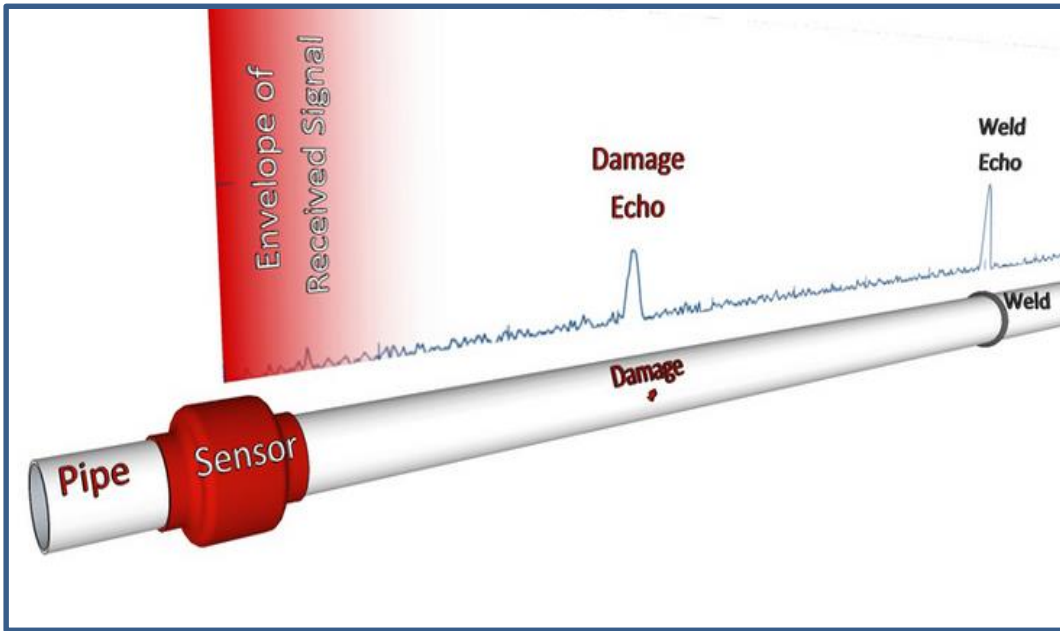
Figure 14. Ultrasonic guided wave pipeline inspection diagram). Courtesy of 164th Acoustical Society of America Meeting

axis. Guided wave technique is applicable for pipes with a diameter greater than 50mm and wall thicknesses less than 40mm, also elevated pipe can be inspected using such a technique. However, it is limited by 30m length away from the ring.

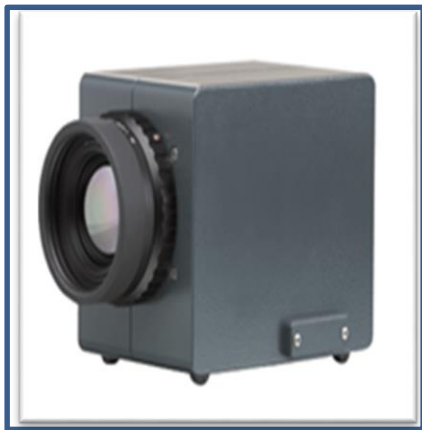
Figure 16. VarioCAM hr head thermographic system

A *VarioCAM hr head* thermographic system was used in performing the set of field experiments Figure 15. The system has a Long Wave Infrared spectral range (LWIR) of 7.5 to 14 μm . The lens reflects the object scene onto a microbolometer array at a resolution of 384 x 288 pixels, which means that each image will be translated to 110,592 temperature data points. A wide-angle lens was used to capture the IR radiation emitted by the object in the field of view (FOV) and to duplicate it onto the detector array with a focal length of 12.5mm and a minimum focus of 0.2m. Other properties and technical specifications of the *VarioCAM hr* system are stated in Table 6.

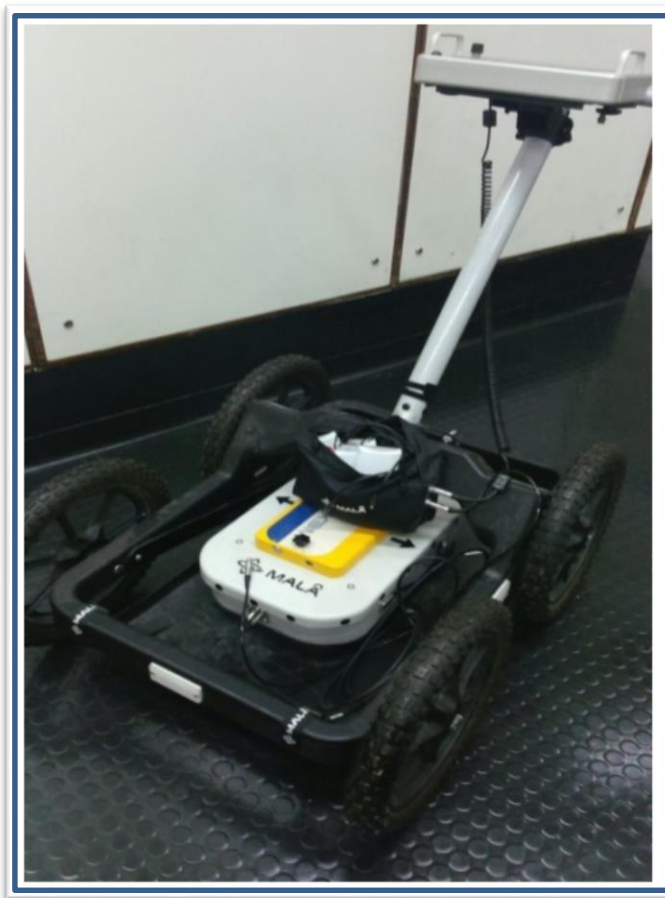
Figure 17. Ground Penetrating Radar (GPR), on a Terraplug Rough Terrain Cart

A MALÅ Ground Penetrating Radar (GPR), placed on a Terraplug Rough Terrain Cart (RTC), was used in this study Figure 16. The MALÅ GPR was equipped with two shielded antennas, 250 MHz antenna (Dimensions: 0.74 x 0.44 x 0.16 m – Weight: 7.85 kg) and the shielded 500 MHz antenna (Dimensions: 0.50 x 0.30 x 0.16 m – Weight: 5.0 kg).

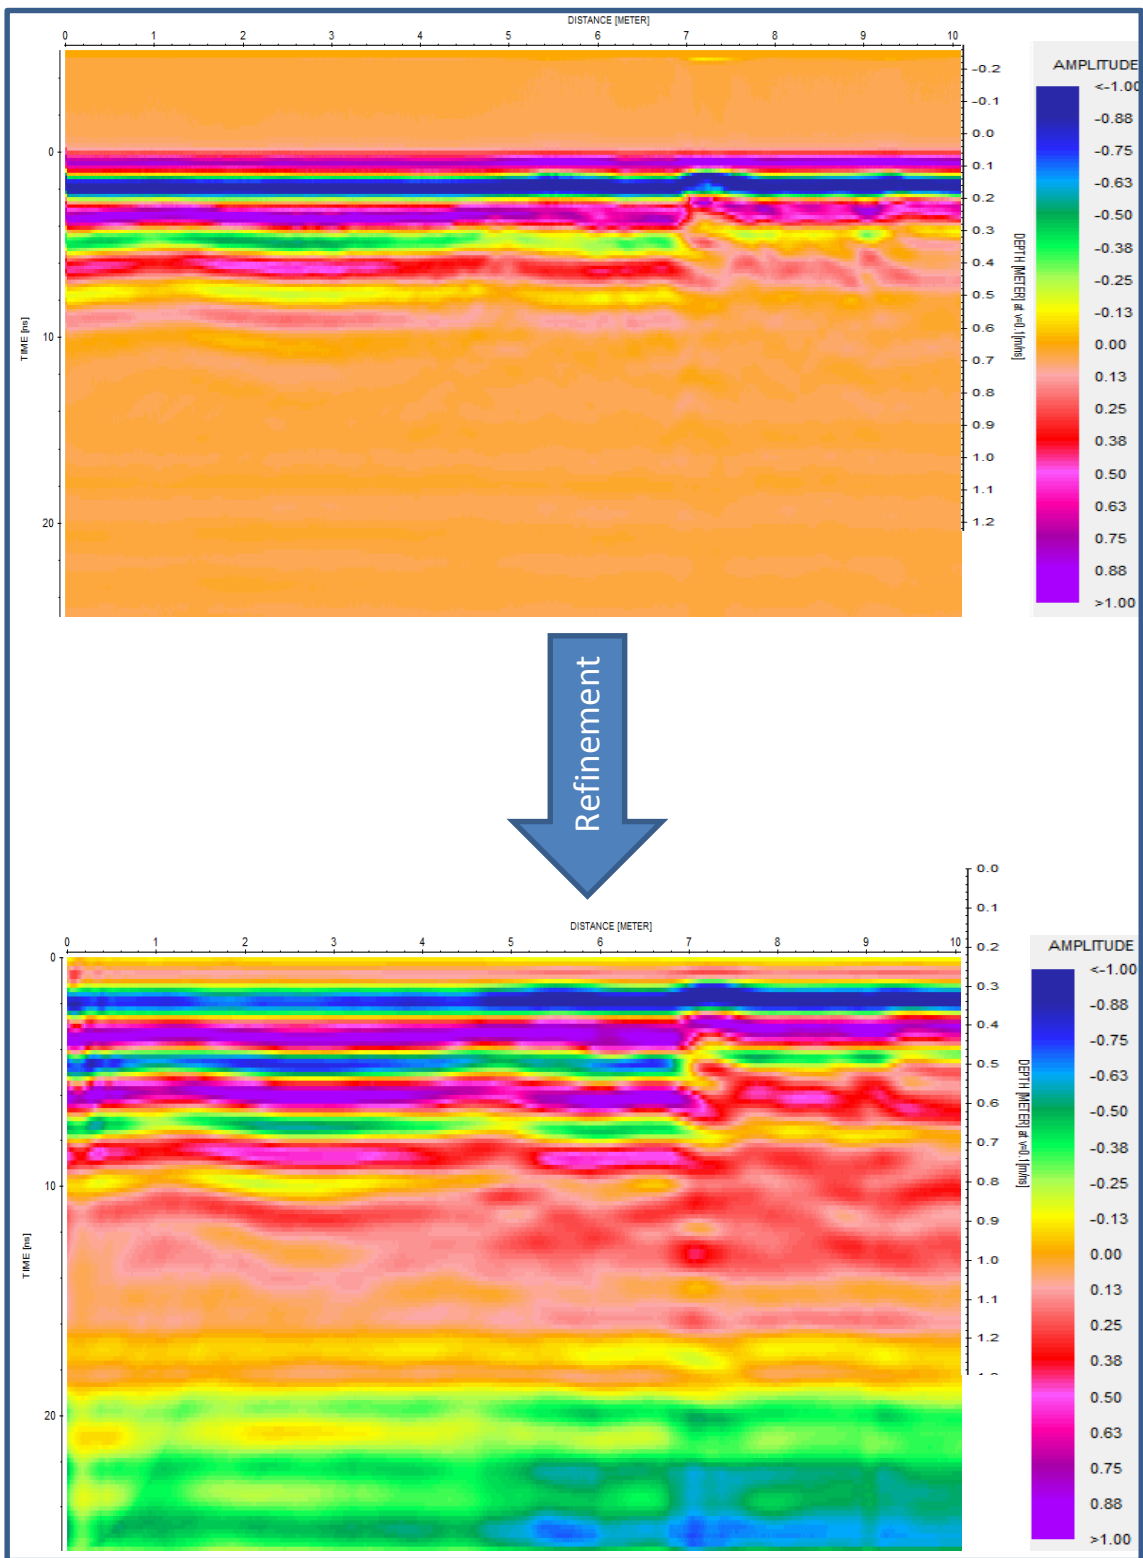
Figure 18. Difference between the raw radargram data and the refined data (after migration)

Additional refinement includes eliminating the undesirable features of the radargram profile such as the area of the ground surface (separation between the antenna and the ground surface). This area is illustrated by the negative values of the depth scale. Those anomalies were processed using the static correction function. As mentioned earlier, electromagnetic properties of the scanned medium or mediums identify the nature of the reflected GPR waves (signatures). Signatures such as reflection strength, polarity, signal attenuation, two-way travel time and hyperbolic reflection are fundamental for the qualification and identification of subsurface features.

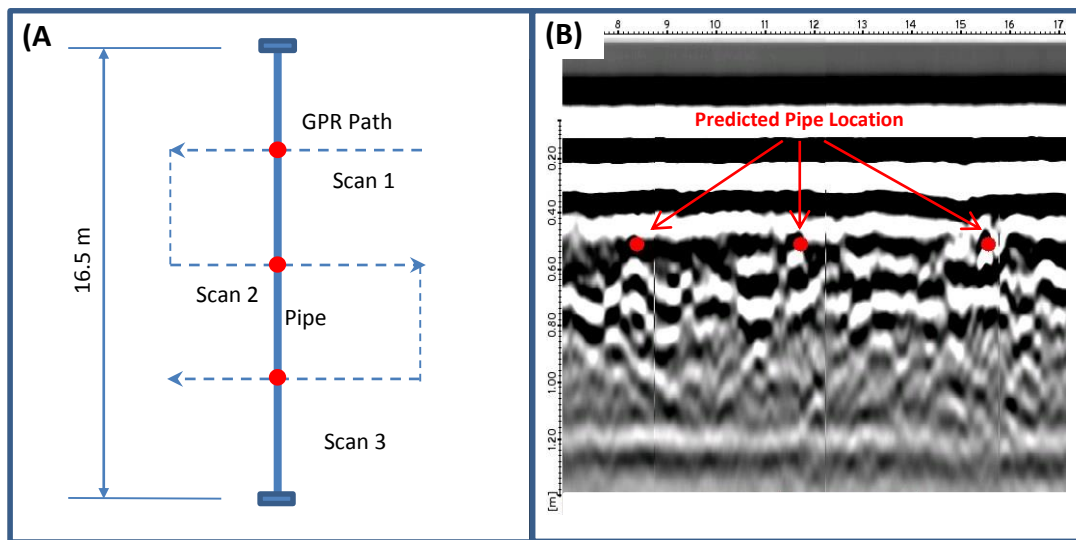
Figure 20. (A) Profile of the subsurface using the MALÅ Ground Penetrating Radar (GPR) equipped with the 500 MHz shielded antenna, location of the pipe is indicated by the hyperbola indicated by the red dots (B) Path of the GPR on top of the buried pipe

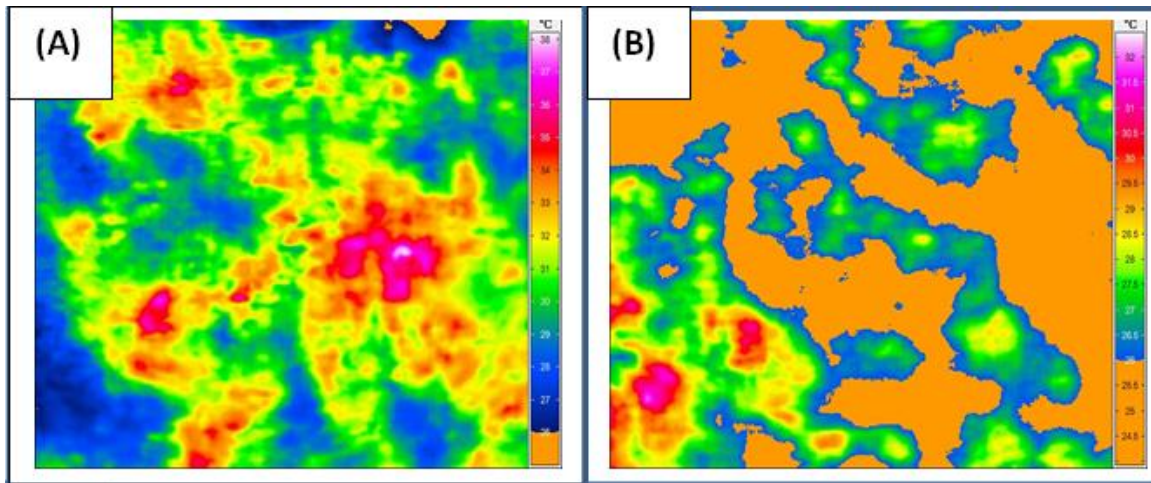
At a height of 1 meter and speed of 2 km/h the first trial of thermography was performed resulting in 15 thermal images distributed along the 16.5 meters pipe. After collecting the IR images, their scale was adjusted to obtain a strong color contrast. As shown in Figure 21(A) the color degradation for the simulated leak ranged from pink (37°C), representing the highest temperature, to blue, representing the lowest temperature (26°C). Since the temperature of the water used to simulate the leak (i.e. 24°C) was less than the surrounding ground surface temperature, the orange color in Figure 21(B) could represent the leak. In the same manner, the scale of images collected from each operating condition was adjusted.

Figure 21. (A) IR image for simulated leak case study “dry location” (B) IR image for simulated leak case study “wet location”

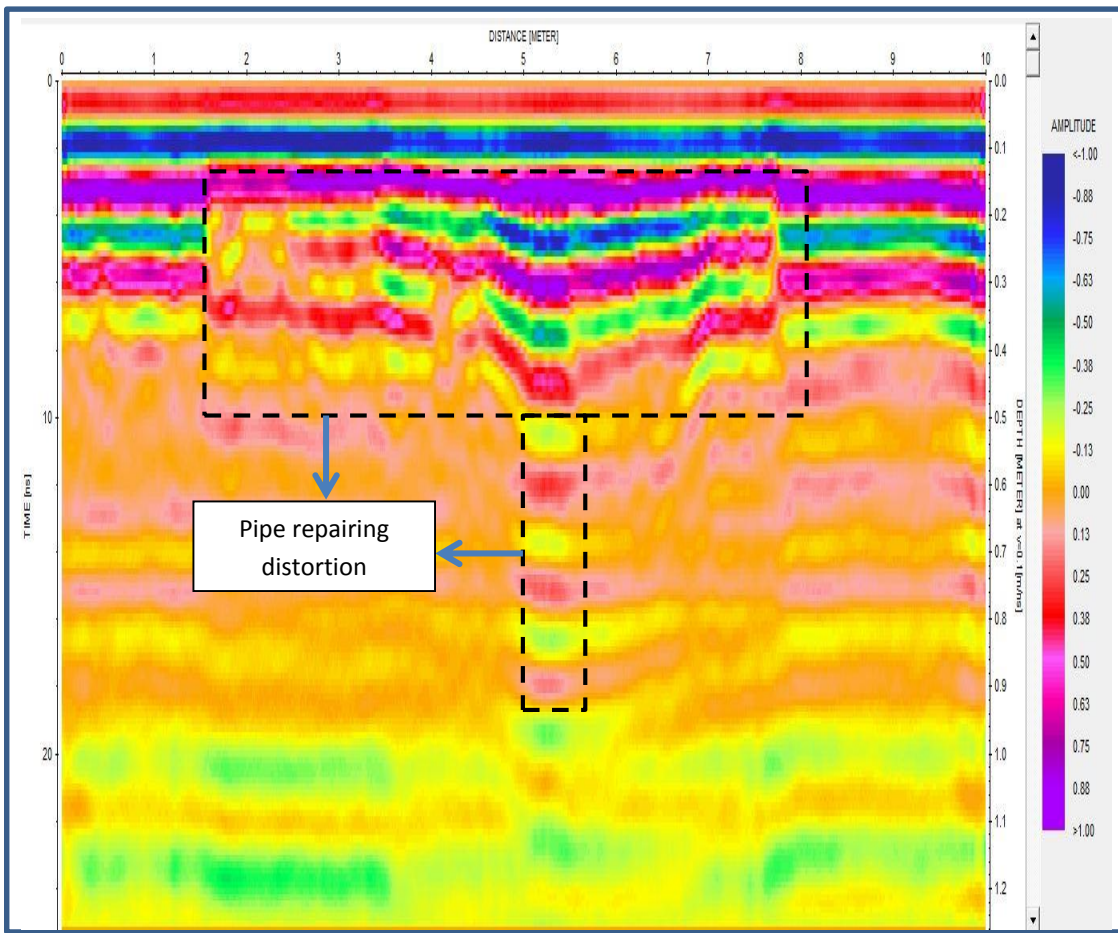
Figure 52. Refined radargram of the dry case

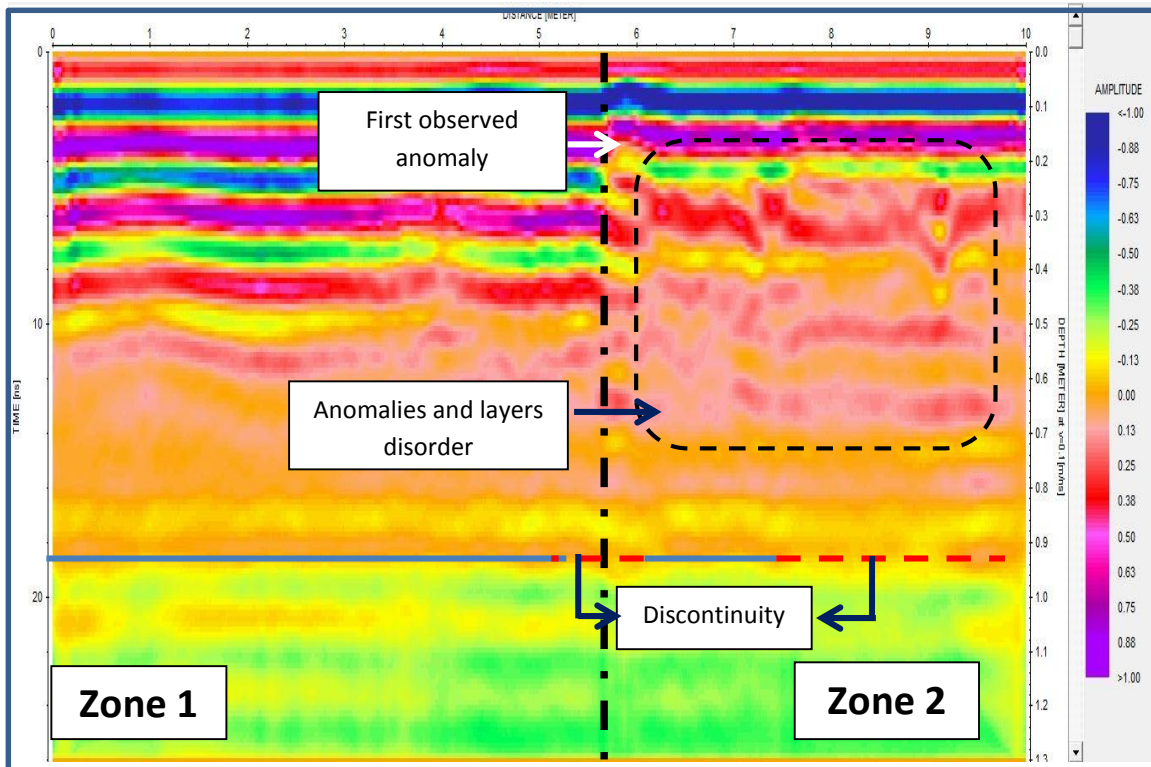
Figure 53. Refined radargram of the wet case

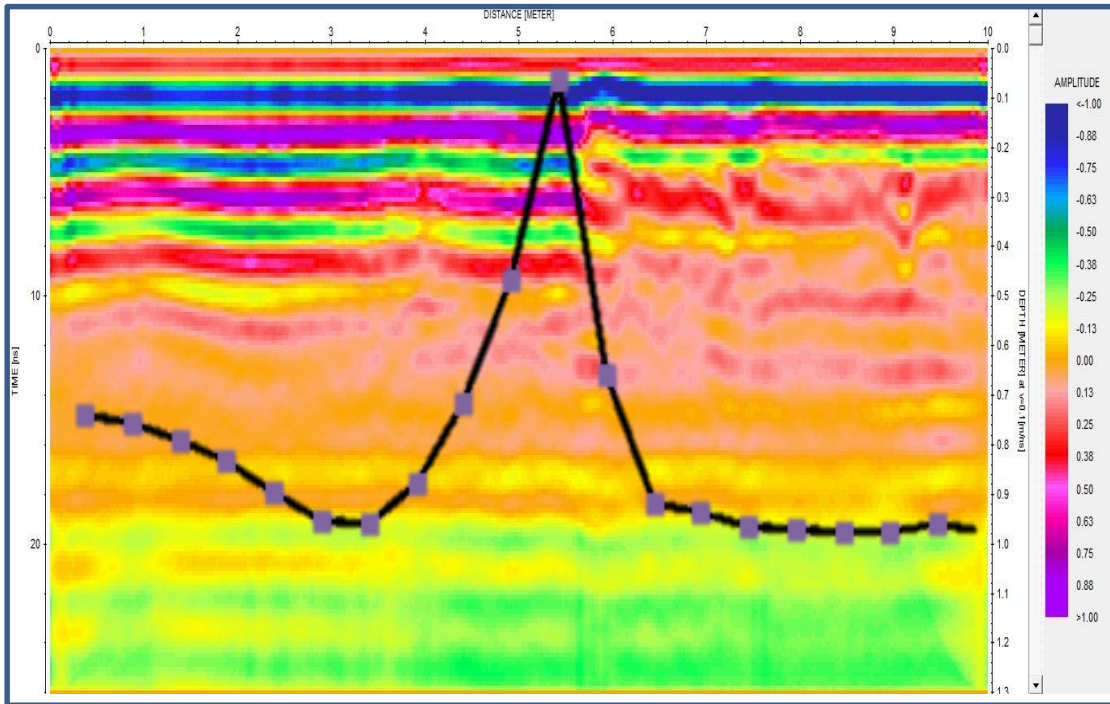
Figure 54. IR Results superimposed on the refined wet radargram
