Design and Construction Risk Management of Souq Waqif Station of Gold Line, Doha Metro

ABSTRACT

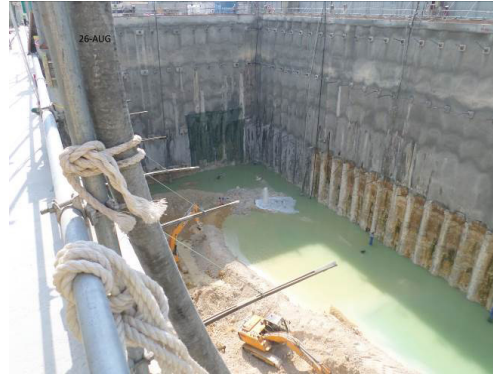
Figure 4: Water ingress inside the station due to karstic feature

On the 25th August 2015, during the excavation works and with approximately 2m remaining ground to be excavated until the base slab formation level was reached, a karstic feature was encountered resulting in excessive water inflows inside the station (Figure 4). This adverse condition posed great difficulties to the continuation of the station excavation and hindered the base slab casting to enable the timely passing through of the approaching TBMs, a critical schedule activity associated with contractual milestones. Prior to encountering the karst feature, the water inflow recorded due to the active dewatering was around 12,000m³/day, whereas post the occurrence of the event, the water inflow recorded was 24,600m³/day as an average value with a recorded maximum of 56,688m³/day.

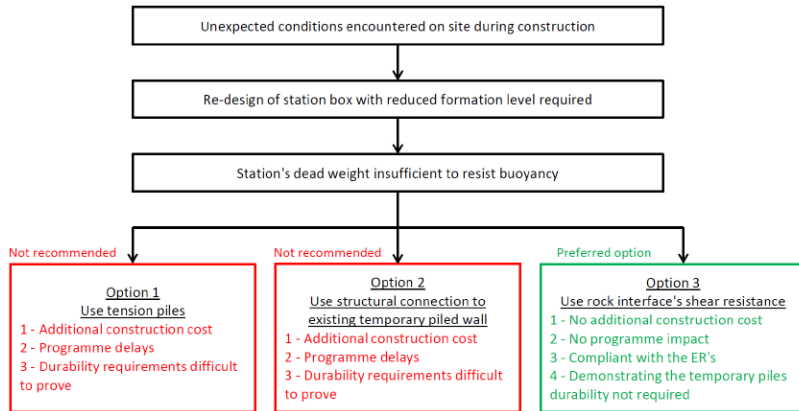
Figure 7: Comparative assessment of alternatives considered to counterbalance buoyancy

The original station design foresaw a 3.4m layer of unreinforced concrete over the station base slab to counterbalance the buoyancy effect (see Figure 6). Due to the planned future development next to the station box and the requirement for direct connection of the station's concourse level with the development, there was very limited overburden available for landscape purposes and utilities, which was practically neglected in the flotation checks. In addition and as per the Qatar Rail Employer's Requirements, the groundwater design level was considered to be on the ground surface. That was considered the worst case given the proximity of the station to the sea and the adjacent construction and dewatering works, which were taking place concurrently in the area. In fact and based on past aerial photographs, it was identified that the station was located very close to the original coastline.

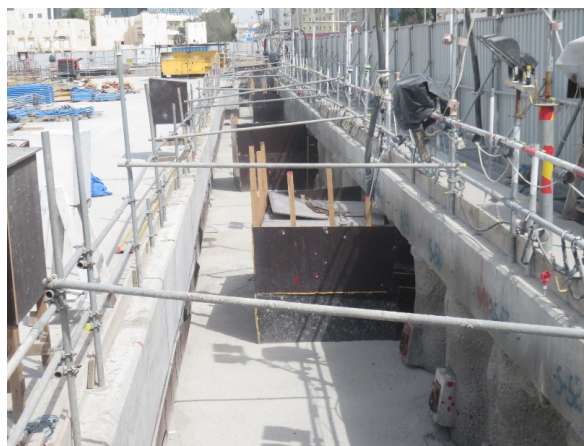
Figure 11: Encased dewatering well inside the lean concrete backfill

As per the original design, the area between the temporary support pile wall and the external wall of the station would be backfilled with permeable rock type fill material. With this configuration in place, the groundwater would be filtered and led to the pumps inside the dewatering wells and any overpressure would be relieved through the drainage channels below the base slab. However, given the spatial constraints which dictated the backfilling and compaction equipment to be used, the productivity rate was lower than anticipated. Hence in order to improve the backfill construction performance which would also enable the earlier decommissioning of the dewatering system, it was decided by the contractor to replace the rock type fill with lean concrete. The backfill with impermeable material necessitated thus the construction of an encasement around the dewatering well, which was filled with permeable material (see Figure 10 and Figure 11).
