An Innovative Structural Solution to Failed Stabilized Earth Embankment in Multilevel Interchange

Cite this article as: Kara A., Tahoun T., “An Innovative Structural Solution to Failed Stabilized Earth Embankment in Multilevel Interchange”, *International Conference on Civil Infrastructure and Construction (CIC 2020)*, Doha, Qatar, 2-5 February 2020, DOI: <https://doi.org/10.29117/cic.2020.0116>

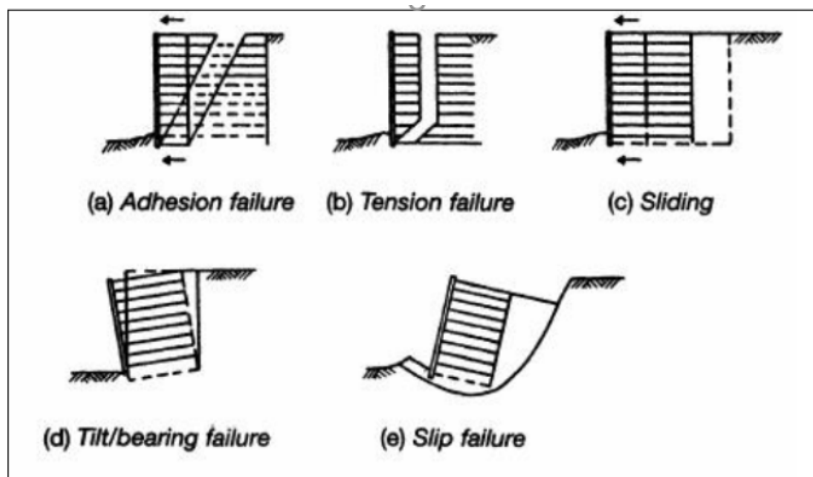
Figure 3: MSE Walls Typical Failure, adapted from (Bobet, 2002)

Accordingly, it was concluded that the partially failed section in the MSE wall at the side is typical to tilt/bearing capacity failure mode as described by (Bobet, 2002), see Figure 3

The likely cause of the bearing capacity failure is the repetitive migration of dune sand under the adjacent road due to several leaks and movement of water, resulting in partial loosening of the foundation ground under the outer part of the MSE wall. The movement took place at the current location since the foundation fill, because of loosening, could not carry anymore the load/height of the MSE wall. On the other hand, the sections towards the lower level of the embankment, which are mostly affected by the migration of the sand with several wash out cavities, did not fail due to their reduced height (less than 2m).
