## **Erosion-Corrosion Behavior and Failure Analysis of Offshore Steel Tubular Joint**

*E. Mahdi<sup>\*</sup>, A. Rauf, S. Ghani, A. El-Noamany and A. Pakari*

Mechanical and Industrial Engineering Department, College of Engineering, Qatar University, P. O. Box 2713, Doha, Qatar, Tel. No: +9744034309,

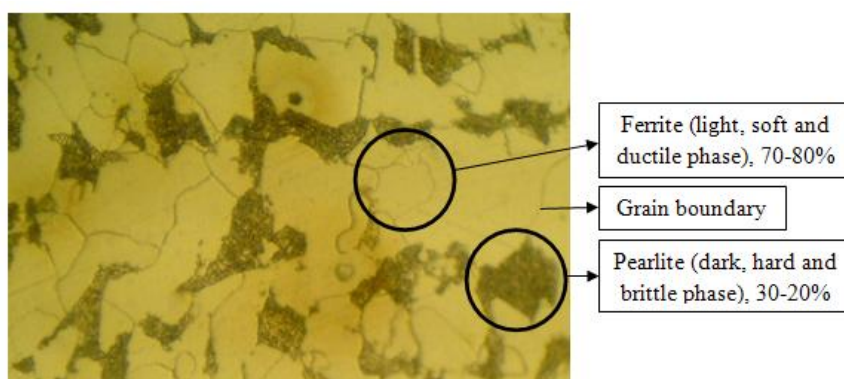
Figure 19. The microstructure at a magnification of 1000X

The microstructure at different magnifications (100X, 200X, 500X and 1000X) is shown in Figure 18. The fact that the microstructure was revealed using Nital validates the assumption that the material used to make the T-joint is Carbon Steel. To determine more information concerning this material, the microstructure at a magnification of 1000X is further studied (Figure 19). Two phases can be seen in the microstructure; the light Ferrite and the dark Pearlite phases. The availability of those two phases indicates that the material is Carbon Steel with Carbon content in the range from 0.022 to 0.76 wt% C. The Ferrite phase is a soft and ductile phase, but the Pearlite phase is a hard and brittle phase. The Ferrite phase is available in more quantities than the Pearlite phase. The ratio is approximately 7:3. This indicates that the material is actually Low Carbon Steel (0.05 to 0.25 wt% C). Due to the existence of those two phases, the material properties are expected to be intermediate between them but a little closer to the properties of the Ferrite phase since it is available in more quantities. Also, the metal has likely been slowly cooled during the heat treatment of manufacturing process. ASTM E112 standard test methods considers one of the most widely cited ASTM standards,

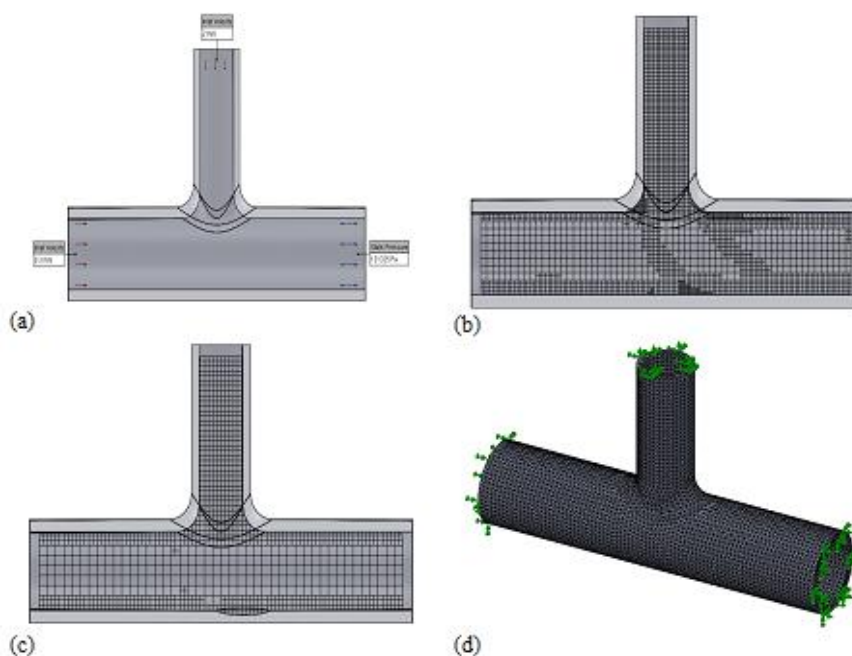
Flow simulation is carried out using SolidWorks [24]. Flow Simulation on undamaged and damaged (i.e. eroded) models with the boundary conditions shown in Figure 27. Using flow simulation results (Figure 28), fatigue analysis is performed assuming repeated loading conditions. The results include cut plots of the velocity contours and vectors, the turbulence intensity contours, the velocity contours and vectors of the eroded section, the pressure contours of the eroded section, the fatigue load factor of the eroded section. From these figures, it is noted that the flow from the 2 m/s velocity inlet directly hits the eroded location and that a swirl is developed in that location. It can also be seen that the highest turbulence intensity is noted in the eroded location. These observations indicate that our earlier discussion of flow direction is valid. It is also noted that the swirl developed is growing in size as the location erodes. The highest pressure is noted in the vicinity of the eroded location. This indicates that the eroded location is under high loads. It can also be noted that the eroded location is susceptible to fatigue. Noting that this location has a very rough surface and thin walls, and that fatigue life is highly depended on surface condition, the eroded location is, in fact, the location most susceptible to fatigue cracking. FEA greatly helped in determining and verifying the failure mechanism.

**Figure 27.** (a): Section of the T-joint model with boundary condition (b) The mesh of undamaged T-joint model (c) The mesh of the eroded T-joint model (d) Complete model.
