## Failure Analysis of 316L Air Cooler Stainless Steel Tube in a Natural Gas Production Field

The purpose of this work was undertaken to study an industrial case regarding the failure behavior of 316L SS air chiller tube supplied by a Qatari Gas Company. Macroscopic failure characteristics of the specimens were examined using SEM and XRF techniques.

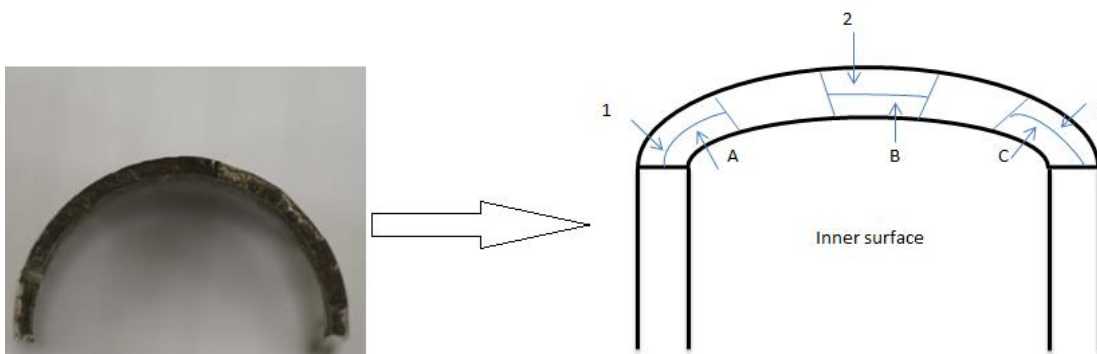
**Figure 2.** Schematic macrograph for the investigated areas at the fracture surface of 316L SS tube.

At the outer surface of the tube (exactly behind the crack) a horizontal cross section parallel to the crack propagation plane was done without touching the crack surface, as shown in Figure 2. The test locations are indicated by arrows as shown in Figure 2. In other words, the fracture surface has been divided into six sections, the three alphabets sections are closed to the inner surface exposed to the gas (A, B and C) and the other three numerical sections are closed to the outer surface. The length of each inspected section is 10 mm.

In Figure 2, regions A, B and C show the SEM images taken from the inner surface which was in contact with the processed gas and regions 1, 2 and 3 show the SEM images of the outer surface. Fry's Reagent Etching techniques per ASTM standard E. 407 as No. 79 revealed the microstructure.
