Impact of Prolonged Exposure to Sour Service on the Mechanical Properties and Corrosion Mechanism of NACE Carbon Steel Material Used in Wet Sour Gas Multiphase Pipeline

The corroded sample analyzed in this research is part of a wet gas inlet pipeline coming from offshore and going to the slug catcher. The corroded piping was a 2" bypass of an emergency shutdown valve (ESDV13) installed on a 38" mainline, as seen in Figure 1.

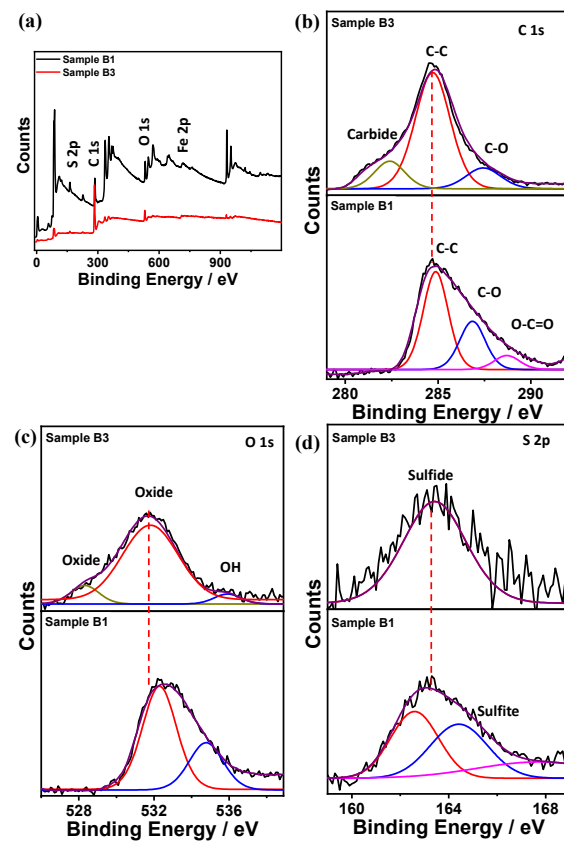
The peak fitting of XPS data shows the presence of hydrocarbon, iron oxides, iron sulfide, iron sulfite, and elemental sulfur. The presence of elemental sulfur explains the yellow layer observed in the corroded samples during visual inspection. Glycol was injected into the piping during every winter season to inhibit hydrate formation, which explains the presence of hydroxide in deposits. The presence of elemental sulfur in a sour environment makes it very aggressive for corrosion [19]. Elemental sulfur is generally present in the sour gas coming from offshore and is produced due to oxidation of H₂S. Like the temperature, the pressure of the pipeline changes, and the elemental sulfur can accumulate on the pipe surface and cause a catastrophic corrosion of carbon steel [21]. The corroded pipe taken for this research is a dead-leg (a portion of pipe with no flow/intermittent flow), and thus conditions are ideal for the elemental sulfur deposition. Formation of elemental sulfur can take place in an aqueous system as a result of the oxidation of sulfide species, as shown by the following equations [22]:

Other researchers hypothesize that an electrochemical reaction between iron and polysulfide is the driving force for corrosion in systems with the presence of elemental sulfur [24,25]. Though a consensus has not been reached in terms of the actual corrosion mechanism related to the elemental sulfur, Figures 11 and 12 depict the XPS analysis for different corroded samples (A1/A3) and (B1/B3), respectively. XPS, carried out to see the effect of element sulfur on corrosion rate, concludes that the absence of sulfur decreases the corrosion rates by two-fold, thus proving that even 1 ppm of elemental sulfur can significantly contribute to higher corrosion rates [26].

Figure 12. XPS spectrum for samples B1/B3 (a) full survey, (b) carbon, (c) oxygen, and (d) sulfur.

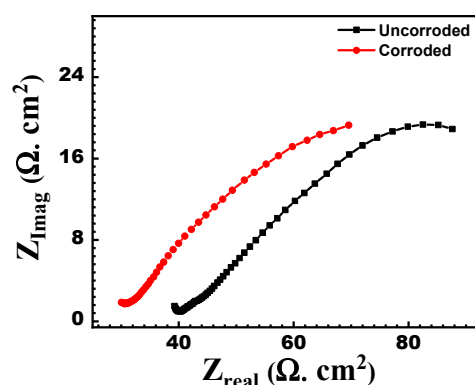
Figure 14 shows the measured Nyquist EIS data for uncorroded and corroded API-5L-X60 specimens immersed in 0.5 M Na_2SO_4 to compare the corrosion behavior of the two specimens. Table 7 clearly shows that the corroded sample (without polishing) exhibits a lower corrosion resistance when compared to the un-corroded polished sample. This also proves that the corrosion product layer on the corroded sample does not adhere and is not sufficient to stop further corrosion. These results are also aligned with the SEM images, which showed the porosity in the corrosion deposits found in the samples.

Figure 14. Nyquist plots for the measured EIS data (dots) for non-corroded (black) and corroded (red) API-5L-X60 specimens immersed I 0.5 M Na_2SO_4 . The solid lines are the fitted curves.
