Coordinated robotic system for civil structural health monitoring

Abstract. With the recent advances in sensors, robotics, unmanned aerial vehicles, communication, and information technologies, it is now feasible to move towards the vision of ubiquitous cities, where virtually everything throughout the city is linked to an information system through technologies such as wireless networking and radio-frequency identification (RFID) tags, to provide systematic and more efficient management of urban systems, including civil and mechanical infrastructure monitoring, to achieve the goal of resilient and sustainable societies. In this proposed system, unmanned aerial vehicle (UAVs) is used to ascertain the coarse defect signature using panoramic imaging. This involves image stitching and registration so that a complete view of the surface is seen with reference to a common reference or origin point. Thereafter, crack verification and localization has been done using the magnetic flux leakage (MFL) approach which has been performed with the help of a coordinated robotic system. In which the first robot is placed at the top of the structure whereas the second robot is equipped with the de

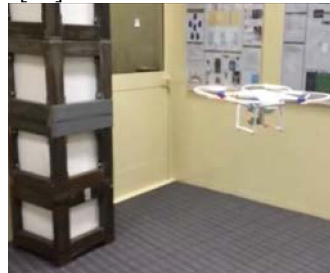
In our research the images has been obtained using a commercially available UAV (Phantom Professional-3), as shown in Fig. 1(a). The reason of selecting this UAV is because of its high stability and control mechanism which is ensured through different control and sensing modules such as gyroscope, 3-axes accelerometer and an ultra-sonic sensor [17]. The UAV during inspection process is shown in Fig 1(b).

Fig. 1. Phantom drone in (a) stationary and (b) during inspection.

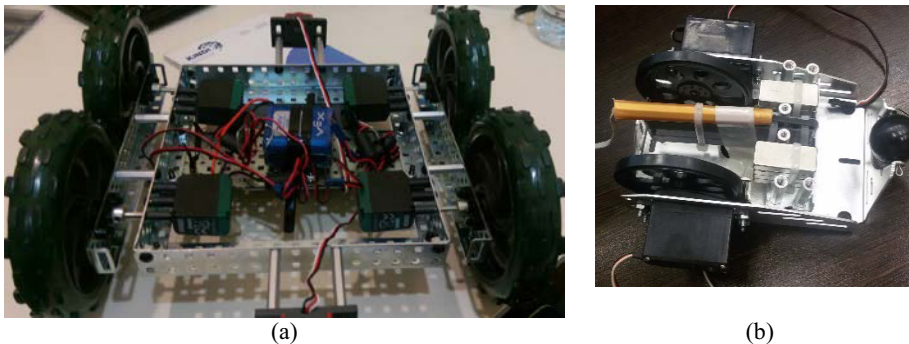
The FMR should be strong enough to hold the SMR and other environmental effects like strong wind, gravitation pull etc. Moreover, it should have a precise motion along with other features like obstacle detection to avoid any collision. However, in this research, a Lab grad scaled version of FMR has been used which is designed using a VEX robotic kit [18], as shown in Fig. 2(a).

The FMR is also equipped with ultra-sonic sensors which can help the FMR to change its path in case of obstacle. The control mechanism of FMR is done with the help of Arduino Mega2560 Microcontroller. It is also responsible to coordinate between the FMR and SMR. A compass and GPS module is also placed in FMR which helps to estimate the target location with respect to the current location.

The SMR is designed in such a way that the size of the robot is small enough to move on all parts of the target structure. It has its own motors and controller as well but the motors are small enough to be easily driven by a 9V battery. The permanent magnet along with the MFL sensor are placed at the lower base of the robot, as shown in Fig. 2(b). The SMR is connect with a wire controlled by the wrench motor placed on the FMR.

Fig. 2. The coordinated robot for MFL (a) FMR and (b) SMR.

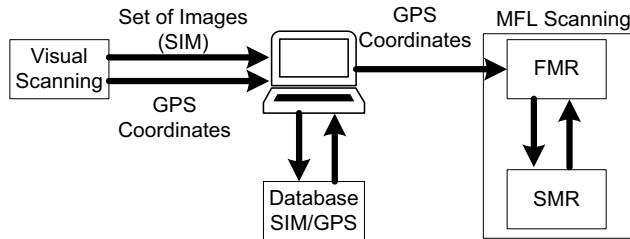
because the FMR is present at the top of the building whereas the drone is flying at particular distance from the building. In order to obtain a correct translation the drone should remain at particular distance from structure during the whole scanning process. The robot will take its direction based on the comparison result between its current GPS coordinates and the translated received GPS coordinates. As the robot moves it will keep checking the current GPS values and take decision accordingly.

Since there might be some temporary or permanent obstacle present on the roof for decoration purpose. Therefore an ultrasonic range sensor has been used such that when the robot come close to an obstacle at defined distance the sensor will guide the robot to change its path and as soon as the obstacle is disappeared from the sensor range the robot will again start checking the GPS value to reach to its target destination.

Fig. 3. Overall Inspection approach.

As it reaches to the target destination it will instruct the wrench motor to allow the SMR to reach to the location and obtain the current MFL reading of that place. These reading will be sent to the System. If an anomaly is detected then it is verified that the structure is having deformation at that particular location. If in vision based approach multiple anomalies have been detected then the robot will perform same procedure to determine the faults.

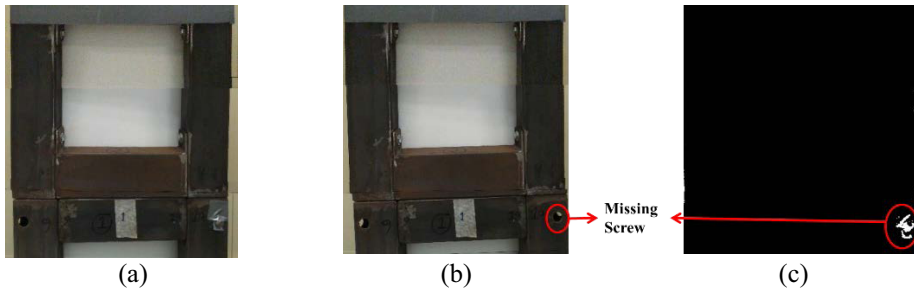
The VBI from UAV has been performed by taking multiple images before and after the induced anomaly. The first set of images which was taken without anomaly are termed as images without crack (IoC), whereas the images taken after anomaly are termed as images with crack (IwC). These images are first stitched together and then the final stitched result of IoC and IwC are subtracted from each other to observe the presence of anomaly.

In this research the anomaly has been created by removing a screw from the structure. The stitched result for IoC and IwC along with the difference between them are shown in Fig. 4. It should be noted that the displaced screw has been clearly identified.

Fig. 4. Stitching results using stationary UAV for (a) IoC (b) IwC, and the crack identification (c) after filtering the subtraction result of (a) and (b).

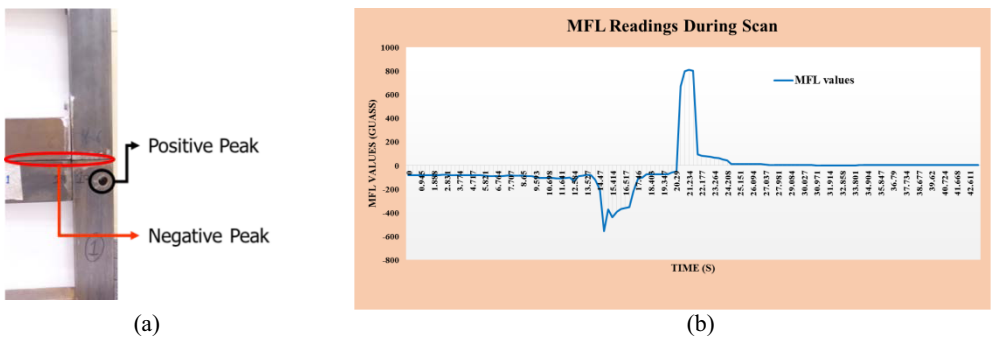
After detecting the presence of anomaly the respective GPS location along with the expected height has been sent to the FMR which directed the wrench motor and the SMR to move to that location and verify the presence of anomaly using MFL. The obtained result has been shown in Fig. 5, it should be noted that the graph has two peaks one is at the negative direction while the other is at the positive direction. Also, the negative peak comes before the positive one.

The reason of having a negative peak is because of the junction between two structural blocks as indicated clearly in Fig. 5(a). The structure which is used in this research consist of three cubes placed on each other. The place where the cubes boundaries touching each other have an inherent cavity at that point. At every junction the metal thickness will increased which decreases the magnetic field. Whereas, the positive peak is actually representing the absence of screw because the leakage in magnetic flux increase if there is an opening.

Although the negative field is false indication but this false indication will be marked for future so that the field change in these points will be ignored in future inspection. However if VBI indicates problem at the points of false indication then an inspector will be required to investigate that area.

Fig. 5. Inspection results from MFL sensor.
